Structural Monitoring of the Mexico City Cathedral

Roberto MELI
Res. Professor
Inst. of Eng., UNAM
Mexico City, Mexico

Summary

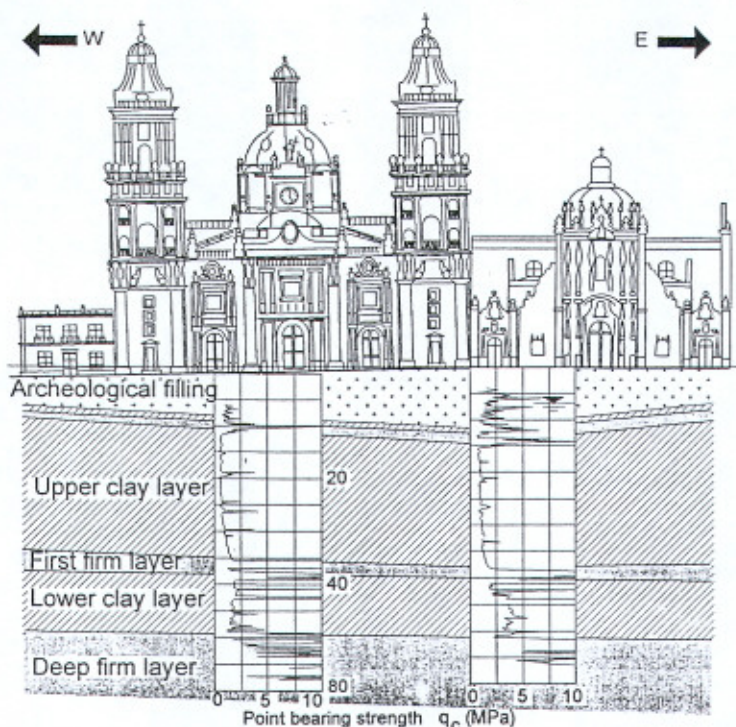
The Mexico City Cathedral has been severely affected by differential settlements experienced by its foundation since the very beginning of its construction. Initially, large settlements were caused by soil consolidation due to the extremely large weight of the monument (1.27 MN) built on the very soft clay deposits of the Mexico City Valley. More recently, the intense pumping of the aquifer has been the main cause of subsidence. The monument was erected on the remains of Aztec temples and pyramids, which had preconsolidated the soil under some parts of the construction while in the rest the soil remained much softer, thus giving rise to large differential settlements. A front view of the Cathedral and of the adjoined Sagrarium is shown in Figure 1, along with a soil profile.

Subsidence has produced structural damage since the time of the construction of the temple, and an almost uninterrupted repair activity has been required, since the age of the temple construction. In recent years, the distortion of the building was such that its structural safety was severely undermined. The differential settlement between the Southwest corner and the Apse reached 2.42 m in 1991 and was increasing at a rate of 12 mm/year. Some of the main columns supporting the roof showed an out-of-plumbness near to 3%, and severe cracks in roof, floors and walls constantly reappeared, in spite of frequent repairs. The total settlement of the monument since the beginning of its construction has been estimated as 7.5 m.

Figure 1 Front view and soil profile of the Cathedral and the Sagrarium (right side)

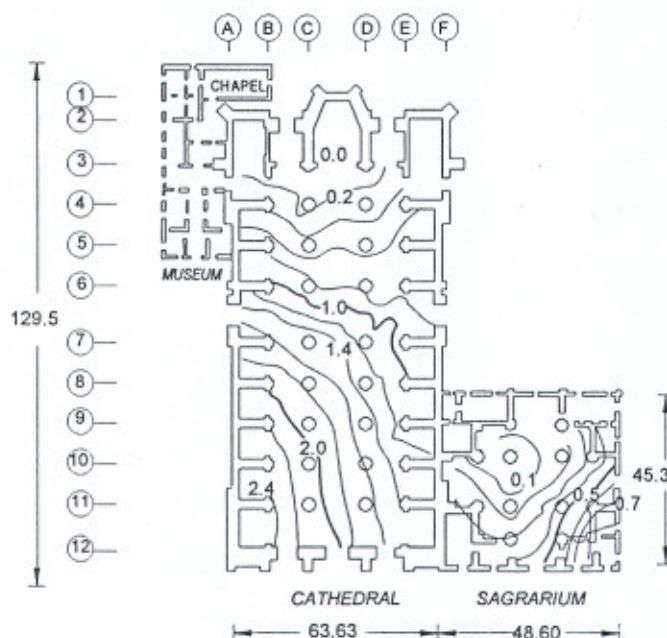
The most relevant results are those of the bimonthly leveling of the floor. Figure 2 shows the pattern of differential settlements before the beginning of the correction. The extraordinary amount of these settlements can be easily appreciated, along with the large distortion they produce to the structure.

Figure 2 Differential settlement, in meters (Dec 1989)

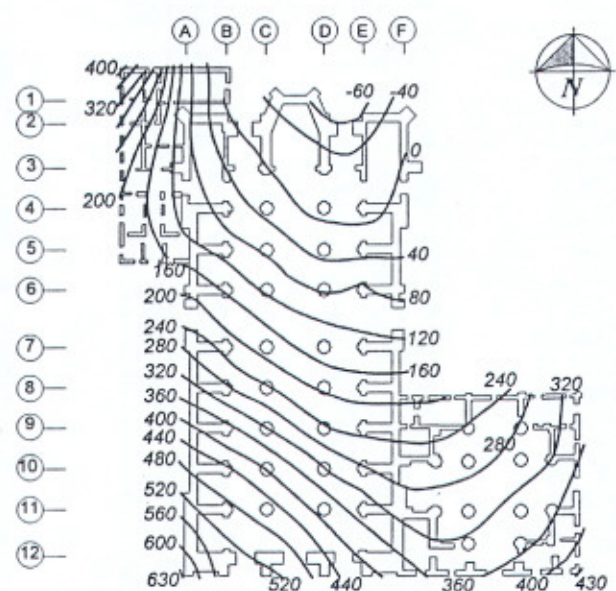
Figure 3 Differential settlements between Oct 1991 and Dec 1996, in millimeters

As shown in Figure 3 the pattern of settlements produced during the correction process is very nearly opposite to the existing one, demonstrating the appropriateness of the adopted procedure.

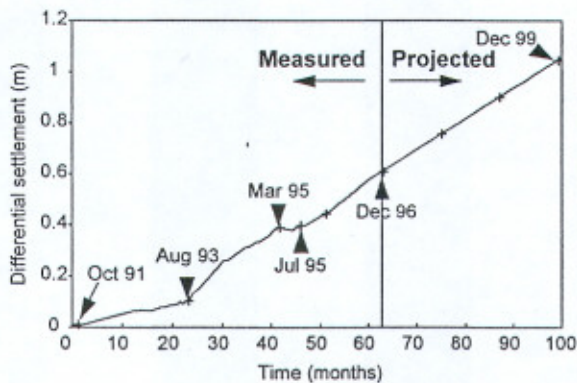
Figure 4 shows the variation with time of the correction of the differential settlements between the Southwest corner and the Apse. As it can be appreciated, a correction of 620 mm has been already reached and, by maintaining the same rate of correction, a reduction of about 1 m can be achieved by the end of 1998.

Figure 4 Evolution of the reduction in the differential settlement between the South West corner and the Apse

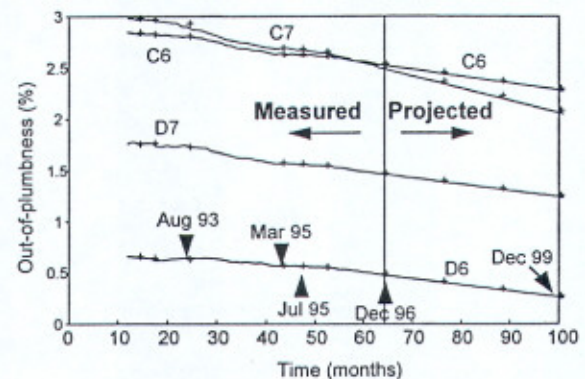
Figure 5 Correction of out-of-plumbness of the central columns

Among the results of other measurements, the reduction of out-of-plumbness of the central columns is to be pointed out. From Figure 5, it can be appreciated how each of the four central columns has been reducing its out-of-plumbness, but that the rate of reduction has been relatively small; therefore, the final correction at this regard cannot be expected to be very large.

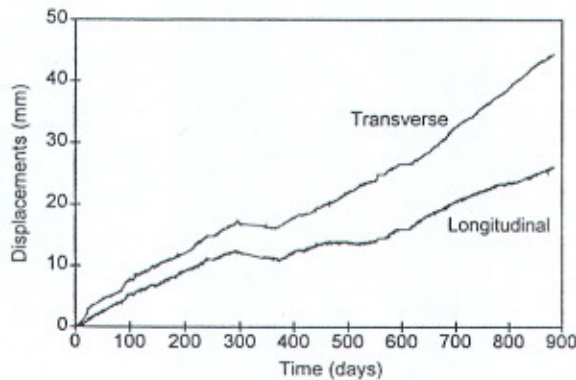
The system has been working without problem; readings are extremely stable and, due to the large size of induced motions, the noise produced by ambient effects is negligible. As an example, Figure 6 shows the displacements experienced by upper parts of one of the central columns, from the completion of the instrumentation, in July 1994, to December 1996. An almost constant correction rate can be appreciated, except for the period from April to June 1995, where the

Figure 6 Displacement of the upper end of central column C7

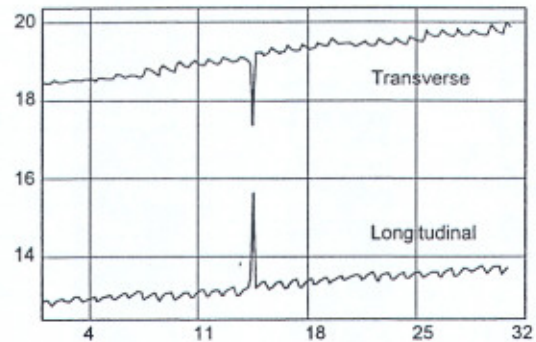
operations had to be interrupted and the original trend of settlements was reestablished. When the underexcavation was resumed, the correction took immediately the same path and rate. A more detailed view of the results is given in Figure 7, where the same results are amplified for a period of one month. The graph is still very stable and the effect of the sudden motion due to a small earthquake can be appreciated.

Figure 7 Displacements of central column C7 during Sep 1996 (mm)

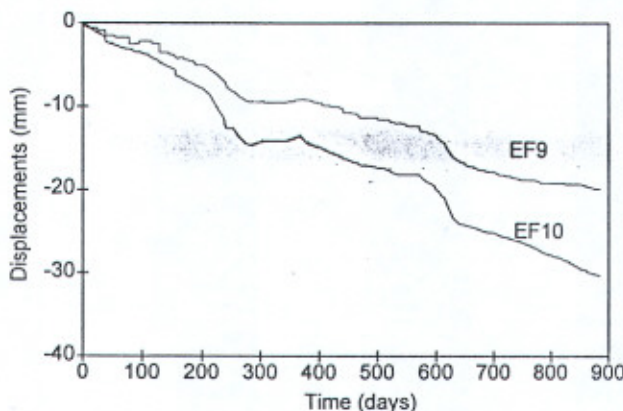
Figure 8 Span reduction of the central nave from Jul 94 to Dec 96

In a similar fashion, the evolution of the closing of the central nave in the southern part of the temple is shown in Figure 8. As it can be observed, initially the rate of span reduction was relatively high, nevertheless, once the existing cracks were closed, the rate of span reduction was significantly diminished, despite attempts to reduce the stiffness of the vaults by cutting some masonry diaphragms in the extrados.

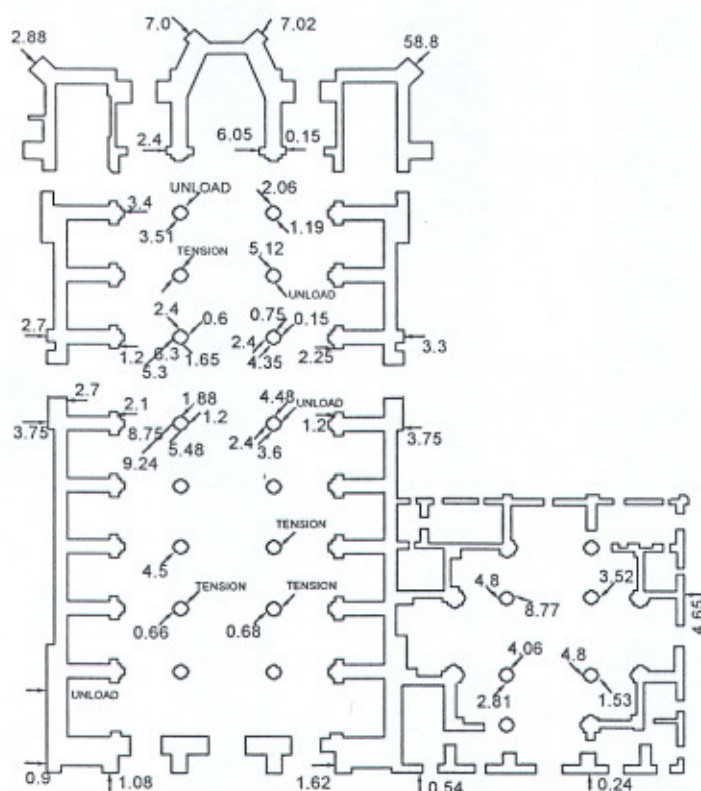
Stresses were measured by this technique in columns at different heights and in some walls. The main results are shown in Figure 9. Maximum compressive stress was 9 Mpa for one of the central columns. A large variation of stresses within the column section was observed, following a roughly linear trend, thus indicating the presence of significant flexure in the columns.

In general terms, measured stresses were rather consistent for different sections and for repeated measurements at the same section. Some readings were affected by a problem derived from the particular way the flat-jack technique was applied to columns in this case. The cuts to introduce the flat-jack were made in the mortar of the horizontal joints. In some of these joints, small pieces of stone had been placed to level the upper line of stones; therefore, large concentrations of stress were produced due to the high rigidity of these stones, whereas the mortar in their vicinity was relieved of stresses. This problem was studied in detail by doing several measurements in column D-10, where some very low stresses had been measured. From these considerations some measurements were discarded because they were made in the vicinity of very stiff points.

Figure 9 Compressive stresses measured through the flat-jack techniques (MPa)

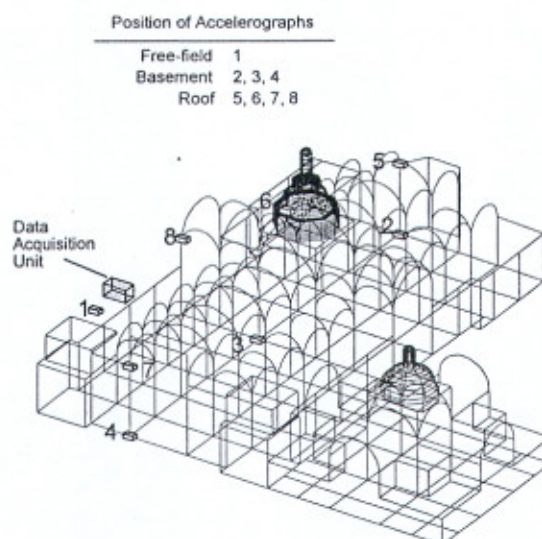
Figure 10 Accelerographic Network

In order to obtain basic information about the seismic response of buildings of this kind, a network of eight accelerographs has been recently installed (Figure 10). One instrument is located in the ground outside the temple, to provide a reference motion in the free-field. Three accelerographs are placed in the basement to identify possible differences in the motion imposed to the buildings due to variation in soil properties and lack of monolithism of the foundation. Four additional accelerographs are placed in the roof to measure the amplification of the motion at different points, and the possible out-of-phase motions of parts of the structure separated by the main lines of cracking.
