## Summary

Following a restoration program commenced in the Seventies, the Church of S. Maria di Castello of Alessandria (Piedmont, Italy) is not plastered and its foundations are bare: this makes it possible to appreciate the severity of the damages to the building. This paper describes a non destructive testing campaign (core drilling and inspection to the brickwork, flat jack tests, monitoring system) which is currently underway.

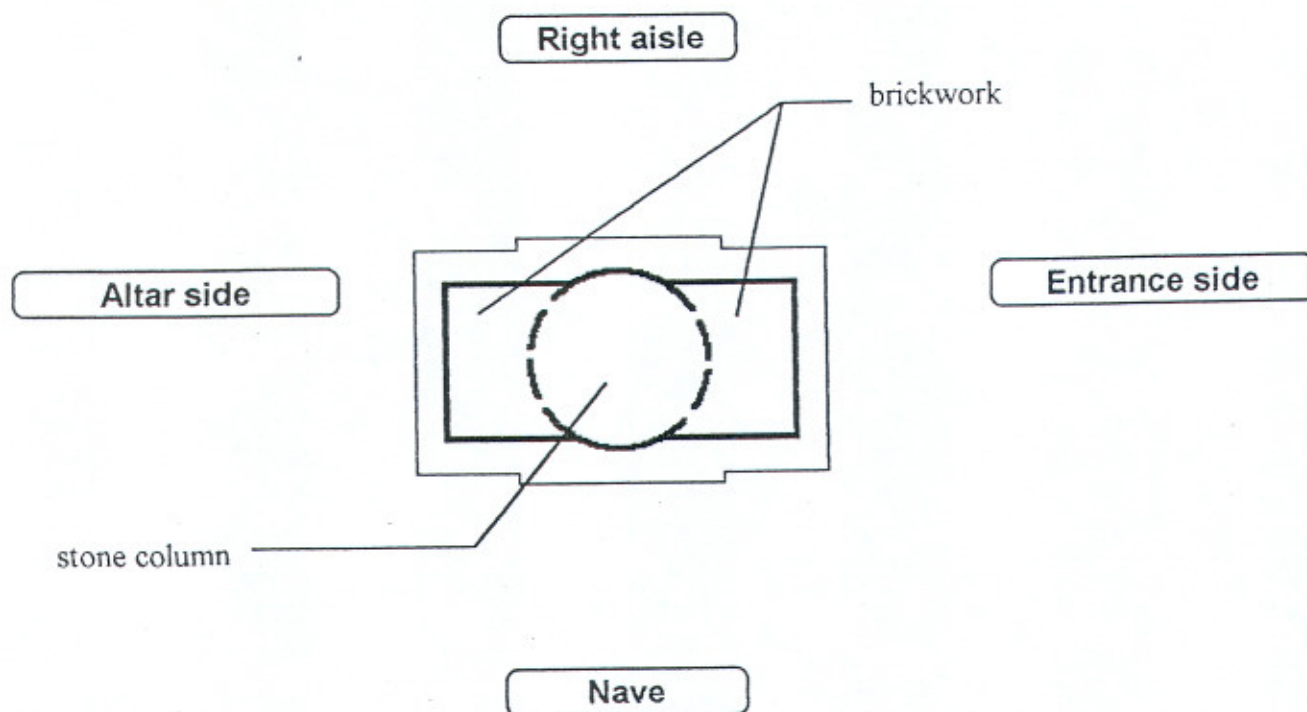
- the facade tends to project out towards the square;
- the stresses in the masonry - according to the numerical analyses - reach relatively high values at various points. Though their size is considerable, the masonry blocks are discontinuous and heterogeneous, not firmly packed together;
- the pillars of the nave, which play a decisive role in the building's static equilibrium, consist of stone columns laterally confined by brickwork reinforcements added at a later time (fig. 2): these raise much perplexity as to the distributions of the stresses inside them, due to the heterogeneity of the materials and repeated tampering over the years;

*Fig. 2 Horizontal cross-section of the first composite pillar on the right starting from the entrance*

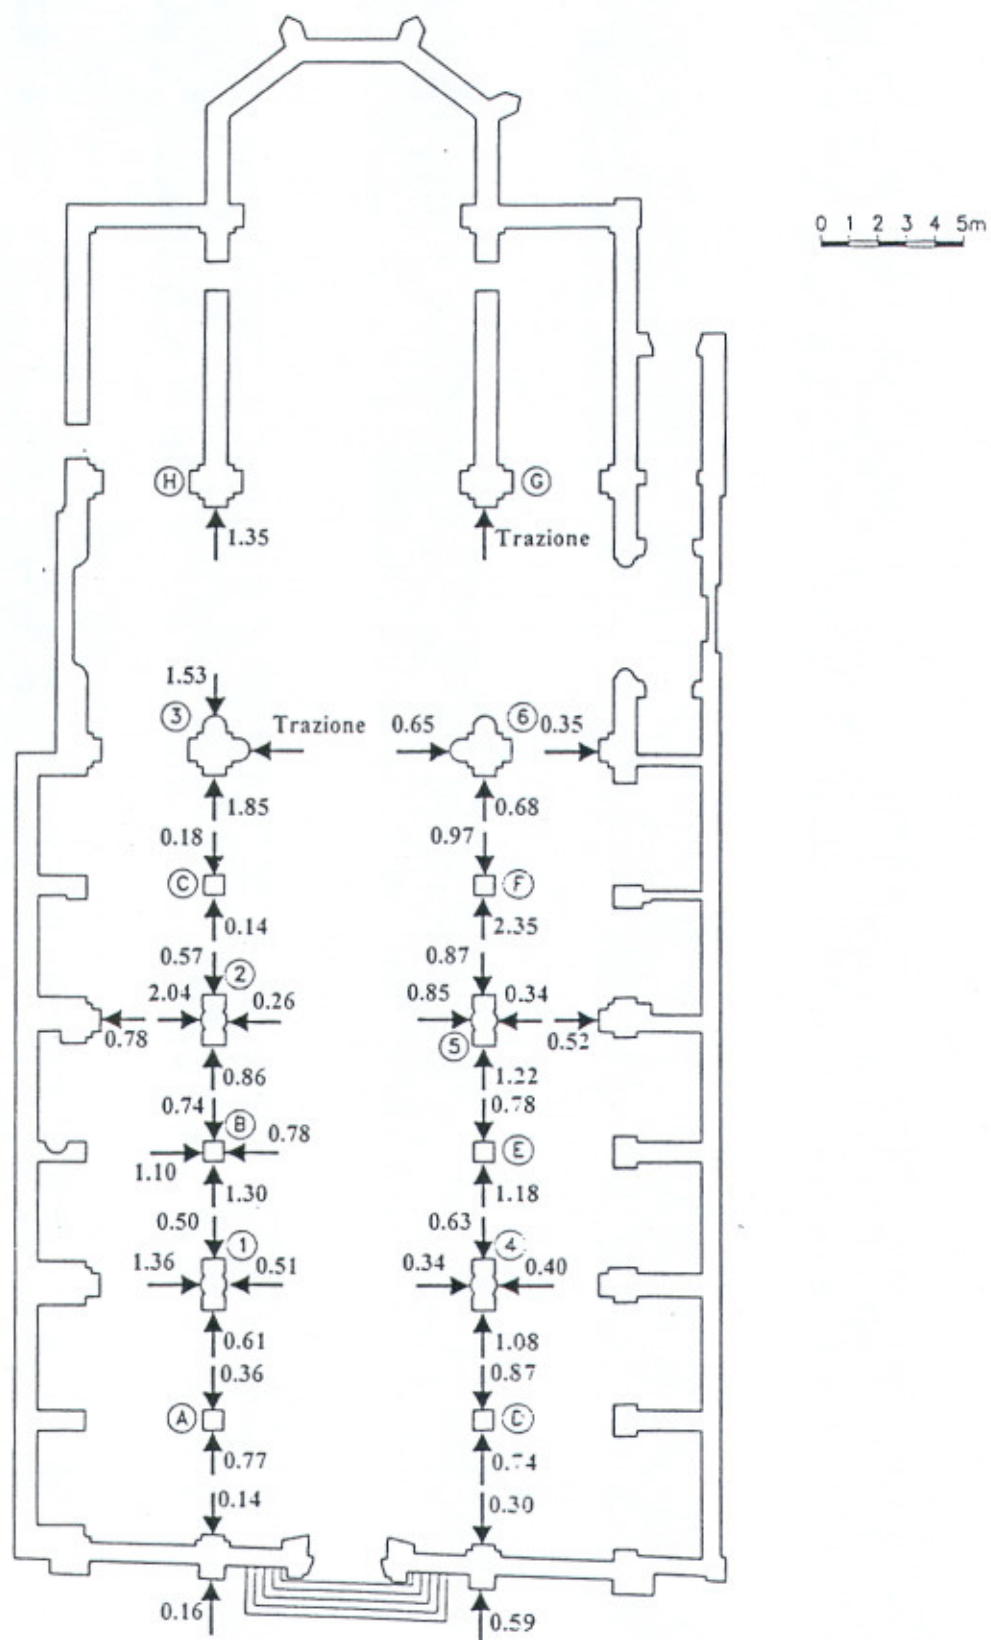
Fig. 3 Plan view of the church with the results of the flat jack tests; the results are expressed in  $N/mm^2$

The systematic inspection of the nave pillars has shown first of all that in general they are subjected to considerable compression and bending stresses, which in some cases are very high. Fig. 3 concerning the overall situation of the state of stress determined from the measurements shows numerous values of over  $1 \text{ N/mm}^2$ , even in the masonry parts, with a peak of  $2.04 \text{ N/mm}^2$  in the stone portion of the first composite element on the left, starting from the transept. Of even greater significance is another aspect that emerges from the data: contrary to the results of the numerical analyses and the phenomena recorded historically, the building now seems definitely "attracted" to the side involved in the archaeological digs and the underpinning works performed in the Seventies. The earlier static equilibrium was reversed by such interventions on the foundations, which caused settlements throughout the eastern part of the church, i.e. the part subjected to the underpinning works. As a result of these settlements, the building has been displaced towards the cloister, with considerable bending and compression phenomena affecting the near totality of the pillars.

The tendency of the building to "reach out" in the perpendicular direction towards the facade was confirmed, however. Save for the zone adjacent to the transept, all the pillars are seen to be subjected to compression and bending towards the facade, fortunately with stress values lower than those recorded in the transverse direction of the building.

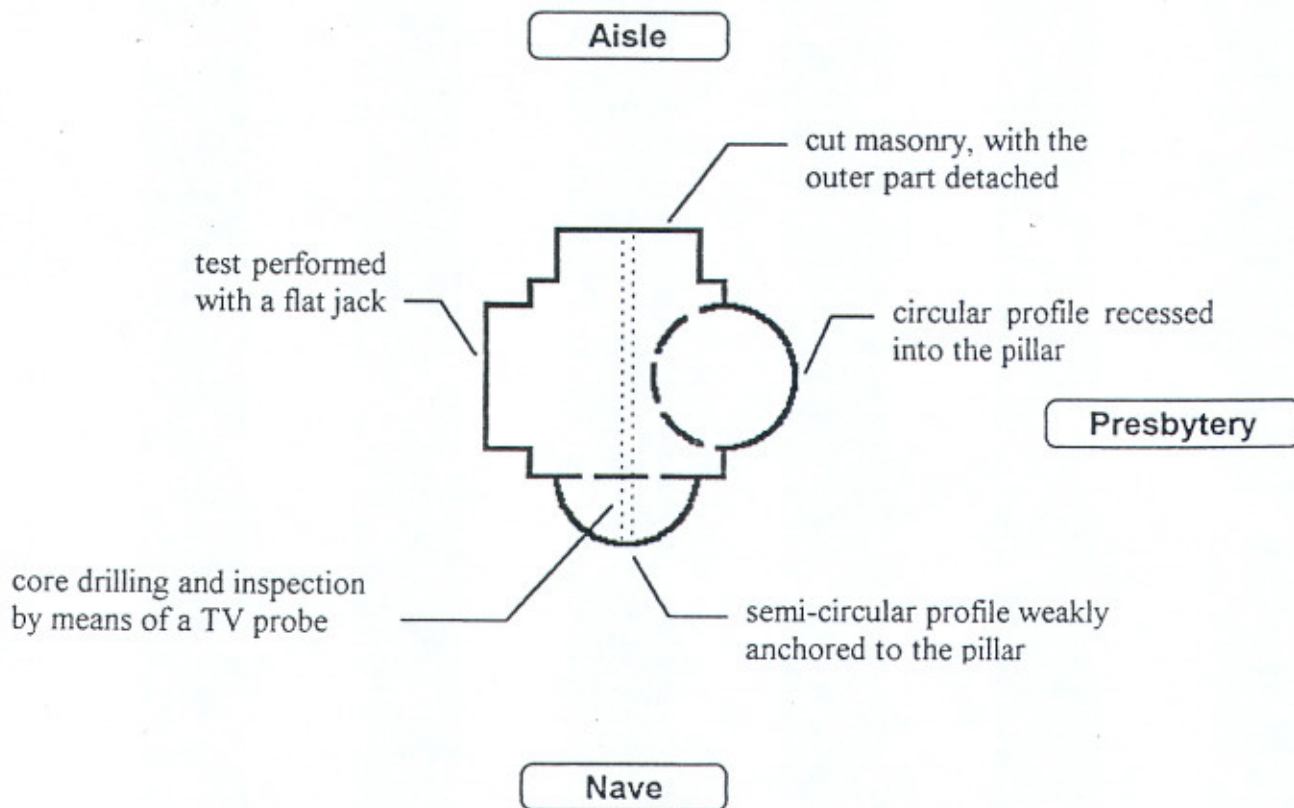
Of special interest proved the inspection conducted by core drilling in the left hand side pillar of the transept, which brought to light the brickwork of the element and the construction methods adopted for its realisation (fig. 5).

Fig. 5 Horizontal cross-section of the left pillar of the transept: showing the configuration of the masonry and the position of the tests performed in July 1996 (by ISMES S.p.A. of Bergamo)

In particular, it can be seen that the multi-lobed section is composite and is the outcome of subsequent interventions over time: the portion facing the aisle looks as if it had been cut out of a pre-existing wall, it is badly cracked and displays a loose fabric. The semi-circular section facing the nave is merely "applied" to the rest of the pillar, whilst the portion facing the presbytery is part of a veritable circular column lodged into the masonry (as demonstrated by the visual examination of a small breakage at the connection with the straight section of the pillar); the masonry of the half-column facing the nave is tightly packed, whilst the inner portion at its back displays small empty zones; the fabric of the portion of the pillar facing the facade is presumably good, according to the results of a test performed with a flat jack, revealing high stress values and, hence, presumably, considerable stiffness.
