Preliminary investigation and monitoring for the design of a strengthening intervention on the Frari basilica, Venice

ABSTRACT: The “latest” S. Maria Gloriosa dei Frari basilica was built in Venice between the first half of the XIV and the second half of XV century in gothic style. From the end of the construction the building suffered from structural deterioration mainly due to settlements affecting the bell-tower. At the end of the 19th and at the beginning of the 20th century the church underwent major repairs because of the increasing sinking and leaning of the bell-tower, causing worrying damages on the basilica adjacent structures. During the 20th century the bell-tower still suffered from differential settlements; the early 900’s foundation strengthening did not stop the tower to settle. This paper presents the main results of experimental and numerical investigation recently carried out in order to assess the present safety conditions of the structures and to feed the necessary strengthening intervention at the level of the bell-tower foundations.

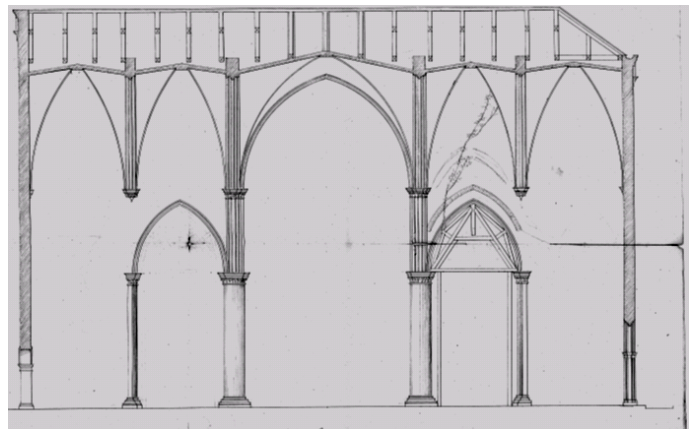
The severe decay conditions of the left aisle arch stone ashlar, badly disarranged as consequence of the arch's deformation (due to the differential settlement of the supports), required urgent remedies (Figure 2). The disassembly and subsequent reconstruction of the arched lintel with repair of the damaged stone elements and the substitution of the ones beyond retrieval, and the insertion of a full thickness relieving arch in the masonry wall just above the damaged stone structure were carried out.

Figure 2. Crack pattern survey, 1867

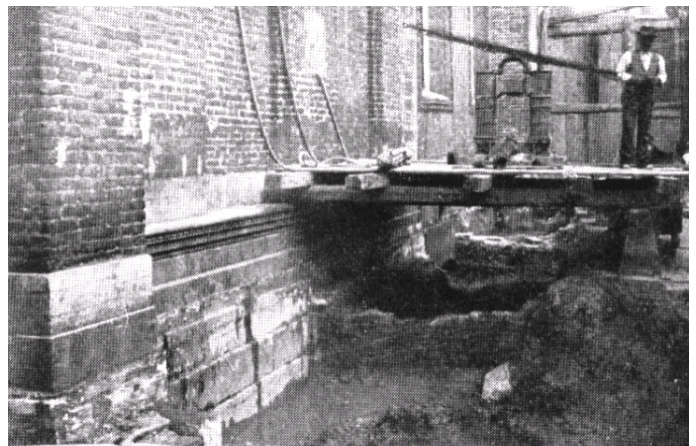
Figure 3. Strengthening intervention on the bell-tower foundations, 1904

The surveys carried out at the level of the foundations revealed an inadequate base respect the bulk of the bell-tower, being this the main cause of the settlements of the tower. For this reason, a strengthening intervention on the bell-tower foundations takes place, consisting in the widening of the foundation base, starting with the south side (toward which the tower was leaning).

The project considered the traditional Venetian soil strengthening technique, with the insertion, close by the old bell-tower foundation raft, of timber piles (made by larch, length 3.80 m, transverse dimensions 0.20×0.20 m), covered by a 2.00 m wide concrete bed, parallel to the side of the bell-tower (Figure 3). All of the masonry walls went repointed with cement mortar that, in addition to restore the cohesion of the brick masonry, improved its strength.

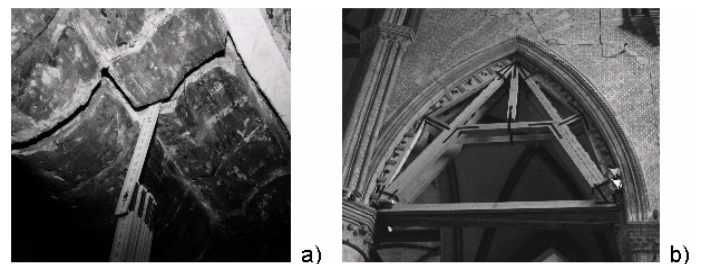
In September 2000, some worrying sign of structural deterioration appeared: new crack patterns, especially in the St Peter's chapel vaults, widening of already existing fissures (Figure 4a), falling of small portions of plaster and bricks from the vaults. An emergency intervention was provided to the structures more affected; in particular, lime mortar grout injections were provided to the cracked St Peter's chapel vaults. Moreover, the serious disconnectedness that affected the stone ashlar of the left aisle arch adjacent to the bell-tower structure, once again consequence of the arch's deformation, required the installation of a timber prop system (Figure 4b).

Figure 4. a) the remarkable widening of cracks in the St Peter's chapel vaults; b) the emergency centering consolidating the left aisle arch adjacent to the bell-tower.

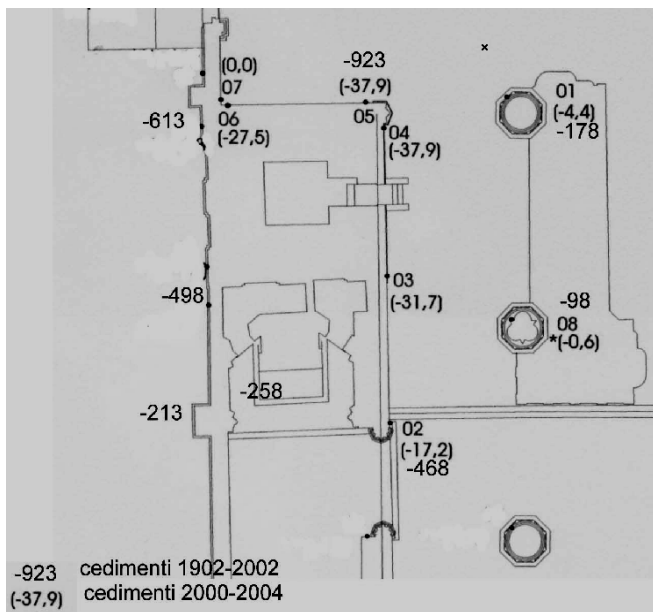
Figure 5. Differential settlements; comparison between the 1902-2002 and the 2000-2004 surveys (measures in 1/10 mm).

A survey aimed at detecting differential settlements in different points of the complex, by comparison with the one of 1902, revealed that the average subsidence of the structure of the church was included between -10 and -20 mm. The area close by the bell-tower and the adjacent masonry structures, shown, on the contrary, far greater differential settlements: -49.8 mm in the East corner, -61.3 and -92.3 mm in the South and West corners of the bell-tower base, respectively.

The differential settlements layout noticed, together with the comparison between the fotogrammetric survey of 1995 and a successive one of 2000, indicated that the bell-tower is tilting in the opposite direction respect the “historical” tendency, meaning that it is going back towards its vertical. Furthermore, a monthly survey carried out from 2000 to 2004 confirms the above mentioned displacement trend, recording an average settlement of 1 mm/year in the South-West corner of the tower respect the most “stable” point inside the basilica (Figure 5).

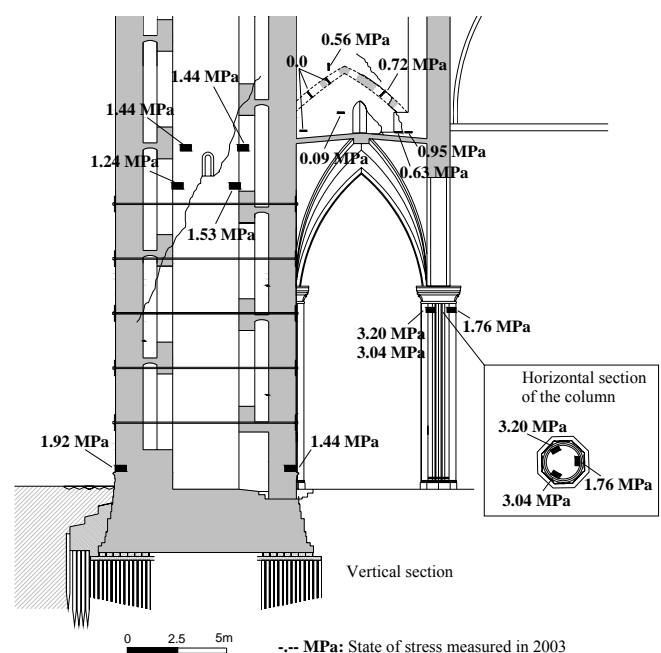
Flat-jack testing technique was used to measure the existing state of stress on the masonry structures of the bell-tower and of the adjacent structures of the Basilica. At the base of the bell-tower an average value of 1.92 MPa was measured on the external side, while on the inner part a mean value of 1.44 MPa was estimated (Figure 7).

Figure 7. Measure of the existing state of stress on the masonry structures of the bell-tower and of the adjacent structures of the basilica by flat-jack technique (2003).

Inside the bell-tower, flat-jack tests were carried out on both sides of an inclined oblique crack which runs along the South-West side of the tower. The similar stress values measured, at two different levels (Figure 7), clearly show that the crack, even if passing through the entire thickness of the wall, does not induce particular stress concentration on the structure. Very high values of compressive stress were measured at the top of the column sustaining the propped arch: 1.76 MPa at the external side and 3.20 and 3.04 MPa on the inner side (Figure 7).

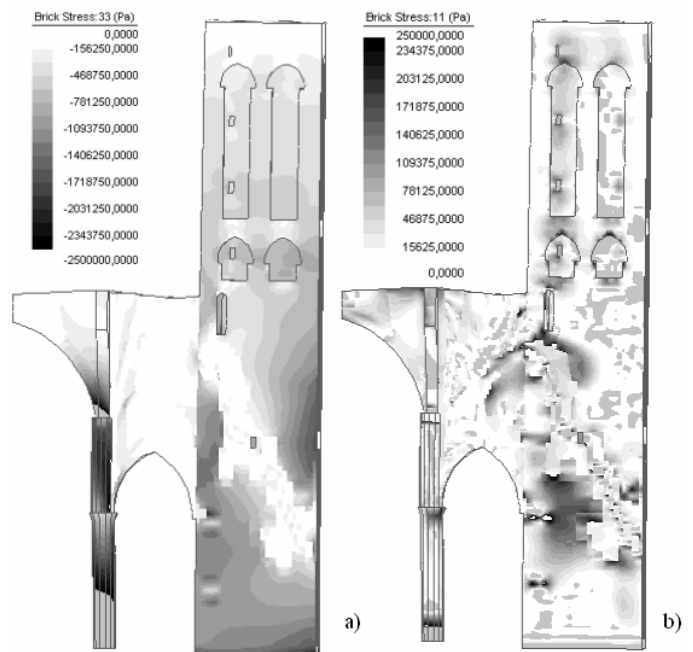
Some results can finally be drawn: 1) preferential channels of compressive stress are localized inside the masonry wall above the propped arch (Figure 11a);

Figure 11. “late” model results: a) principal compressive stresses; b) principal tensile stresses. It is possible to appreciate the “smeared” approximation of the main fissure on the bell-tower's pipe and the crack pattern on the wall above the transverse arch. It is also possible to notice the deform shape of this last, because of differential settlements, and a slight curvature of the pillar toward the main nave.

2) the high tensile stresses found in the same masonry wall, due to the settlements of the bell-tower, reduced by weakening the stiffness of the material, are the cause of the wide crack patterns and may also represent the loss of shape of the stone arch (Figure 11b); 3) the high and uneven stress, found just below the capital of the column, can be ascribed to the horizontal thrust determined by the movements of the bell-tower; 4) a certain amount of tensile stress was found in correspondence of the bell-tower window opening on the transept, presumably indicating the presence of the main fissure on the external pipe of the bell-tower.

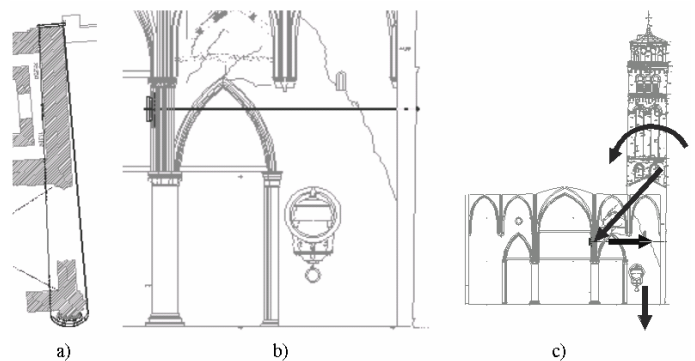
Figure 12. a) Plan view and b) elevation of the provisional steel cable; c) possible evolution: rotation of the bell-tower; transmission of thrust to the top of the column; the steel cable is brought into play.

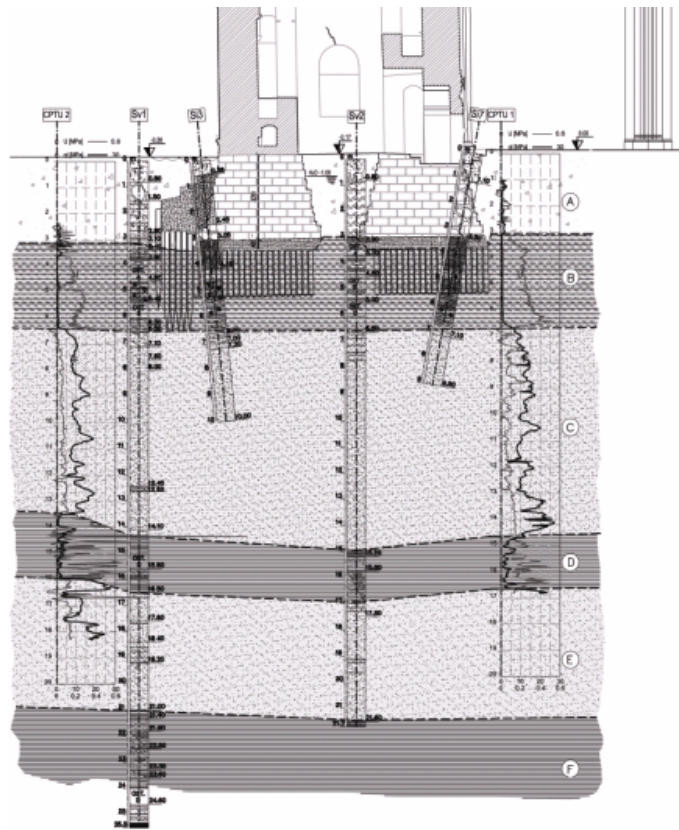
Figure 15 shows a section of the foundation subsoil, drawn along the SE-NW direction. The relevant vertical and inclined boreholes, together with CPTU tests, are superimposed to the above mentioned stratigraphic characterisation.

The typology and geometry of the foundation block is also shown, according to previously available data and to the outcome of the recent site investigation. The foundation is made up of limestone (pietra d'Istria) squared blocks, about 0.20-0.40 m thick, in a remarkable state of preservation. Among blocks the original mortar was also locally found.

Figure 15. Foundation subsoil stratigraphy
