Testing and monitoring for the control of strengthening interventions of Santa Maria Gloriosa dei Frari in Venice

Alberto Lionello¹; Christian Rossi²; Pier Paolo Rossi³

¹ Ministry for Cultural Heritage, Venice, Italy ^{2,3} R.teknos srl, Bergamo, Italy

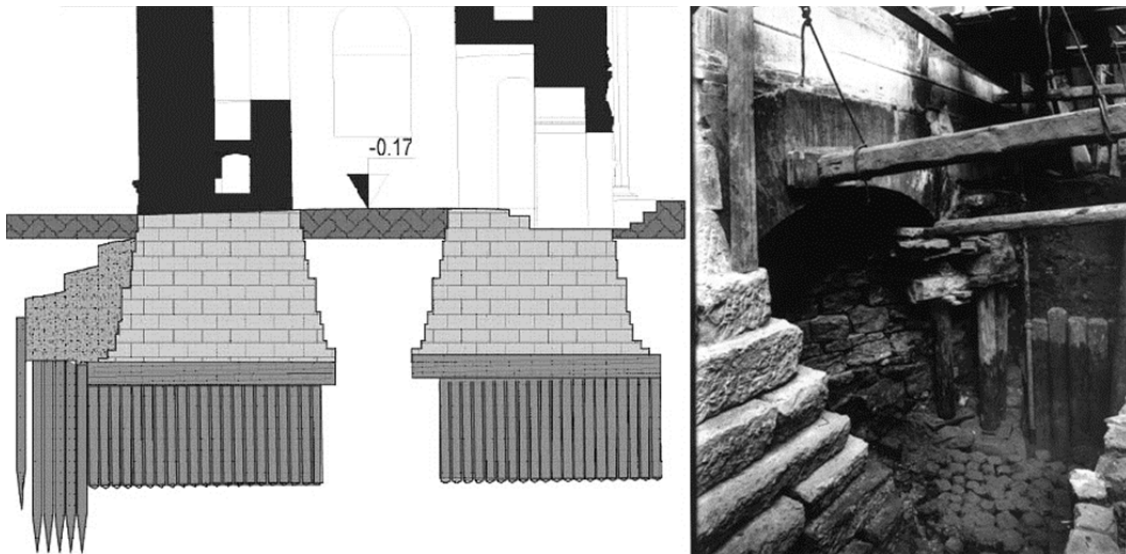
The vertical settlement of the bell-tower induced severe crack pattern in the wall of the Basilica and in the vaults of the St. Peter chapel. In 1904, after the collapse of St. Mark bell-tower, a strengthening intervention was carried out on the bell-tower foundations. This intervention, consisting in widening of the bell-tower foundation base, was carried out only in the external side of the bell-tower and was not extended to the other sides. The strengthening project considered the traditional venetian soil strengthening technique, with the insertion of new timber piles (3.80 m long) covered by a two meters wide concrete bed, parallel to the side of the bell-tower (Figure 1).

Fig. 1 Strengthening intervention on the foundations of the Frari bell-tower at the beginning of the 20th century..

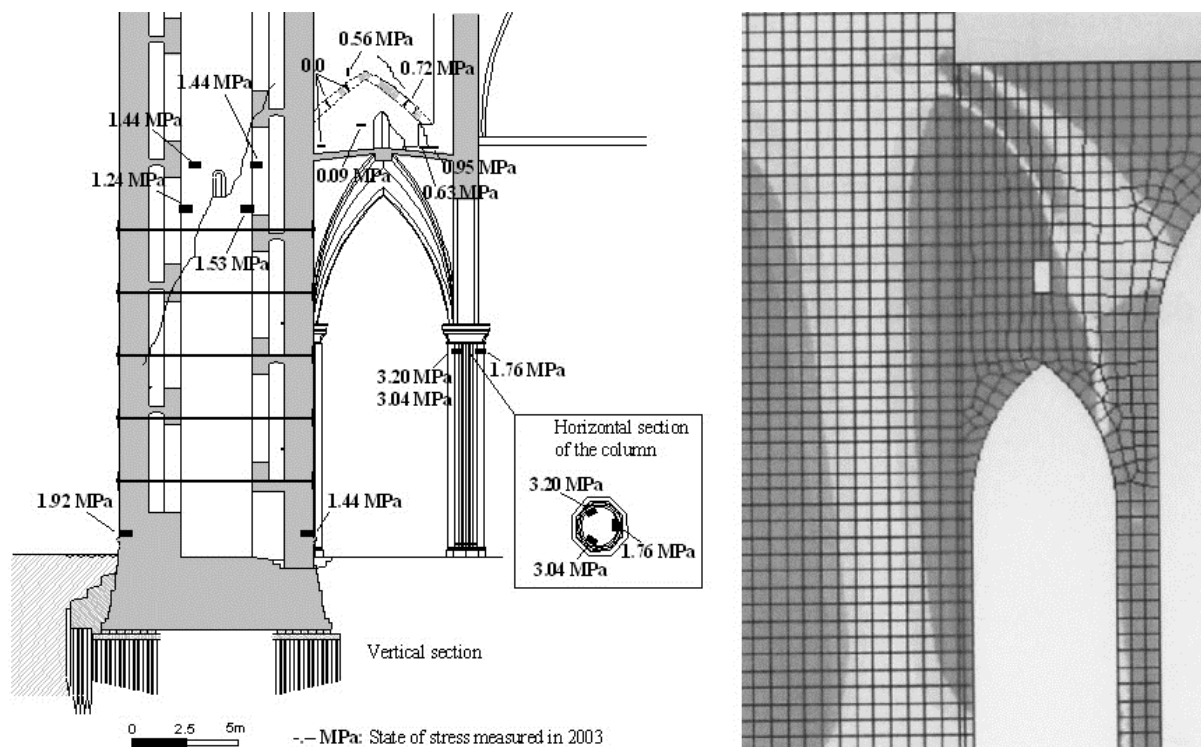
Flat-jack testing technique was used to measure the existing state of stress on the masonry structures of the bell-tower and of the adjacent structures of the Basilica (Figure 2). At the base of the bell-tower an average value of 1.92 MPa was measured on the external side, while on the inner part a mean value of 1.44 MPa was estimated. Very high values of compressive stress were measured at the top of the column sustaining the propped arch: 1.76 MPa at the external side and 3.20 and 3.04 MPa on the inner side.

Fig. 2 Values of the state of stress measured by flat-jack test in the supporting structures of the Frari Basilica and bell-tower and comparison with the results of the numerical model.

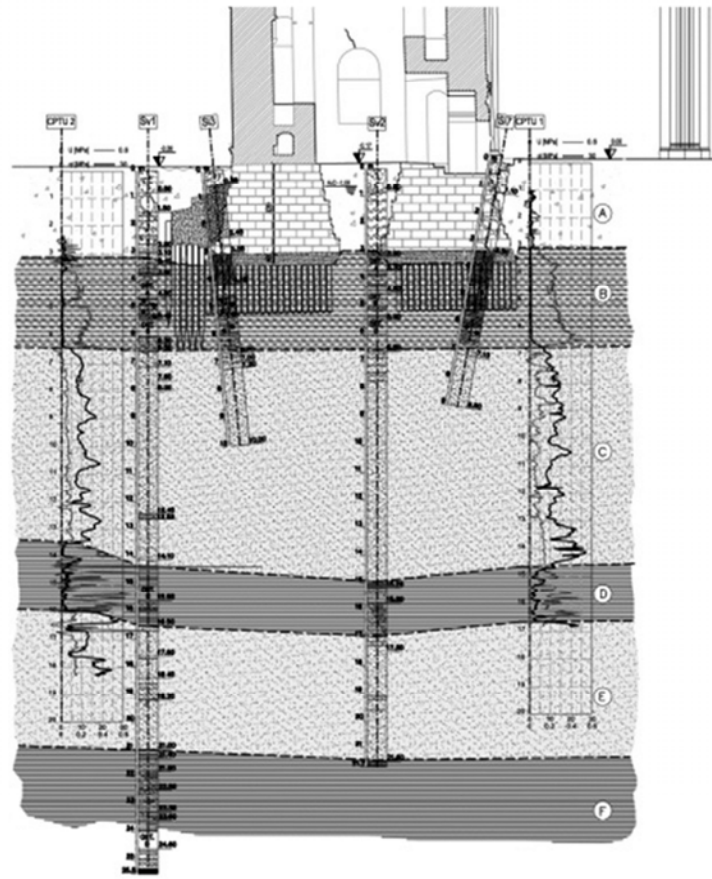
Fig. 3 Stratigraphy of the soil foundation of the Frari bell-tower.

The foundation of the bell-tower is made up of limestone (Pietra d'Istria) squared blocks, about 0.20-0.40 m thick, in a good state of preservation. Among the blocks, the original mortar was also locally found. Below the foundation blocks there is a wooden floor of squared larch boards, 0.40-0.50 m thick. Under the boarding, a thin layer of clean sand was found, probably used to prepare a uniform bedding plane for the foundation. Below the wooden floor, the typical wooden piles layer is made up of short (from 1.5 m to 2.0 m) consolidation piles, pushed into the fully saturated, soft clay, very close each other, often side by side, to make it denser and stronger.

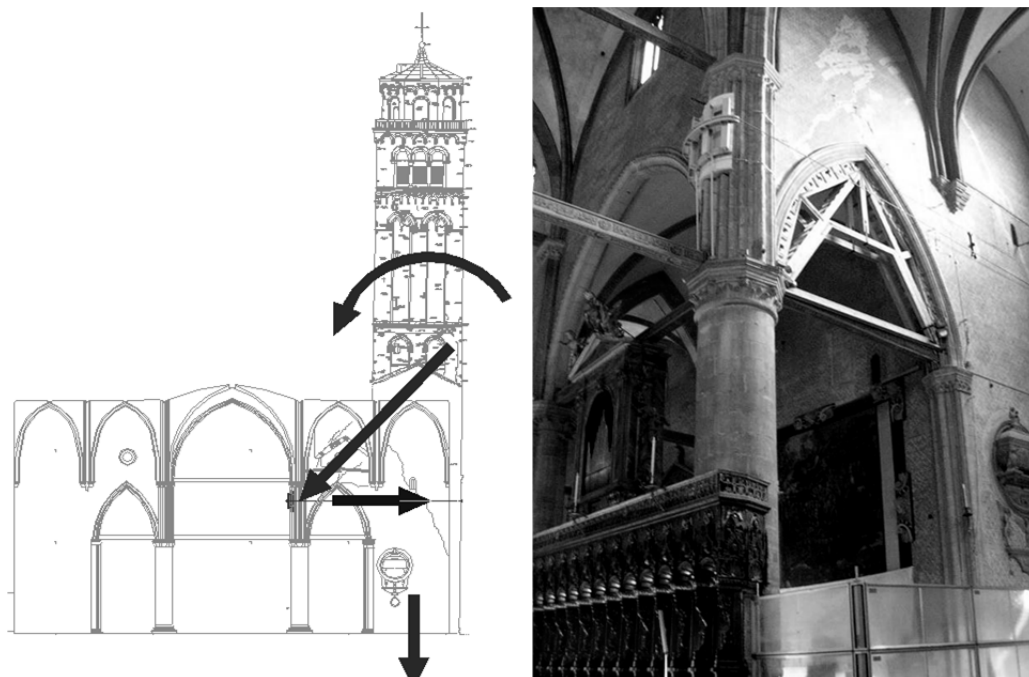
Fig. 4 Temporary intervention with steel cable to support part of the horizontal thrust acting on a column of the Frari Basilica.

The first intervention was required by the considerable deformation induced on the column of the Basilica by the thrust of the bell-tower. A provisional intervention was carried out in order to guarantee the safety of this portion of the Basilica. A steel cable was positioned connecting the stone ashlar just above the capital of the column to the bell-tower structure at a height of 14.40 m. This steel cable aimed at support part of the horizontal thrust acting on the column. The structural scheme of this intervention is shown in Figure 4. Two strain-gauges were installed on the steel cable and the tension was continually controlled during the whole intervention period.

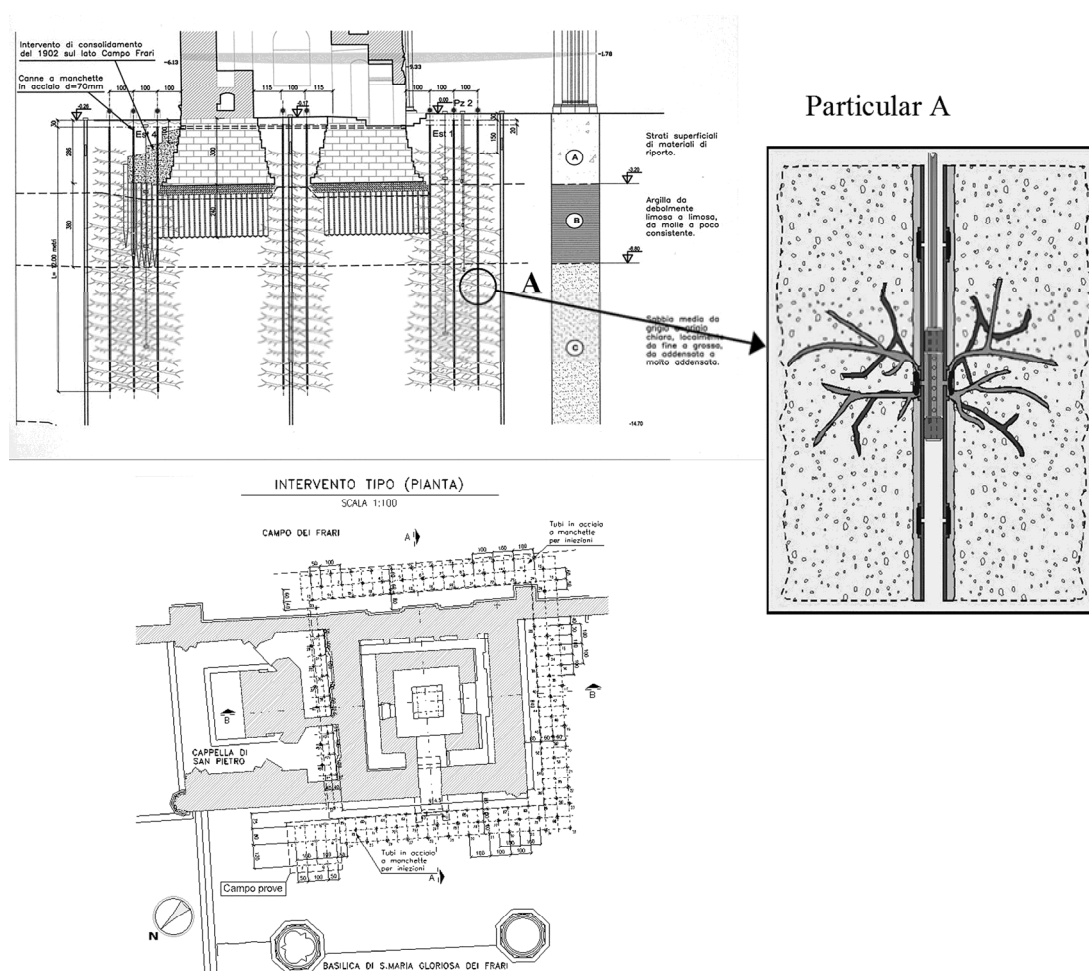
Fig. 5 Scheme of the soil-fracturing technique for the consolidation of the soil foundation of the Frari bell-tower. The position of the full-scale test is also indicated.

The soil-fracturing technique consists in installing special injection tubes in the foundation soil, with valves at different depths. The careful and slow-rate injections of suitable cement and bentonite mixtures is repeated at successive stages, to obtain progressive increments in terms of mechanical characteristics, according to the above-mentioned "observational method". The final outcome is a reinforced soil, made up of the original material and a mesh of thin layers of injected grout, as can be observed in the particular of Figure 5.

After the positive answer of this full-scale test, the soil-fracturing intervention was decided and the scheme of the intervention is shown in Figure 5 where the planimetry and the cross section of the intervention is shown. Around the foundation basement, 88 injection tubes (length 12 m, diameter 88.9 mm, distance 500 mm) with special valves at a distance of 500 mm each other, were installed in two or three lines. A grouting mortar with pozzolanic cement, water, bentonite and limestone filler, was used with a grouting pressure of about 5 bars in the clay levels and 25 bars in the sand ones. The grouting processes were carried out very slowly through a continuous control of the movements and at the end of the intervention about 100 cubic meters of mortars were injected.

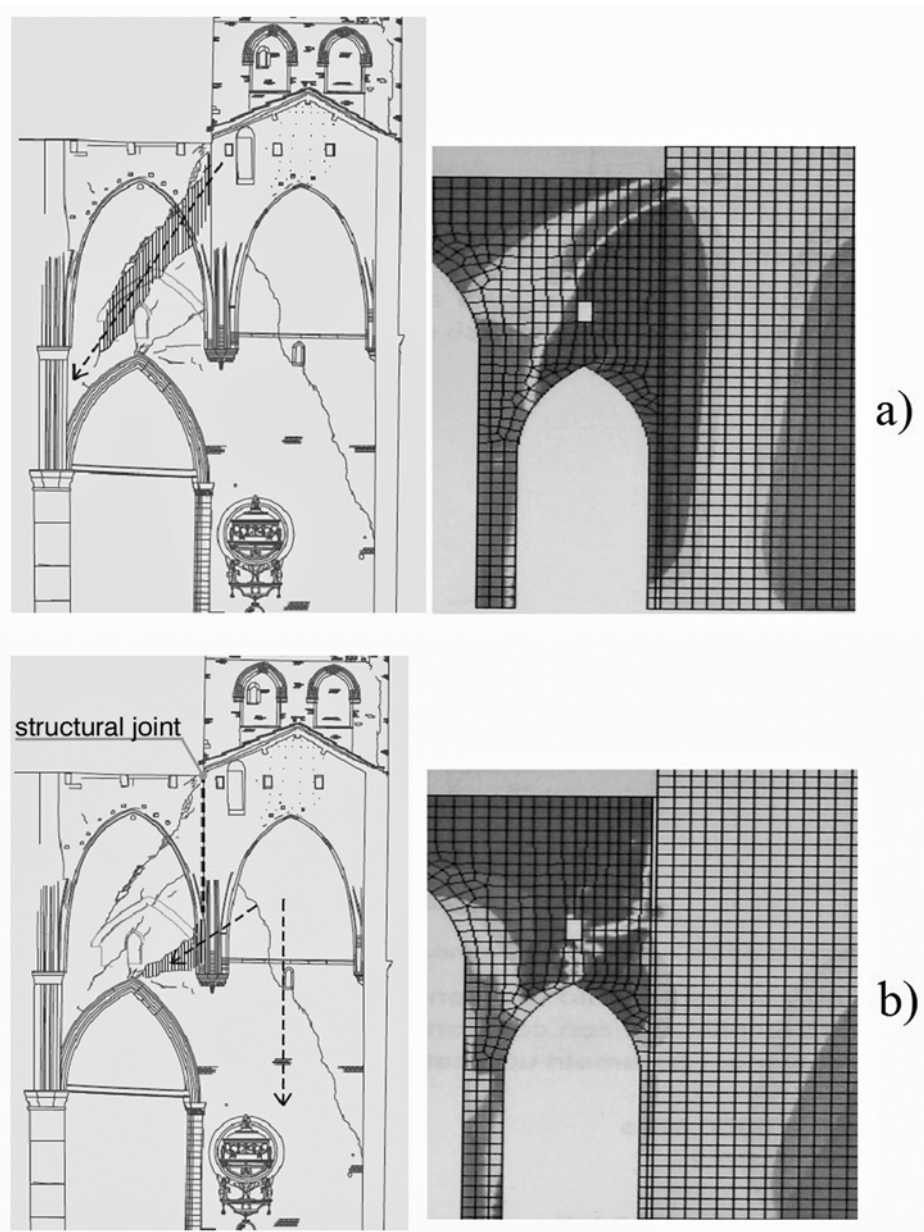
Fig. 6 Direction of the thrust between the bell-tower and the Basilica and comparison with the numerical model results:
a) – before the structural joint execution, b) – after the structural joint execution.

About two years after the end of consolidation works of the soil foundation by soil-fracturing technique, it was decided to introduce a new structural intervention aiming at modifying the boundary conditions of the bell-tower and to reduce as much as possible its interaction with the adjacent structures of the Basilica. At the beginning of June 2008, a structural joint was created between the bell-tower and the Basilica in the position shown in Figure 6. The effect of this intervention was a marked change of the direction of the thrust applied by the bell-tower to the adjacent column. The direction of this thrust, before and after the execution of the structural joint, is shown in Figure 6, together with the corresponding numerical models.

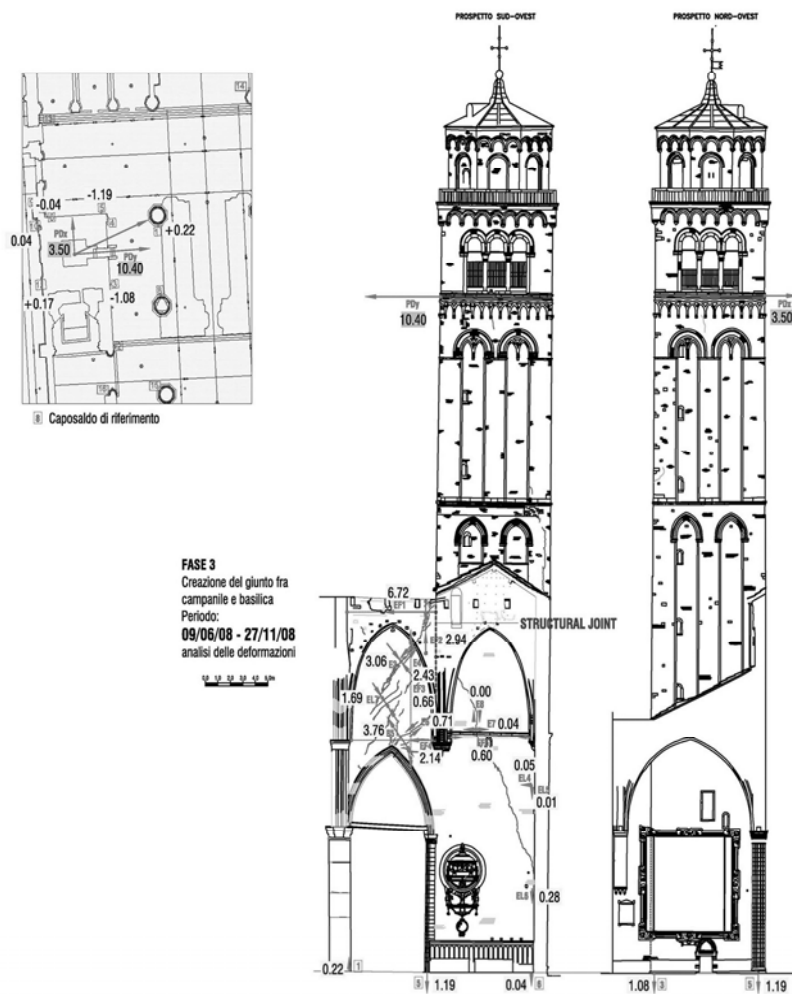
In order to follow with special care the deformation behaviour during the execution of the structural joint, new crack-gauges were installed as well as new long-base extensometers. In Figure 7, the lay-out of the deformation sensors is shown, with the values of the deformations measured during the whole structural joint intervention. In the same figure, also the movements measured by the direct pendulum are shown, as well as the settlements of the soil foundation measured by altimetric levelling. It was observed a marked movement of the bell-tower (10.40 mm) in y direction, towards the adjacent column of the Basilica. This movement is only partly related (about 50%) to the differential settlements of the foundation, while the remaining part is due to deformation processes of the bell-tower itself. The analysis of the deformations shown in Figure 7, indicates a closure of the structural joint of 6.72 mm and appreciable movements of the cracks in the masonry wall which connects the bell-tower to the Basilica, while small movements and deformations are observed on the masonry walls of the bell-tower.

Fig 7 Analysis of the deformations induced by the structural joint execution.

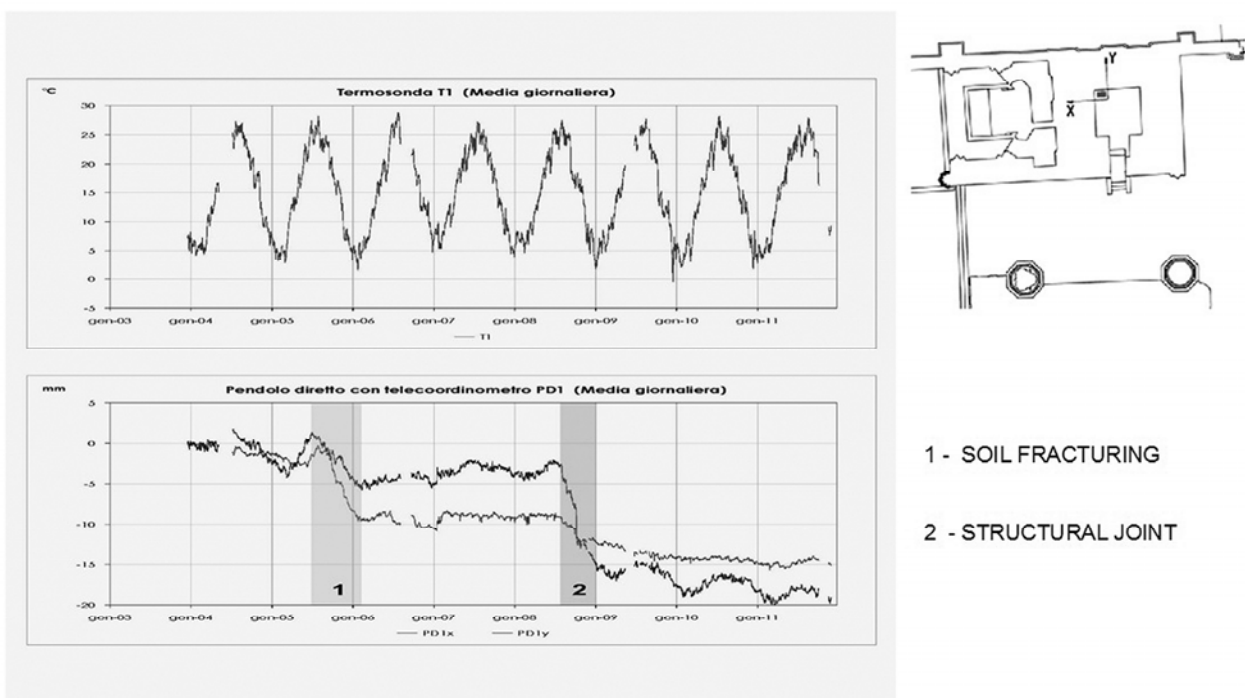
The complete history of the two components of the movements measured by the direct pendulum is shown in Figure 8, where the soil-fracture intervention and the structural joint execution are indicated. It can be observed a great influence of the soil-fracturing on the displacement component in x direction, while during the structural joint execution the effect on the component in y direction is more evident.

Fig. 8 Complete history of the displacement components measured by the direct pendulum with the indication of the intervention phases (soil-fracturing and structural joint execution)
