STRENGTHENING INTERVENTIONS OF THE ROMANESQUE TEMPLE OF SAN TOME' IN BERGAMO

Pier Paolo Rossi
R.Teknos s.r.l.
Via San Giovanni 14
24121 Bergamo
Italy
pierpaolorossi@rteknos.it

Christian Rossi
R.Teknos s.r.l.
Via San Giovanni 14
24121 Bergamo
Italy
christianrossi@rteknos.it

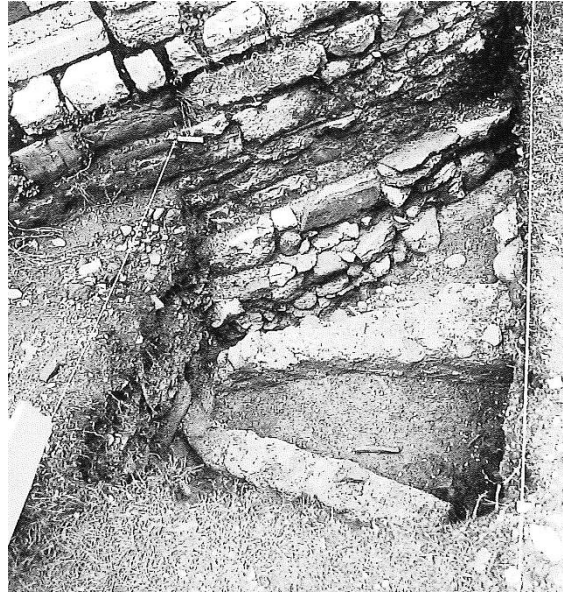
Then, the structural characteristics of the foundation masonries were examined by means of small excavations around the perimeter of the temple. These excavations, included in the program of the archeological surveys, showed the structural characteristics of the foundation masonry which is composed by an upper layer (80 cm thick) made with squared stones well cemented with mortar, which is resting on a lower layer (about 70 cm thick) of masonry built with irregular stones with some mortar. The total thickness of the foundation masonry is about 1.50 m, as is shown in Figure 3

Figure 3. View of the foundation masonry discovered during the archeological survey

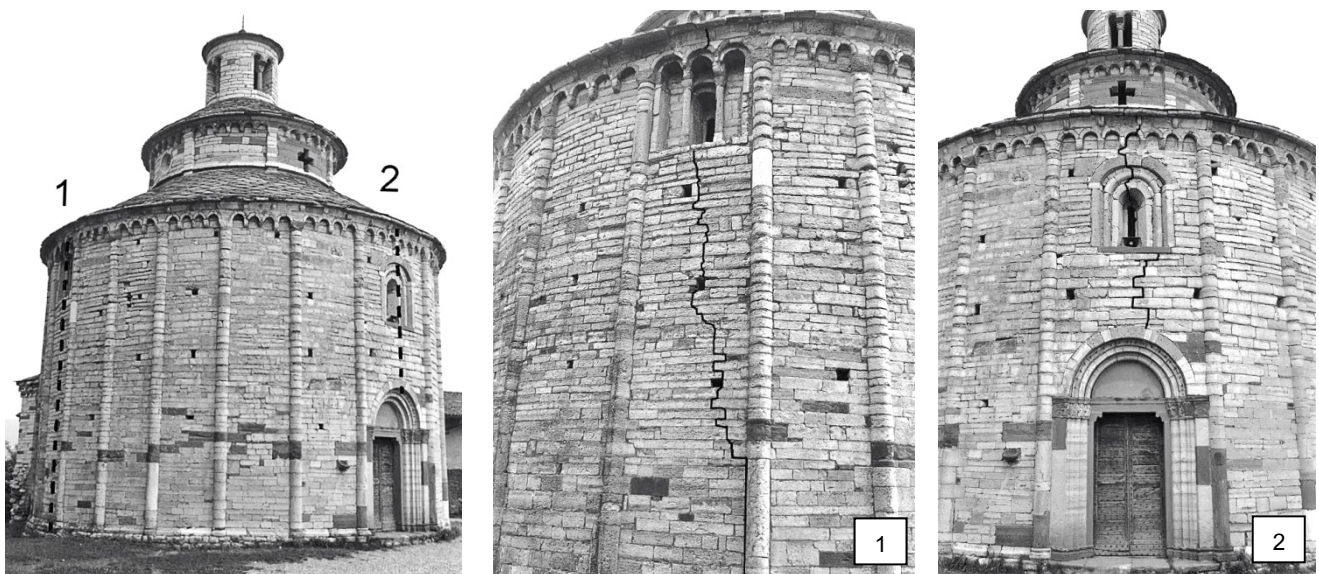
Particular attention was devoted to the crack-pattern survey. Several cracks were observed in the lower cylindrical structure. These cracks are mainly due to the shape of the structure and seem less dependent from differential settlements of the soil foundations. Their direction is generally vertical and some of them cut the whole thickness of the masonry. In figure 4 the two main vertical cracks are shown. The crack number 1 is located in the northern side while the crack number 2 is located in the western side and crosses the main entrance door and the overhanging windows. Both cracks have a great structural importance because they cross the whole thickness of the wall up to the top of the main cylindrical structure

Figure 4. Crack-pattern survey – the two main vertical cracks

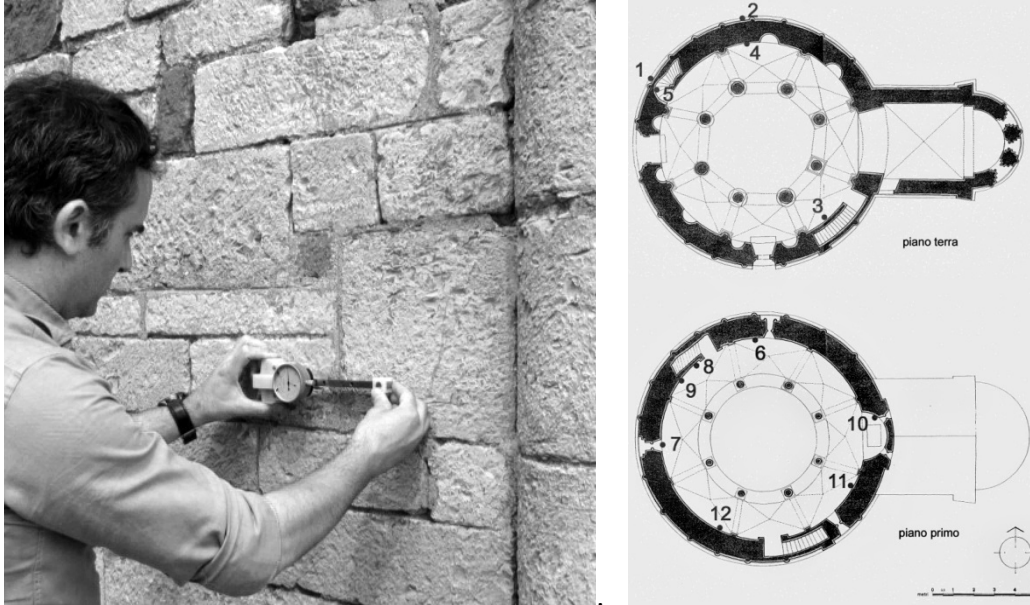
In 1984, several measuring points were installed on the main cracks of the Temple. A removable mechanical crack-gauge was used with a measuring base of 200 mm and the based were composed by a couple of circular steel plates with a diameter of 5 mm. In the figure 5 , the removable crack-gauge with high precision, is shown together with the scheme of the measuring points.

Figure 5. Mechanical removable crack-gauge and lay-out of the measuring points.

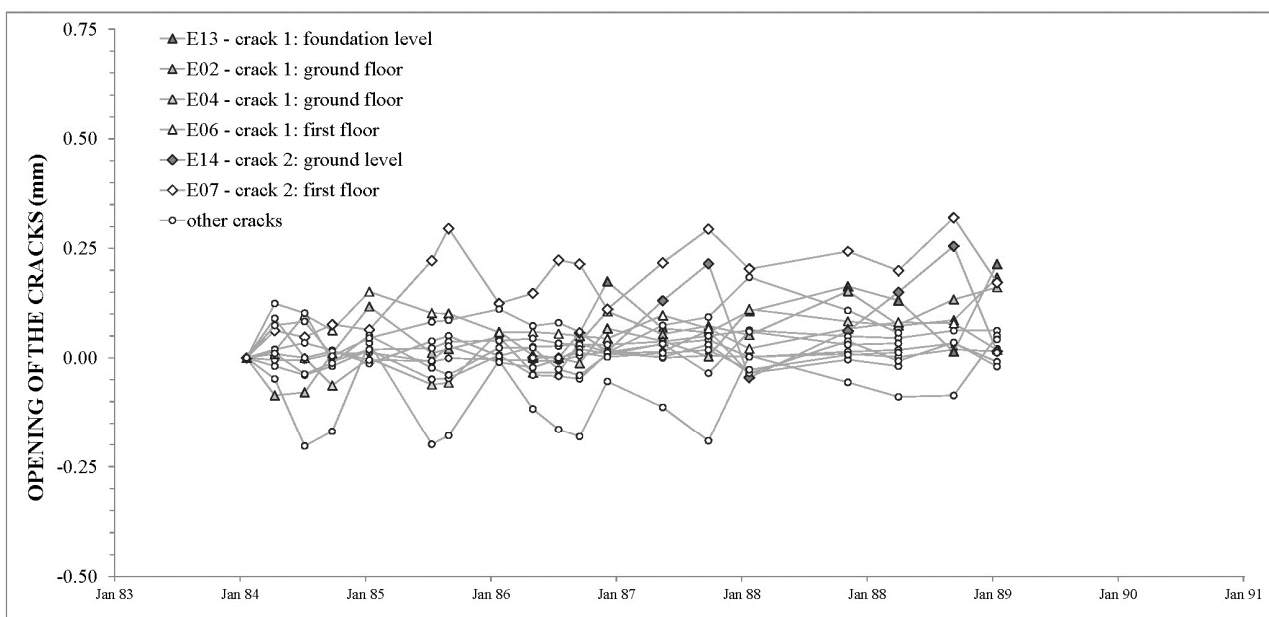
A first period of observation of about 6 years, from 1984 to 1990, allowed the analysis of the opening of the cracks during the seasonal thermal cycles, as function of time and temperature. The diagrams of the opening variations of the cracks are shown in figure 6. The diagrams show a significant influence of temperature on the openings of the cracks. Some permanent deformations were observed on the measuring points installed on the main cracks (1 and 2), with an opening trend of about 0.05 mm/year.

Figure 6. Diagrams of the opening variations of the cracks in the first period 1984-1990.

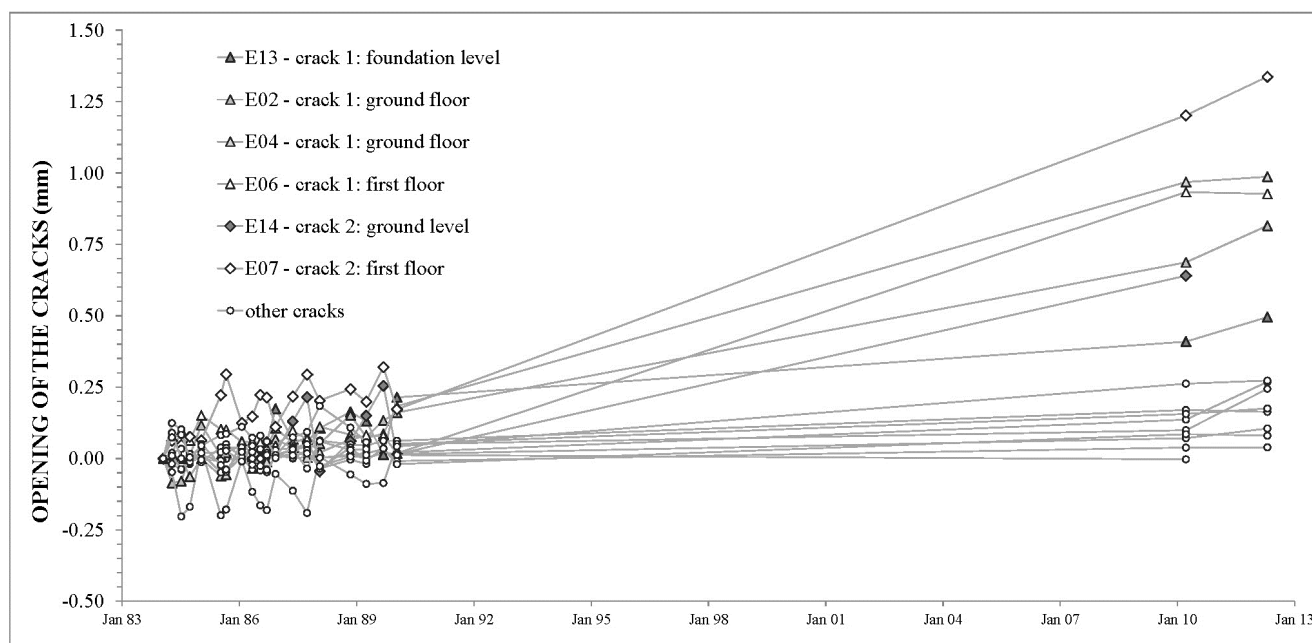
At the beginning of 2010, about 20 years after the end of the first measuring cycle, the authors realized that the measuring bases installed on the main cracks of the Temple were still in order. By using the same removable mechanical crack-gauge of the previous measuring cycle, a new reading of the opening variations of the main cracks was made. The results of this control is shown in the diagrams of figure 7. It can be observed that the measuring bases installed on the main cracks 1 and 2 (see figure 4) show significant permanent opening of the cracks with values up to 1.20 mm. This opening value, divided for the whole measuring period of about 26 years, means an opening trend of about 0.046 mm/year. The measuring bases installed in the other cracks show not significant opening variations. The progressive openings of the cracks 1 and 2, clearly show that the main cylindrical structure of the Temple is involved by radial deformations due to the height and shape of the structure and to the absence of an efficient structural confining system.

Figure 7. Diagrams of the opening variations of the cracks in the whole period from 1984 to 2012.

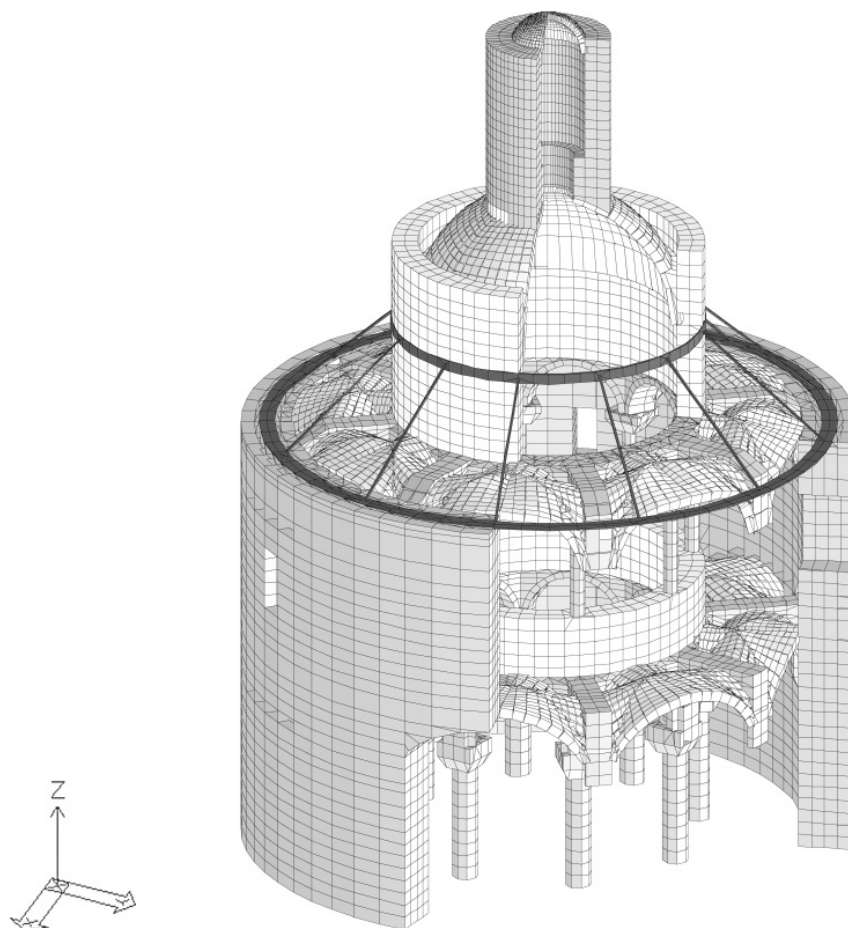
Figure 9. Finite elements mathematical model

The deformation behaviour of the structure has been analyzed for the most severe combination of static and dynamic load. The comparison between the results of the cases A and B clearly shows the effect of the main cracks on the radial displacements of the perimetral wall. The increasing of the radial displacement in the zone involved by the crack 1 is 94% in comparison with the case A , while in the zone of crack 2, the increase of the radial displacement is 104%.

The comparison between the cases B and C is particularly significant because it let us to evaluate the effect of the strengthening works under the most severe combination of static and dynamic load. A remarkable reduction of the radial displacements was observed due to the confining steel structures. In the zone of crack 1, the reduction of the radial displacements was about 33% in comparison with the case B, while, in the zone of crack 2, the decrease of the radial displacements was 28%.

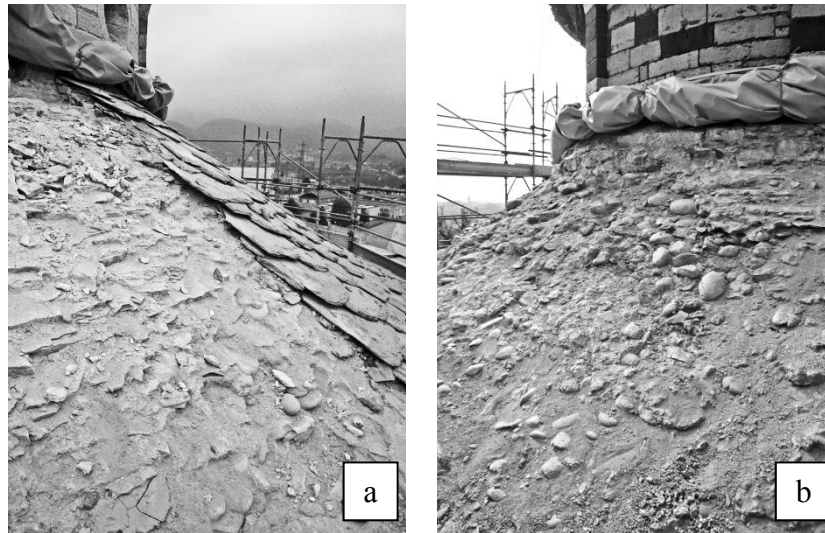
During the removal of the stone slabs from the roof, it was observed, under the slabs, the presence of a masonry made of irregular stones cemented with lime mortar in several areas of the roof (see figure 10a). In some areas cohesionless material was found, with irregular stones and earth, without mortar (see figure 10b). The presence of this heterogeneous filling material under the roof slabs, advised to cover it with a layer of lime mortar (from 50 to 80 mm thick) reinforced with a stainless steel mesh (50 x 50 mm).

*Figure 10. Removal of the stone slabs from the roof and analysis of underlying masonry:
a- Irregular masonry cemented with lime mortar
b- Cohesionless material*

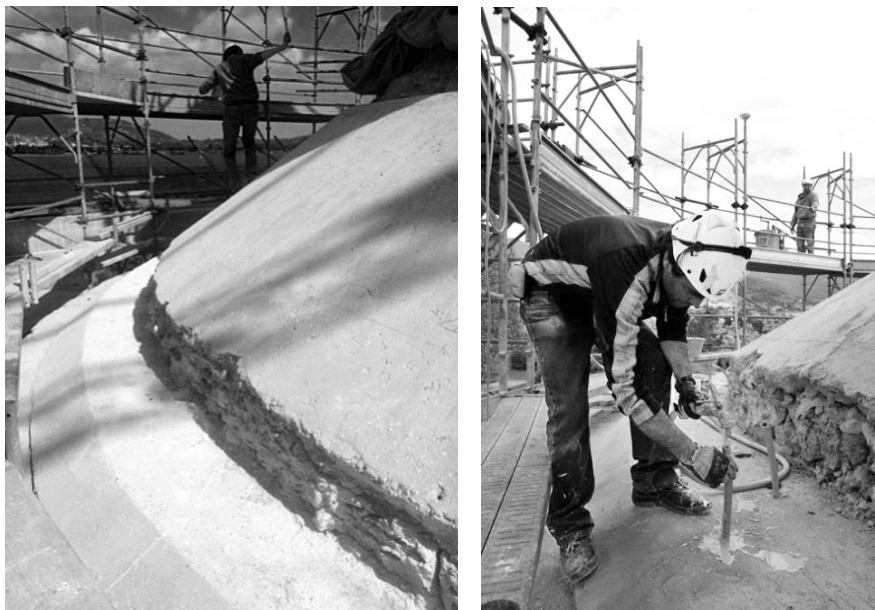
Figure 11. Preparation of the vault for the installation of the lower ring and consolidation of the upper layer of the perimetral masonry by grouting with lime mortar

To allow the installation of the lower confining ring, the surface layer of lime mortar was cut, as shown in figure 11. Before the installation of the ring, the upper layer of the masonry was consolidated by grouting lime mortar with low pressure into boreholes 1.0 m deep, as shown in figure 11.

The sectors of the lower steel ring were then installed and connected each other in order to obtain a rigid structure which was connected to the masonry beneath by means of stainless steel anchors (1.0 m long).

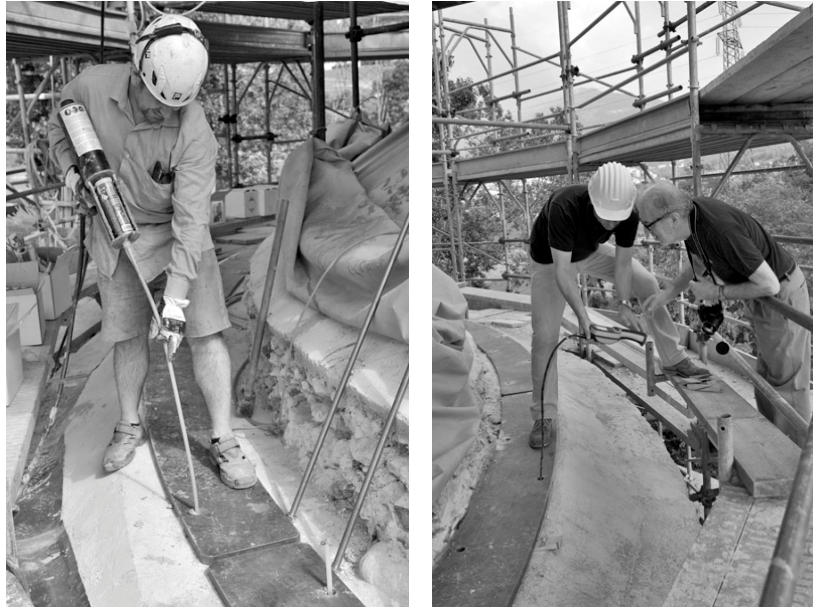
Figure 12. Grouting with lime mortar of the steel anchors which connect the steel ring to the masonry and investigation of the boreholes with video-camera

In figure 12, the grouting of the steel anchors, by using special lime mortar, is shown. Before the installation of the steel bars, the boreholes were investigated by video-camera survey in order to check the effect of the grouting intervention which was carried out before the installation of the ring to improve the mechanical characteristics of the masonry.

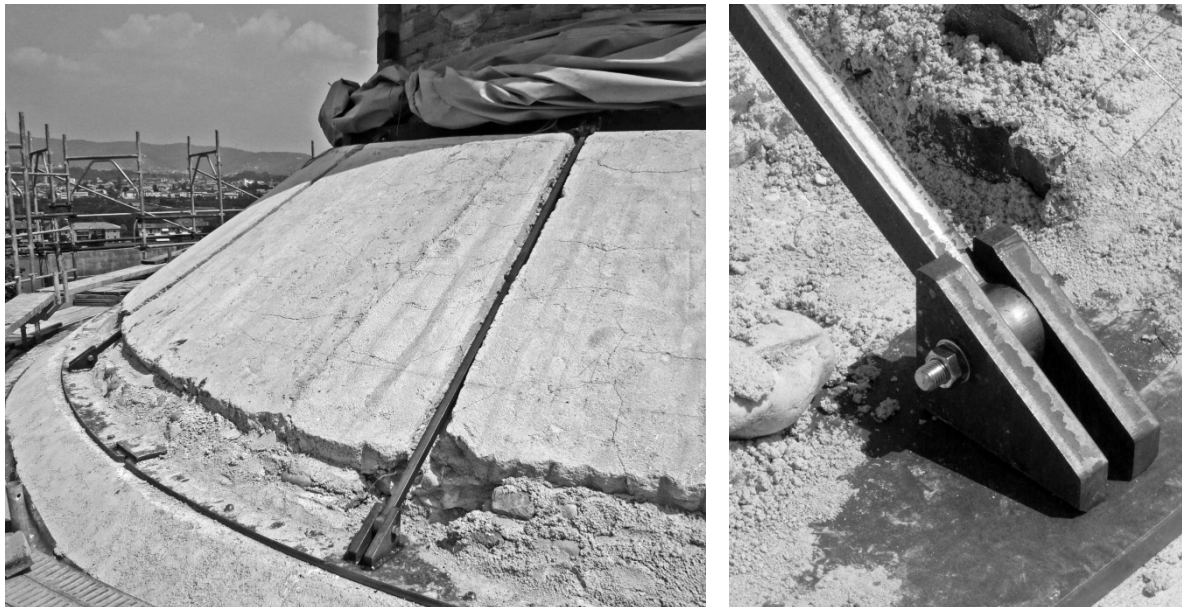
Figure 13. Connection between the upper ring to the lower and detail of the connection of the tendon to the lower ring.

Then, the upper ring was installed at the base of the upper cylindrical structure and the two rings were connected by 12 steel tendons, as shown in the particular of figure 13. For the installation of the tendons, cuts were made in the mortar layer which was cast over the roof.

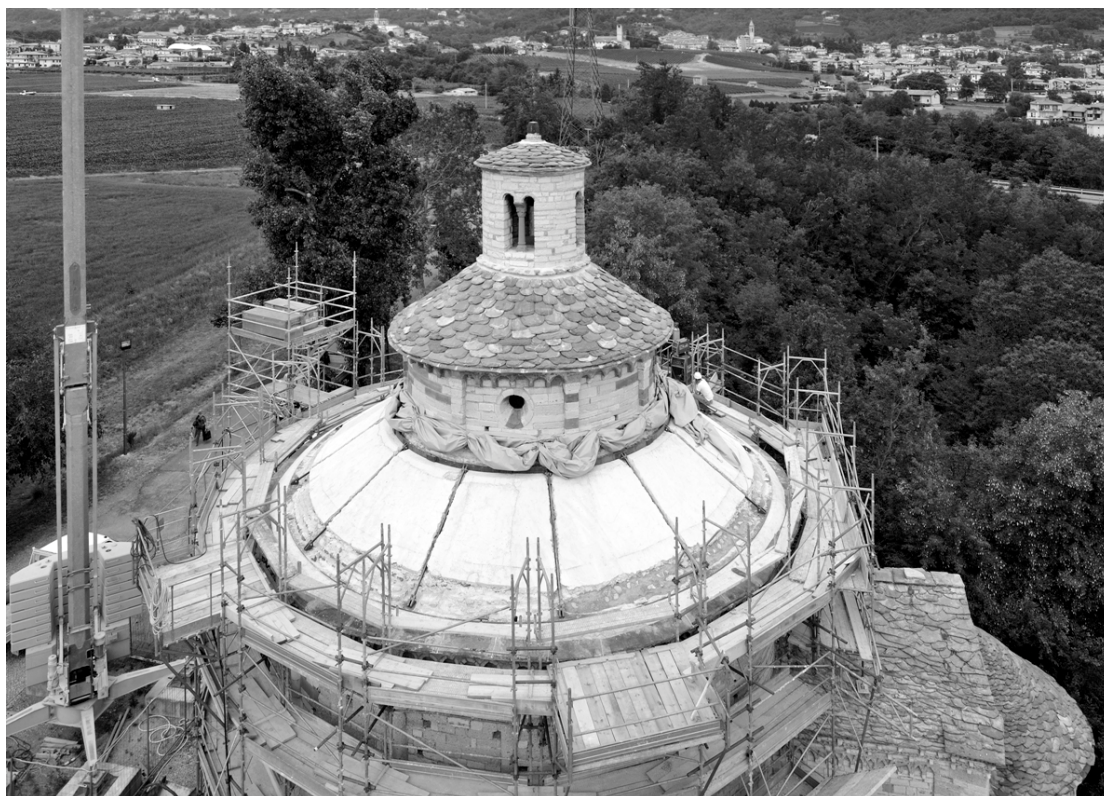
Figure 14. General view of the complete installation of the steel strengthening system

A general view of the complete installation of the steel strengthening system is shown in figure 14. It can be observed that also the lower ring has been covered by lime mortar and now the surface of the roof is ready for the installation of the stone slabs.

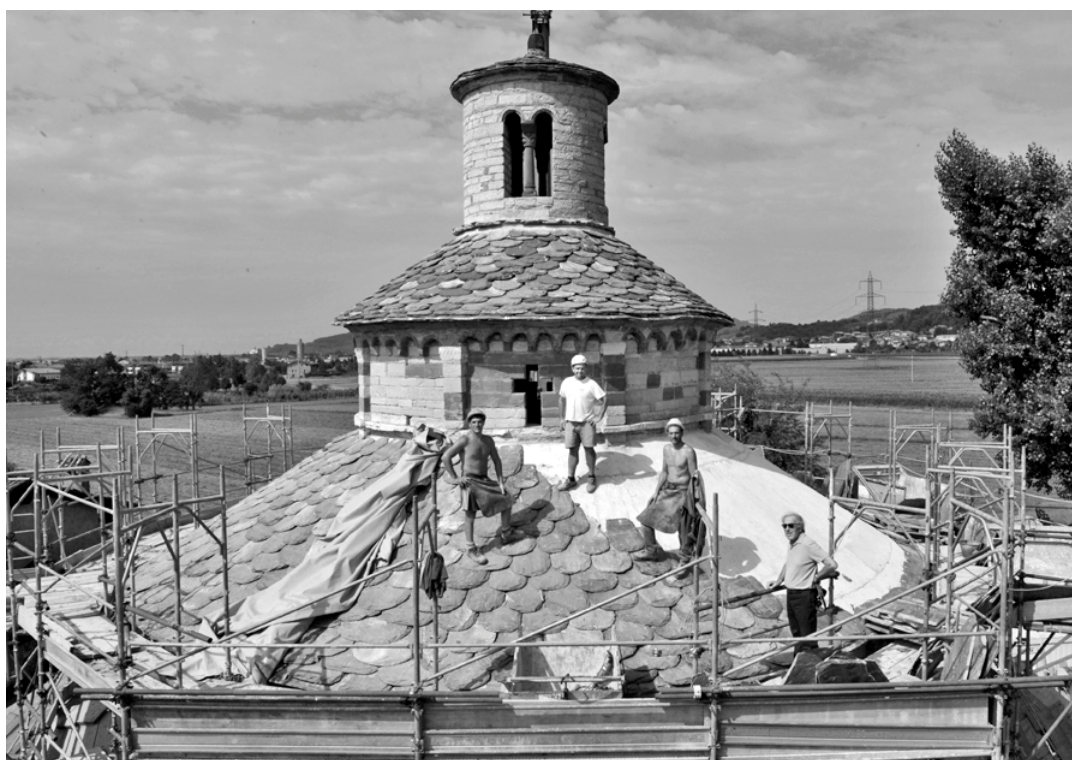
Figure 15. Final step of the straightening intervention: the placing of the stone slabs on the roof.

The placing of the stone slabs, which are connected to the mortar layer by means of nails, represents the last phase of the structural intervention, as shown in figure 15.

It can be clearly observed that roof slabs are completely covering all the strengthening steel structures. After the end of the replacing of the roof slabs, the restoration of the walls of the Temple was completed.

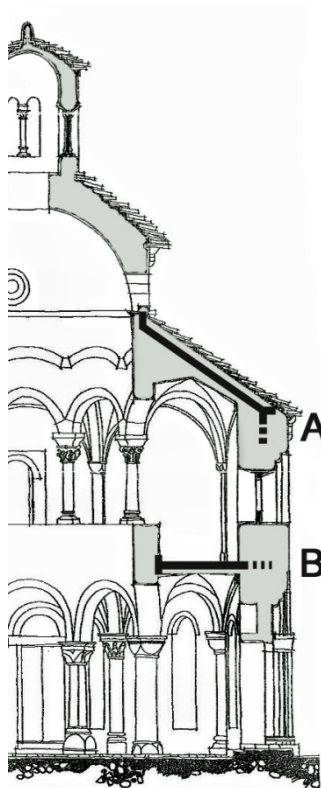
Figure 16. Strengthening confining interventions:
A- Intervention described in the paper
B-Future confining intervention at the level of women's gallery

A second strengthening intervention should be necessary to complete the confining effect on the main cylindrical structure and to increase the reduction of the radial deformations. This intervention should be carried out at the level of the women's gallery, as shown in the scheme of figure 16. Before the reconstruction of the floor of the women's gallery, a new steel confining system should be designed to connect the perimetral wall to the inner one.
