Monitoring-driven design of a multiphase intervention for the preservation of the Frari bell Tower in Venice

Summary

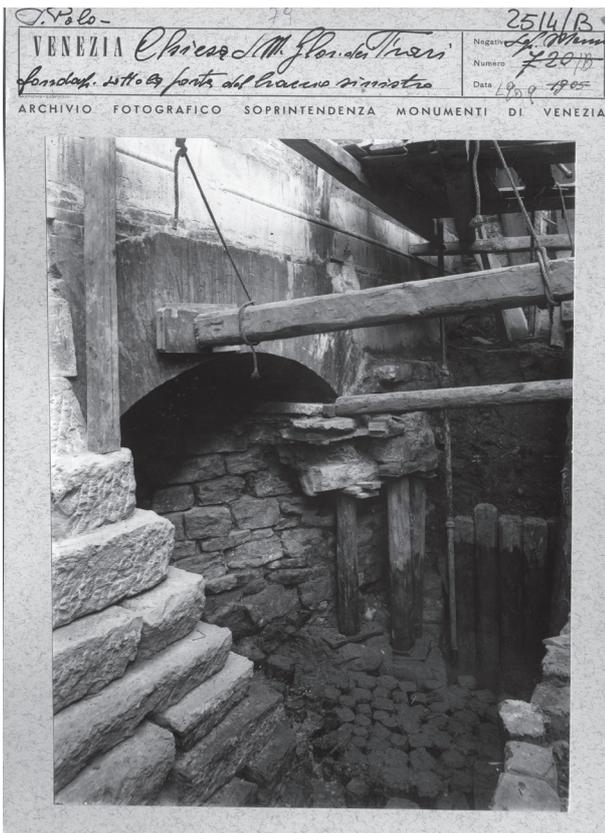
Fig. 2 – Picture of the strengthening intervention on the bell tower foundations, dated back 1904 (Photo archive of the “*Soprintendenza per i beni architettonici e paesaggistici di Venezia e laguna*”).

the bulk of the bell tower, this being therefore the main cause of the tower settlements. For this reason, a strengthening intervention on the bell tower raft foundations was carried out, consisting of widening its base, starting from the south side (toward which the tower was essentially leaning). At the time, the intervention was designed according to the traditional Venetian soil strengthening technique (MARCHI *et al.*, 2006), with the insertion of closely spaced timber piles. The piles, 3.80 m long, 0.20 × 0.20 m of transverse dimensions and essentially touching each other, were made from larch and covered by a 2.00 m wide concrete bed, parallel to the side of the bell tower (Figs. 2 and 3). All the masonry walls were also treated with cement mortar to restore the cohesion of the brick masonry and improve its strength. Such raft foundation enlargement had been most probably designed as to be extended to the other sides; as a matter of fact, however, for emergency reasons that gave priority to other interventions, it was never completed (LIONELLO *et al.*, 2007).

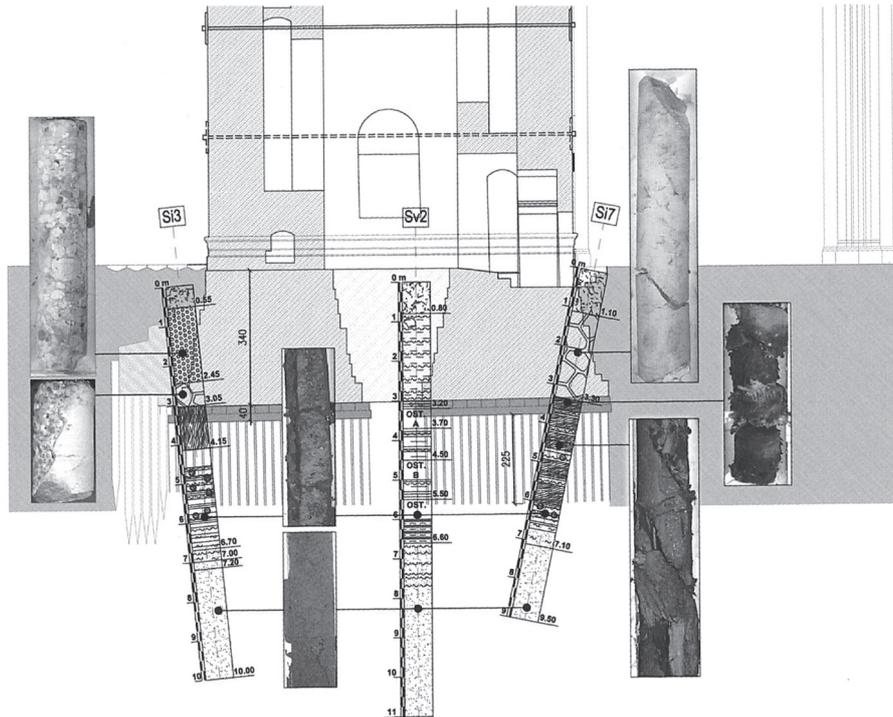
Fig. 3 – Schematic drawing of the foundation with the foundation enlargement of the 1904 on the left and pictures of samples extracted during the recent survey (Lionello, 2008).

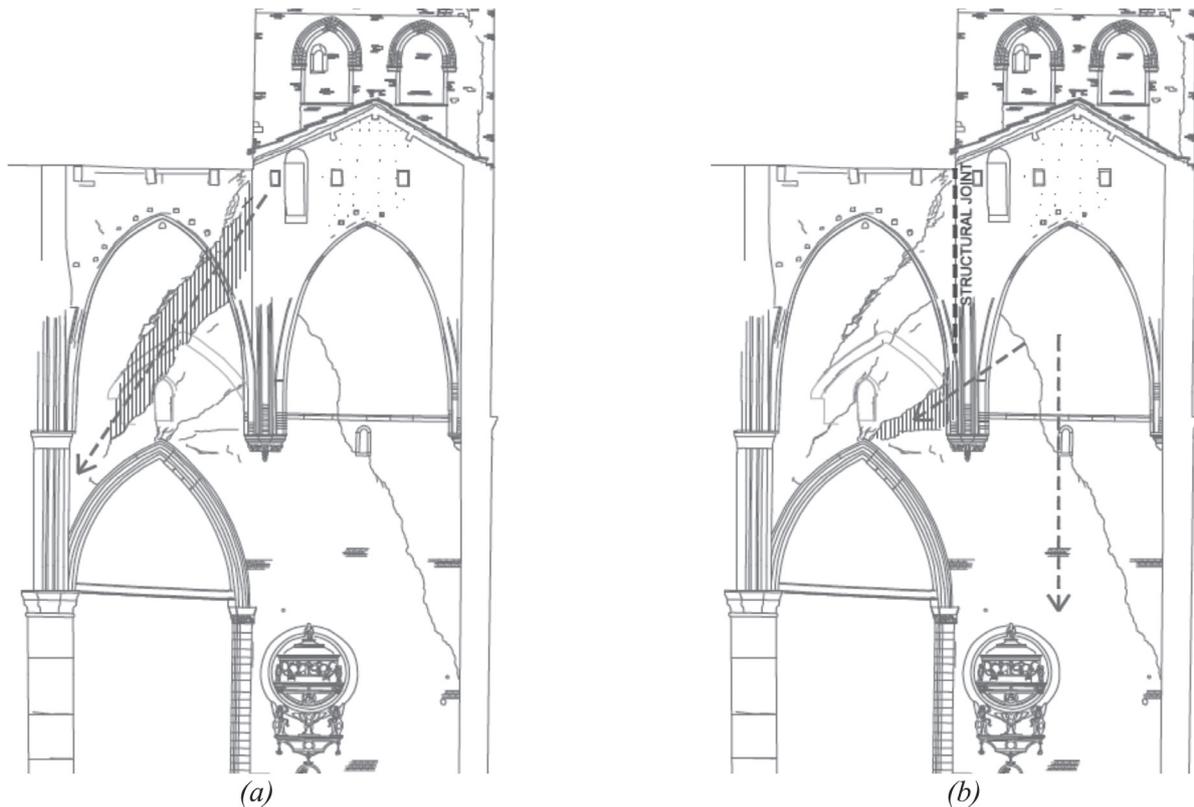
Fig. 13 – Direction of the thrust between the bell tower and the basilica: a) before the structural joint execution, b) after the structural joint execution.

According to a suitably conceived approach for the restoration and preservation intervention, it was therefore opted, instead of opposing against the current forces acting on the structures, to reduce their stress distribution (LIONELLO, 2011). About two years after the end of strengthening works on the foundation soil, it was decided to insert a gap between the bell tower and the adjacent church by creating a structural joint that would allow the relative movements and prevent the mutual stress transmission. It was assumed that the compression stresses flowing above the arch and transmitting substantial forces to the column of the Basilica (Fig. 13a) could be thus reduced.

The structural joint was created at the beginning of June 2008 in the position shown in figure 13b and, in order to preserve the Basilica architecture, it was carried out only above the vaults where, on the other hand, mechanical interaction was greater. During the intervention, it could be confirmed that the existing structural link had been executed only after the construction, probably together with the early 20th century interventions, when it was wrongly

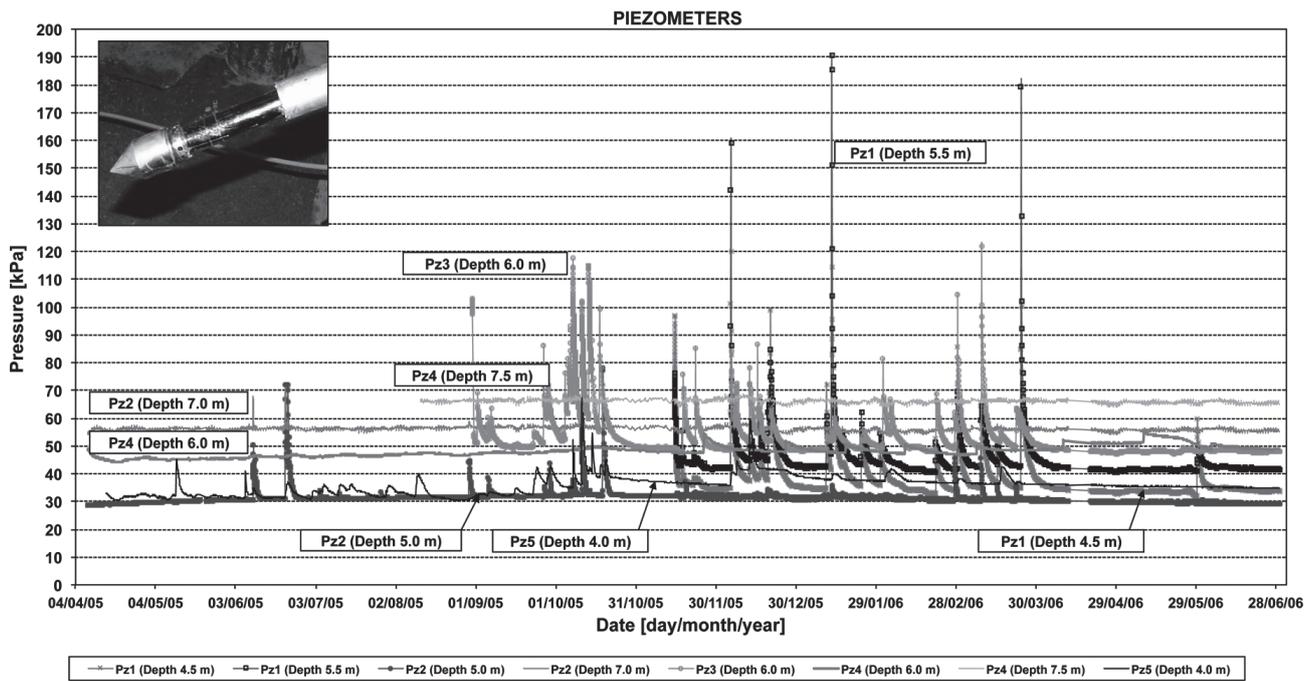
Fig. 14 – Records of most electric piezometers installed within the silty clay layer (after Lionello, 2008).

As reported in section 2.3, the geotechnical instrumentation installed throughout the area of the intervention enabled to carefully check the effects of the soil fracturing. As an example, in figure 14 the records of most electric piezometers installed within the silty clay layer are provided: the pore pressure peaks induced by adjacent grout injections

are clearly visible as well as the subsequent relatively quick consolidation rate, which enabled to drive the operations under constant control and safety conditions.

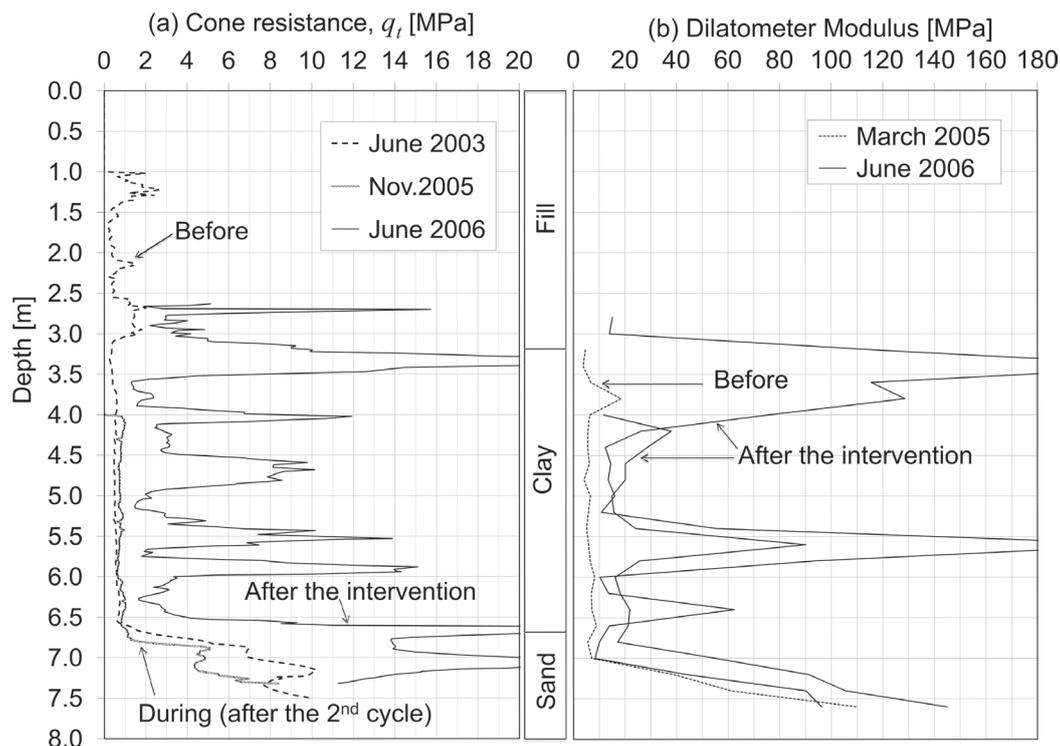
Fig. 15 – Comparison between (a) CPTU tests and (b) dilatometer modulus (MPa) before the intervention after the second injection cycle and at the end of the injections (after Marchi *et al.*, 2014).

As designed, the injections led to soil fracturing: evident and diffuse cement lenses in the soil were found in undisturbed continuous core sampling carried out at the end of the intervention. Specific additional in situ geotechnical investigations (piezocone and dilatometer tests) were planned and carried out to assess its effect on the mechanical properties of soil. The global effect of the injections could be assessed by comparing the results of in situ tests performed at different stages of the intervention. The soil strength improvement is clearly noticeable from all the CPTU tests carried out before the intervention, after the second injection cycle, and at the end of the injections (Fig. 15a) (respectively CPTU "n"/A, /D and /E in Fig. 6). Peaks of the tip resistance are due to the diffuse presence of grout lenses, although the relevant average increase among them was more effective. Figure 15b shows analogous data related to the dilatometer modulus. The relevant stiffness increase was also confirmed by laboratory oedometer tests, which provided a modulus increase of approximately 100% at 50 kPa and approximately 20% at 400 kPa (LIONELLO, 2008).

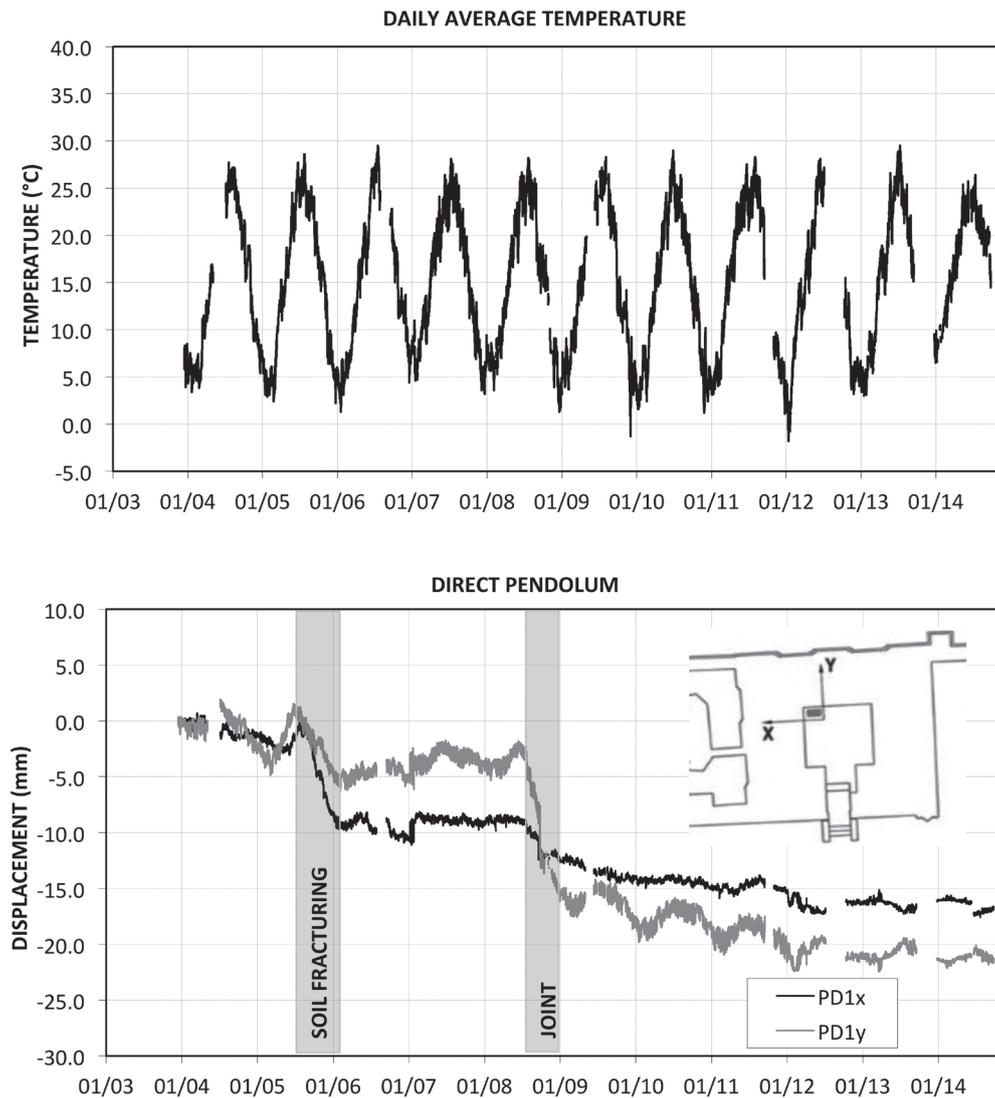
Fig. 16 – Complete history of the displacement components measured by the direct pendulum with the indication of the intervention phases: soil fracturing and structural joint execution (to 27/10/2014).

However, more comprehensive information for the analysis of the structure behaviour during the soil fracturing works come from the direct pendulum records and precision leveling surveys. In figure 16, the movement trend along two orthogonal components from direct pendulum are shown. The period of observation is from December 2003 (date of installation of the monitoring system) to the end of October 2014. During the soil fracturing intervention (from April 2005 to March 2006, grey shadow), the monitoring system was also useful to define the rate of the intervention phases as well as to support decisions on the parameters of the grouting procedures (injection pressure, flow rate, etc). A significant movement of the bell tower during this intervention phase was observed, the component in x direction (toward the apse) being about 9.0 mm and in

y direction (toward the Basilica) about 5.0 mm. After the end of the soil fracturing, the rate of the bell tower movements showed a quick reduction, reaching a lower value than that observed before the intervention. Movements of cracks in the stone arch which connects the bell tower to the Basilica also showed a marked increase during soil fracturing and a rapid decrease after.

An interesting indication of the bell tower response to such structural modification can come again from the measurements of the direct pendulum (Fig.16, second shadowed time interval). It can

be observed a more evident effect along the y direction, i.e. consistently with the newly introduced lack of support.

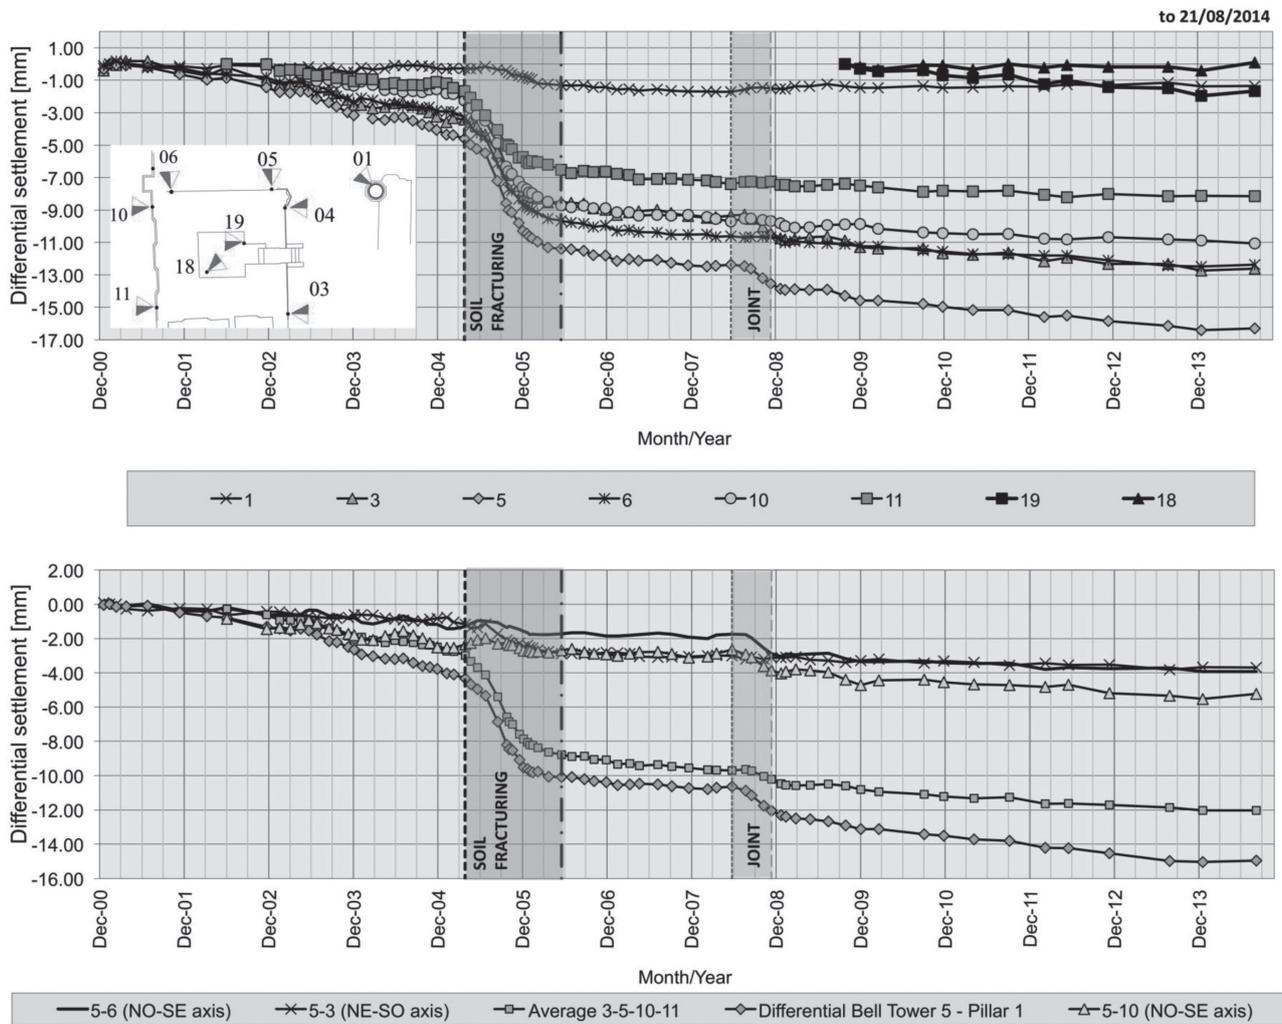
In figure 17 the settlement trend of several benchmarks from precision leveling is provided. A more pronounced vertical movement of the bell tower west and south corners (points 5 and 6) is clearly observed during the soil fracturing intervention (time interval highlighted in grey), but all measuring points display a similar rate increase during the intervention and a significant reduction immediately after, also with respect to original rates be-

Fig. 17 – Settlements (left) and differential settlements (right) of several benchmarks from precision leveling (courtesy of FOART srl, Parma), to 21/08/2014.

It is finally extremely interesting to compare the average foundation settlement during the 5 years after the joint execution with the readings of two adjacent benchmarks (18 and 19 in Fig.17) located inside the bell tower, one at the foundation level (+1.00) (benchmark 19) and the other –more recently installed – anchored in the soil, at -6.00 m depth, just below the tip of timber piles (benchmark 18). Despite some scatter of the rea-

dings, due to the position of the benchmarks inside the bell tower, such comparison suggests that a large part of the continuous soil straining (about 80-90% of the overall foundation settlement) occurs in the first 6 m of depth. This evidence would confirm that the progressive and already established (rather unexpected in these terms, though) decay of timber piles can count for most residual movements of the bell tower.

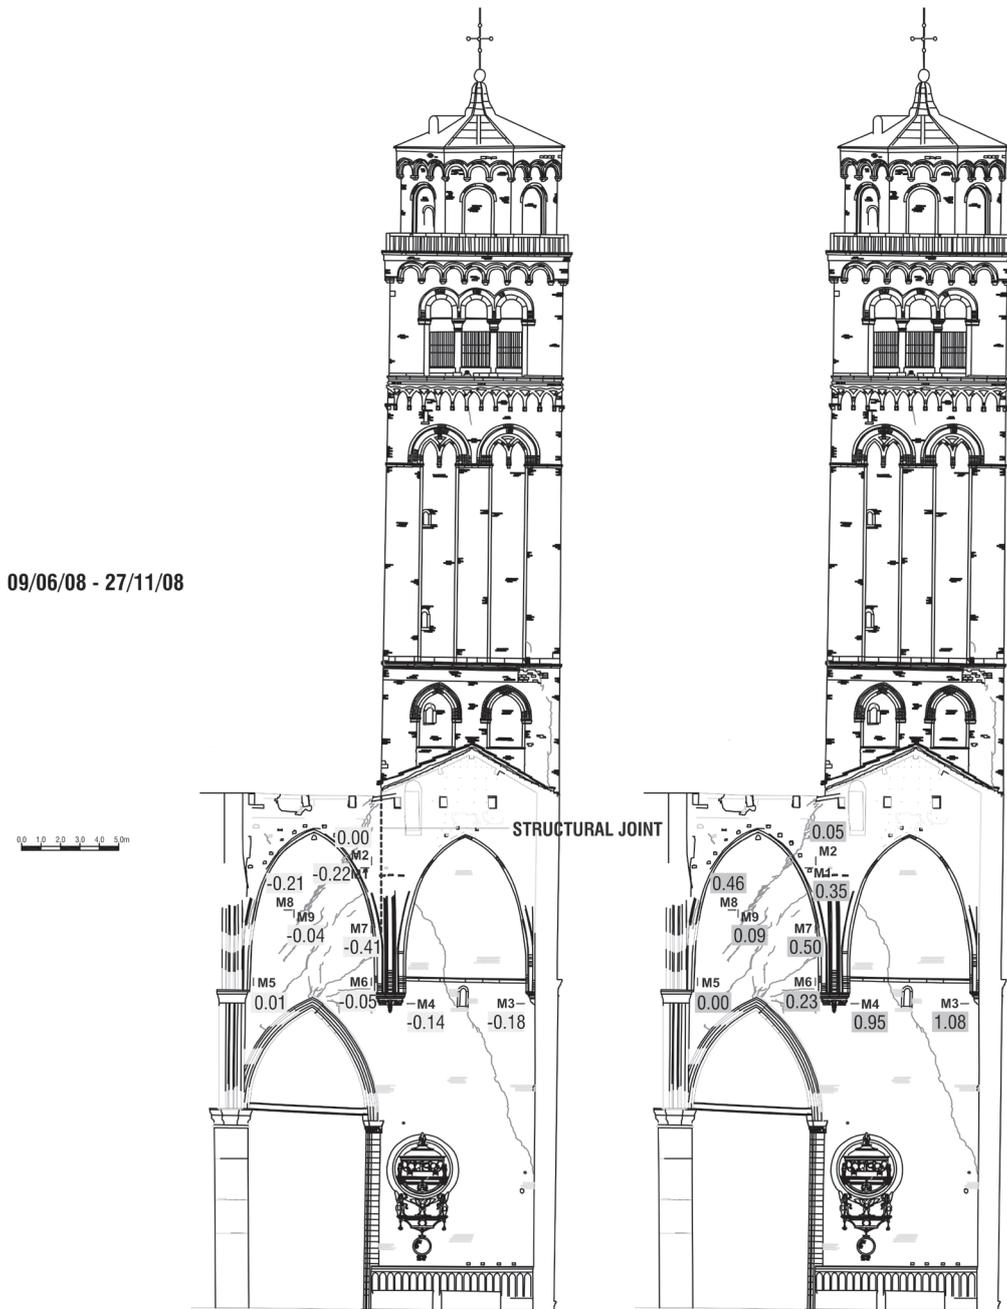
Fig. 19 – Measurements of the state of stress before the structural joint execution (on the right) and variation of the states of stress induced by the structural joint execution (on the left) (Rossi & Rossi, 2012).

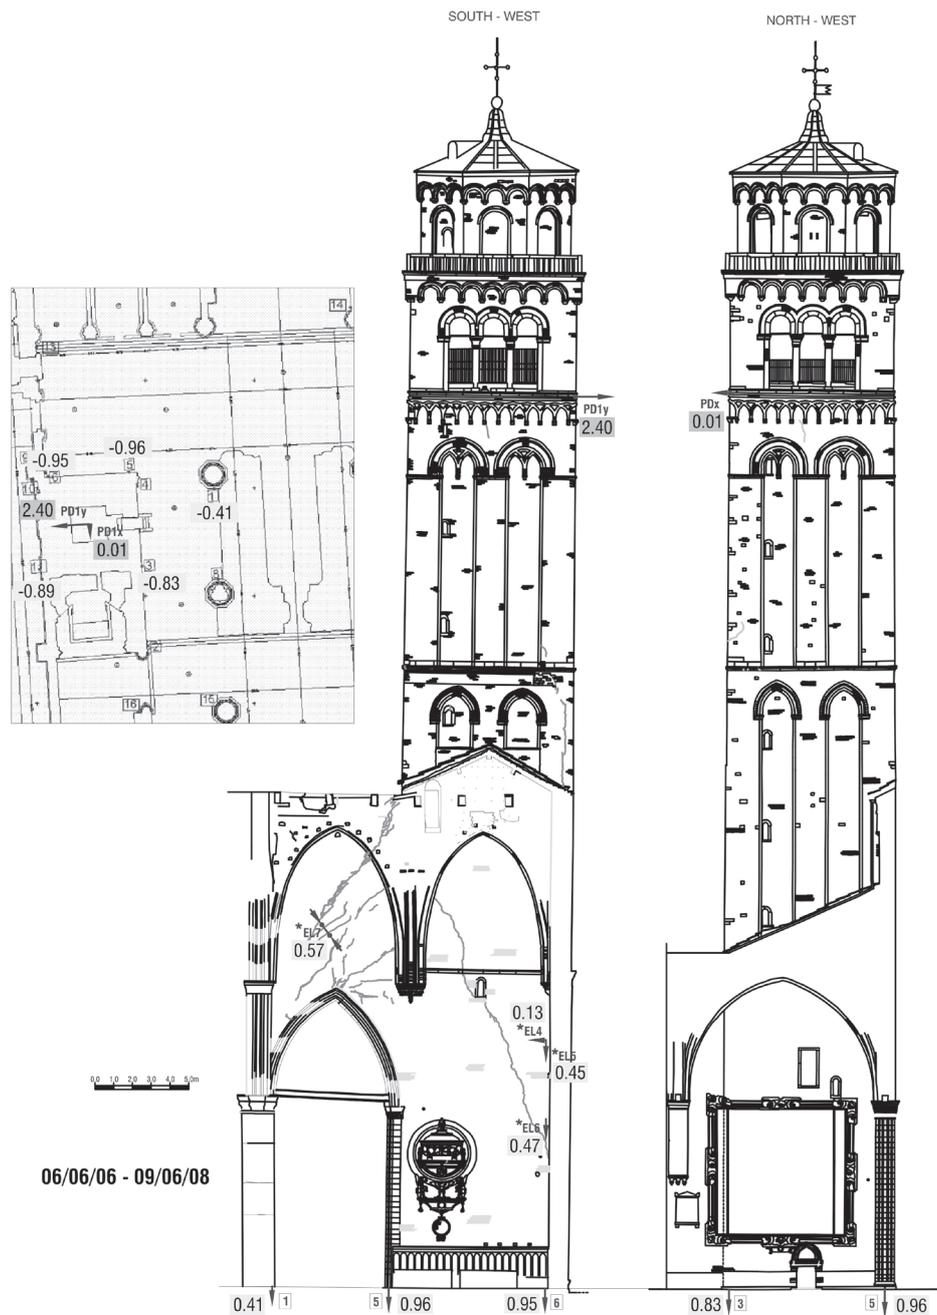
years - between the soil fracturing and the structural joint, the tower has settled less than one millimeter (see surveying records at the top left of Fig. 20), with a modest inclination toward the external side.

Fig. 20 – Analysis of the deformations measured during a period of two years, between the soil fracturing intervention and the structural joint execution.

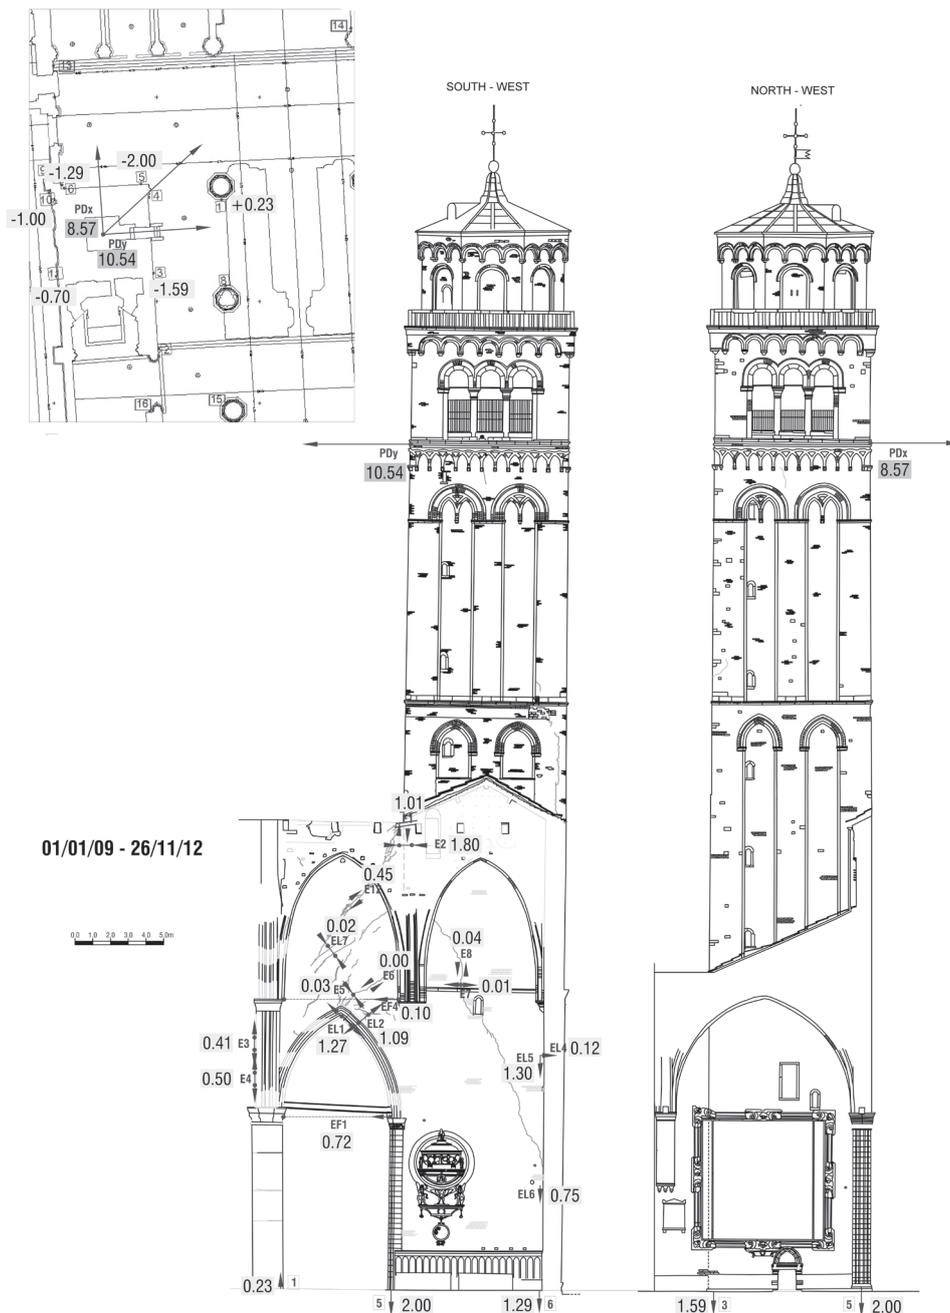
and the column (which incidentally has even showed a temporary upward relative movement, benchmark 1 in Fig.17), all the monitoring devices (Figs. 16, 17, 20, 21 and 22) show a consistent trend. The average – and still rather uniform - settlement of the bell tower has proved to be about 0.3 mm/year, in the 4 years after the joint execution (from January 2009 to November 2012) and 0.15 mm/year, in the last two years and a half (from February 2012 to August 2014). When compared to the rate of more than

Fig. 21 – Analysis of the deformations measured during a period of about four years, after the structural joint execution.
 Fig. 21 – Analisi delle deformazioni misurate in un periodo di tempo di circa quattro anni, dopo l'esecuzione del giunto.

1 mm/year before the soil fracturing intervention, it appears that its overall effectiveness can be confirmed.

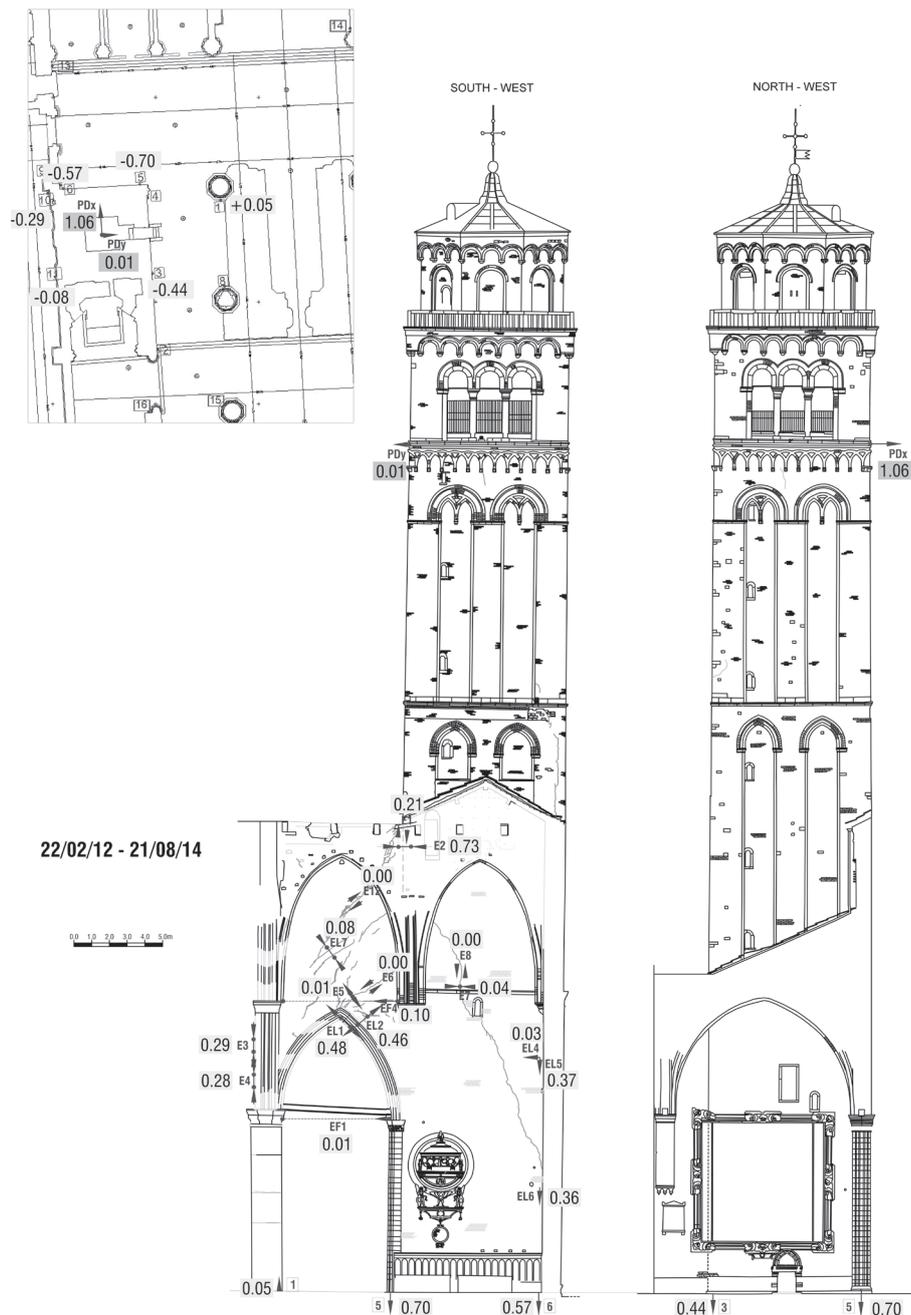
Fig. 22 – Analysis of the deformations and displacements measured in the last two years and an half.
