Experimental and numerical analysis of the structural behaviour of St Stefano's bell-tower in Venice

A. Lionello, I. Cavaggioni

C. Modena, F. Casarin

ABSTRACT: The paper illustrates the results of two series of in situ tests for the analysis of the mechanical behaviour of the masonry structures: flat-jack tests, coring and video camera survey as well as a detailed crack-pattern survey. All the tests were carried out with the aid of climbers, without any kind of scaffolding. An automatic monitoring system was installed, including direct pendulum, crack-gauges, long-base extensometers, clinometers and thermal gauges for measuring air and masonry temperature. The diagrams of the measures recorded during a period of about two years are presented. A FE model was implemented in order to better interpret the results of both the experimental investigations and the monitoring.

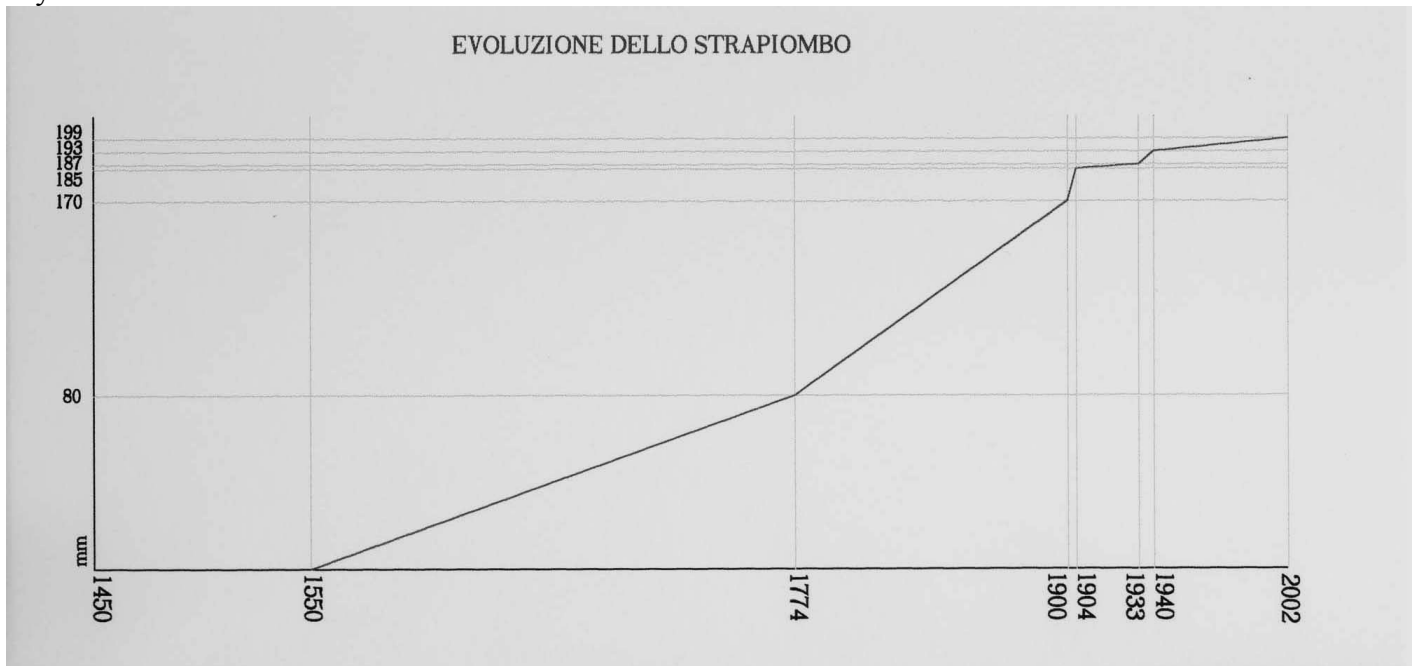
The first evidence of a leaning of 0.80 m towards the east-west side, dates 1774; in 1900 it was observed a sensible increasing of the leaning (about 7 mm per year) which leads the deviation from verticality to 1.70 m, measured at the level of the bell's cell.

Figure 1. History of the leaning of St Stefano's bell-tower measured at the level of bell's cell (44 m)

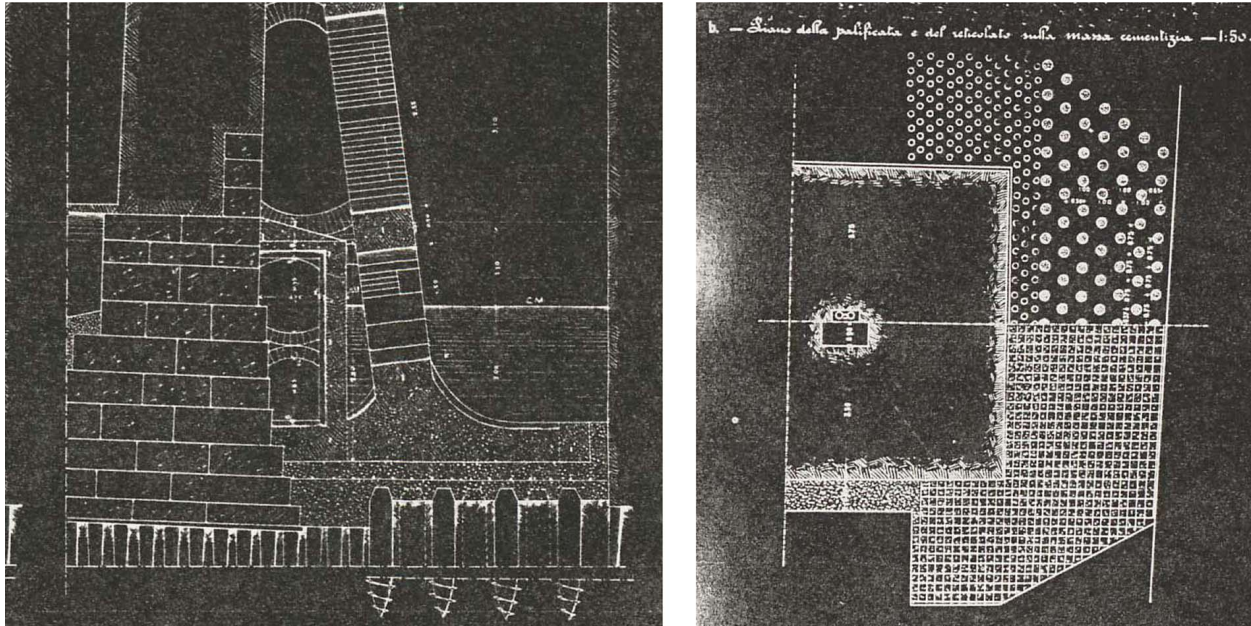
It was discovered that the primary cause of the decay of the structure was due to the erosion of the mortar

between the stone blocks of the foundation, induced by the water of the canal. From the scaffolding, the engineers could verify directly the conditions of the structural masonry that had revealed to be "sound, regular and resistant" excluding some detachments of the bricks forming the pilaster strips and the arches of the cornice from the inner masonry.

Figure 2. Consolidation intervention carried out in 1904

tresses, 12 m high, were inserted in the existing masonry of the bell-tower and connected by a system of straight and inverted arches reinforced with steel elements; the load of the new buttresses was discharged on a new foundation system realised with inverted arches and vaults connected by steel chains as those used for the reinforced concrete, which guaranteed both a rapid execution and a reduction of the load on the bottom of the canal.

The strengthening of the bell-tower was realised by the new five buttresses (with a section of 1.50×0.75 m) and enlarging the foundations with a con-

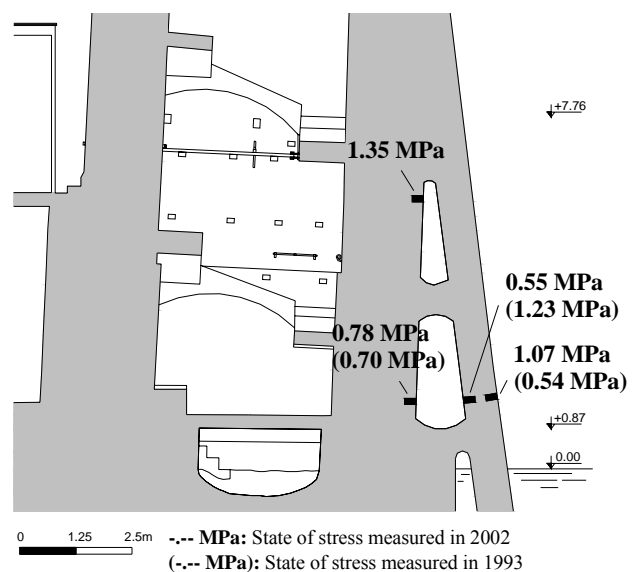
Figure 3. Measure of the state of stress in the east side of the bell-tower by flat-jack technique: comparison between the stress values measured in 2002 and 1993

It can be observed a redistribution of the stresses in the buttresses: on the outer side, the mean stress is increased from 0.54 MPa to 1.07 MPa, while in the inner one a decrease is observed from 1.20 MPa to 0.55 MPa. At the base of the east side of the tower the stress is nearly the same. The redistribution of the stresses in the buttresses could be partially related to the movements of the bell-tower in the period (9 years) between the two testing phases.

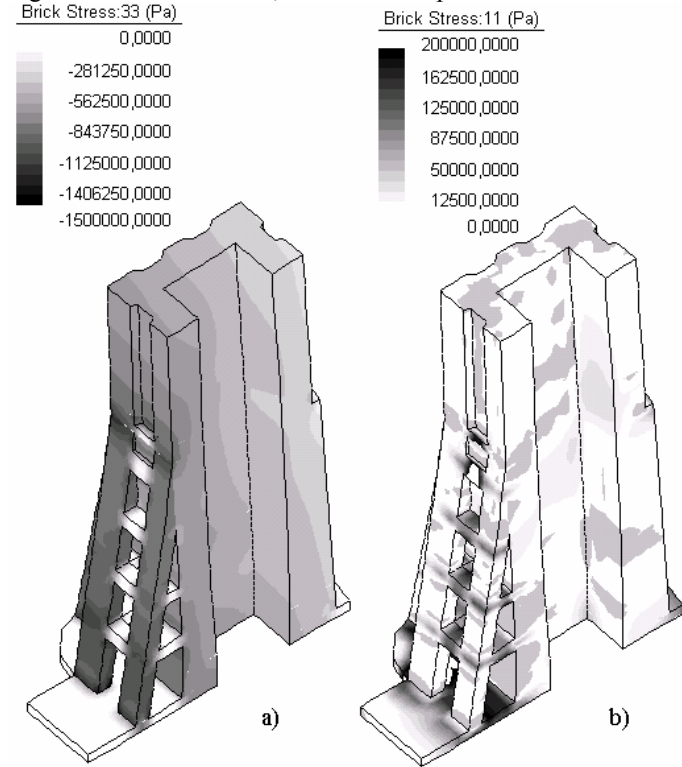
As load conditions, only the dead load was considered. Figure 5a and 5b respectively show the principal compressive and tensile stresses obtained in the “1994 model”. It is possible to notice that quite all of the elements are subject to compression; the maximum σ_{33} value is localized at the connection between the buttresses and the structure of the bell-tower, and is equal to 1.75 MPa.

The tensile stresses, quite negligible in the model, are considered “acceptable” within the limits of the linear elastic analysis, showing a maximum value, in a very reduced area, of 0.27 MPa.

Figure 5. 1994 model results: a) principal compressive stresses; b) principal tensile stresses

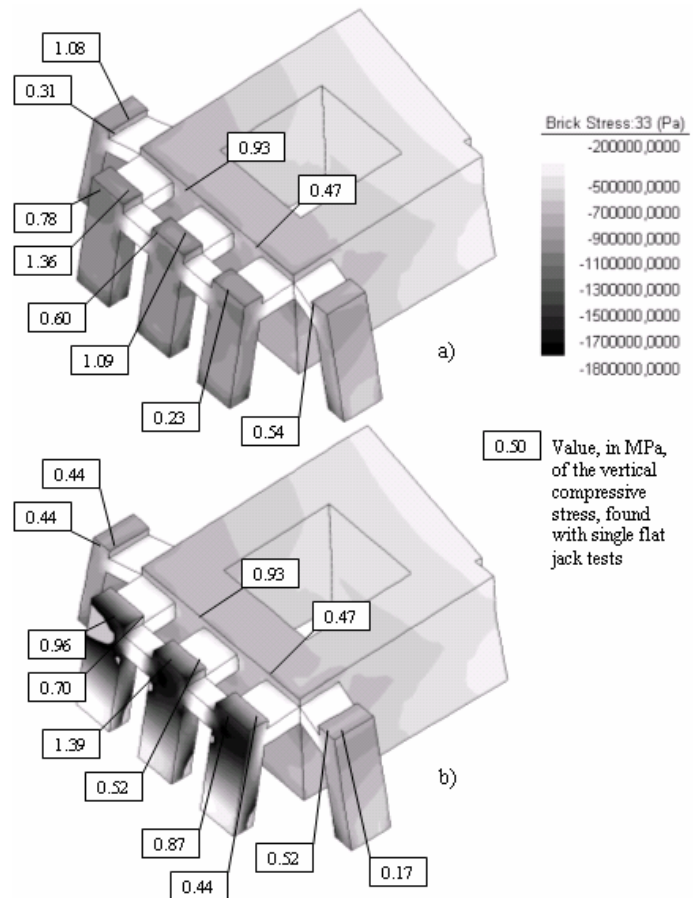
The results, in terms of principal compressive stresses, are in the same range as those obtained by several flat jack tests performed on the masonry structures (see Fig. 6a).

Figure 6b shows a comparison between theoretical and experimental distributions of principal compressive stresses due to gravitational load. A fairly good agreement with the experimental results is thus obtained. Some local inconsistencies between the results were found, both in the "1994" and in the

"2002" models, likely due to material inhomogeneity, not included in the numerical simulation.

Figure 6. Comparison between the experimental and numerical vertical stresses – a) year 1993; b) year 2002

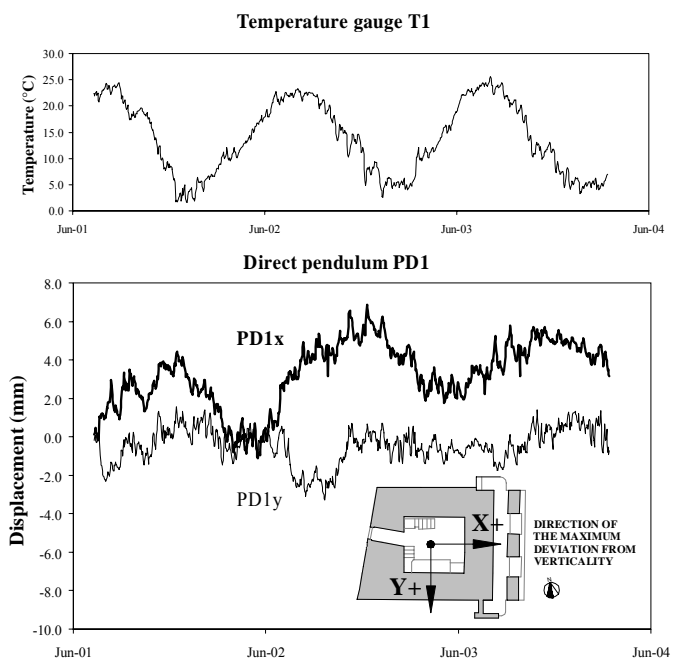
Figure 8. Diagrams of the data of the temperature gauge T1 and of the two components of the absolute horizontal move-

ments of the top of the tower measured by the direct pendulum. The average daily values are reported.

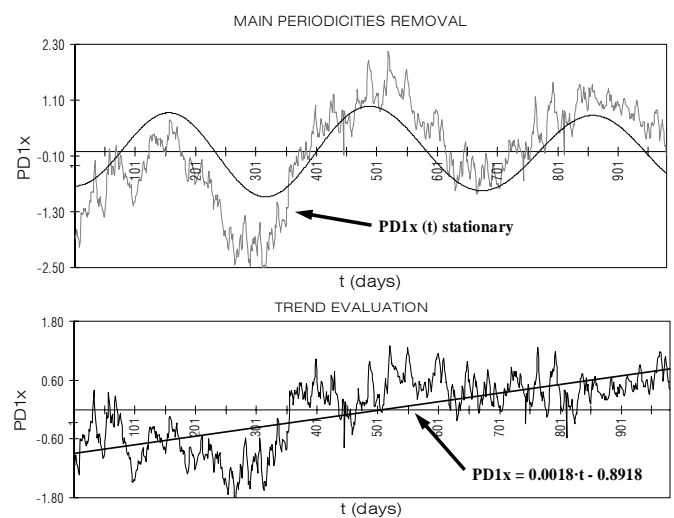
Figure 10. Signal analysis implemented for the direct pendulum (component in direction of maximum deviation from verticality). The trend of 0.0018 1/day obtained is pertinent to the stationary process: the real trend can be obtained by considering the method used to render signal stationary; for the X-component of the pendulum the real trend is 1.076 mm/year.

- the absolute horizontal movements of the top of the bell-tower, measured by direct pendulum, shows a significant trend which is about 1.08 mm/year in the direction of maximum deviation from verticality (X-component) and 0.22 mm/year in the Y-component.
- all the long-base extensometers EF1÷EF6 and the crack-gauge EL1÷EL4 and EL8, installed on the bell-tower leafs, do not show significant deformation trends;
- the crack-gauges EL5, EL6 installed on the joint between the tower and the vertical walls of adjacent building, show a positive trend of opening of the joint with an average value of 0.10 mm/year;

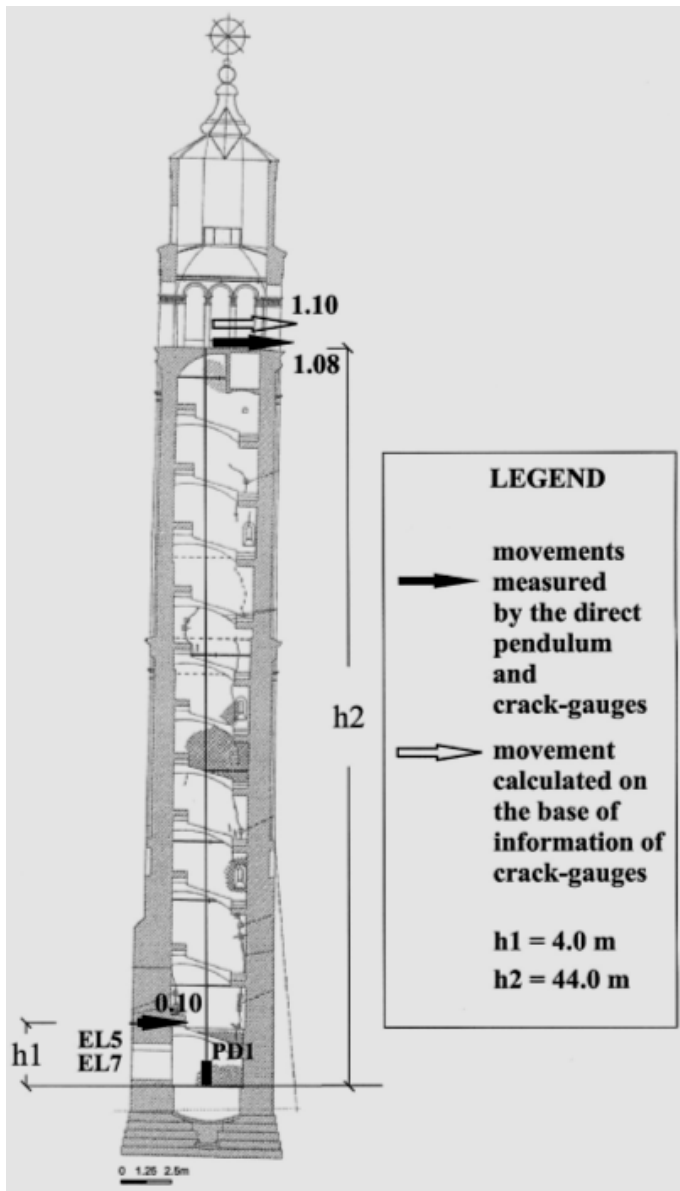
Very significant is also the opening of the joint between the tower and the vertical wall of adjacent building, which is measured by instruments EL5 and EL7. These crack-gauges show an average deformation trend of about 0.10 mm/year at a height of about 4.0 m from the ground which means 1.10 mm at the top of the tower where the wire of the direct pendulum is anchored (Fig. 11).

It can be observed that this value is very close to the value measured by the direct pendulum.

Figure 11. Comparison between the deformations trends measured by the crack-gauges EL5 and EL7 and the component X of the direct pendulum. The crack-gauges show an average deformation trend of about 0.10 mm/year at a height of about 4.0 m from the ground which means 1.10 mm at the top of the bell's cell (44 m) where the wire of the direct pendulum is anchored. This value is very close to the value measured by the direct pendulum (1.08 mm).

The progressive tilting movements of the bell-tower, clearly shown by the monitoring system, indicates the need of urgent strengthening interventions aimed at eliminate or strongly reduce this trend. These interventions must involve the soil-foundations system of the tower, taking into account the complexity deriving not only by the particular properties of the soil in Venice but also by the interaction between the quite different original foundation of the tower and those of the buttresses.
