G. Oberti, F. Bavestrello, P.P. Rossi, F. Flamigni

***Rock Mechanics Investigation,
Design and Construction
of the Ridracoli dam***

(reprinted from *Rock Mechanics and Rock Engineering XIX*, 3, july - september 1986)

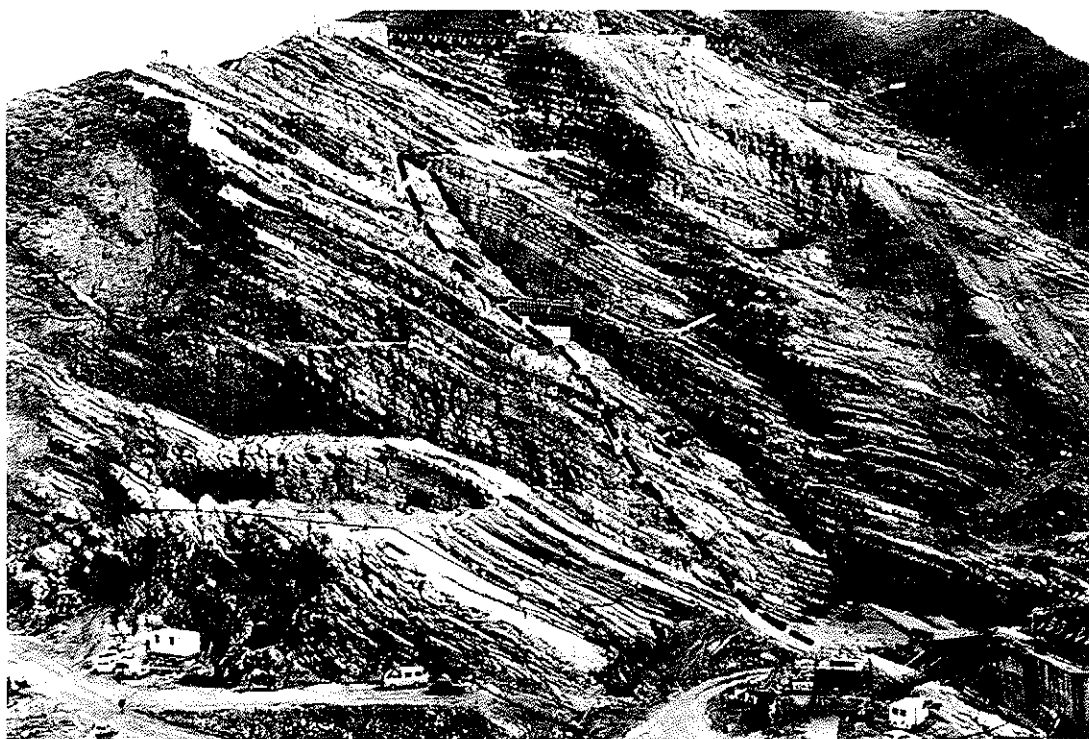
Fig. 18. View of the foundation rock at the right abutment

Dam foundation excavation, especially at the right abutment, was one of the main problems to be solved during the construction of the dam. Owing to the structural features of the formation (layers dipping downhill,

toward the excavation: see Fig. 18) unstable equilibrium conditions of the downstream wall were determined, with possibility of slide of substantial rock volumes.

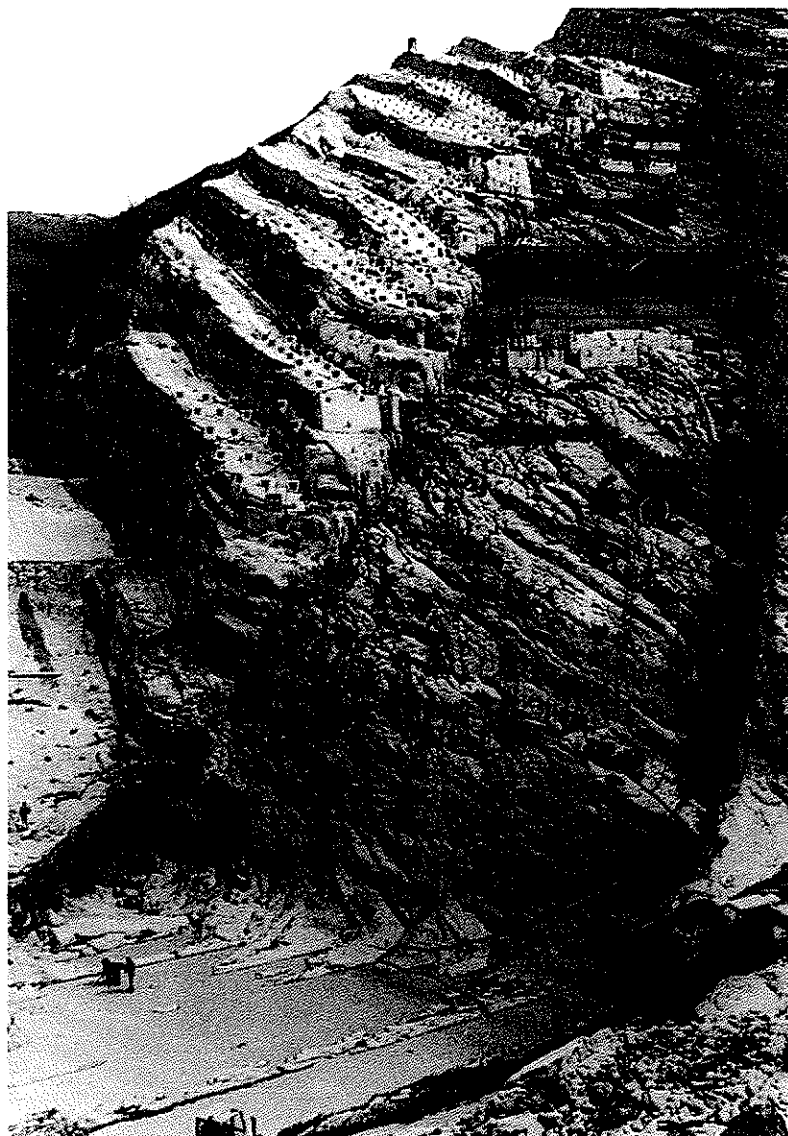
Fig. 21. View of the right abutment. The arrangement of the prestressed anchors on the berms is shown

The distribution of these forces along the wall of the excavation is shown in Fig. 19. The heads of the cables are shown in Fig. 21. The anchors were arranged to allow prestressing at any time, during the whole construction (at least 5 years). Each cable (see Fig. 22), being covered along the active section by anti-corrosion and lubricating materials, could slide inside a protective 2 mm-thick polyethylene wrapping. The anchor fixing was achieved

The tendon's head is formed by a steel bearing plate and by a thick steel collar tube grouted into the rock.
