P.P.Rossi

***Recent developments of the flat-jack
test on masonry structures***

(paper presented at the workshop Italy-USA *Evaluation and retrofit of masonry structures*, august 18-29, 1987)

ismes s.p.a.

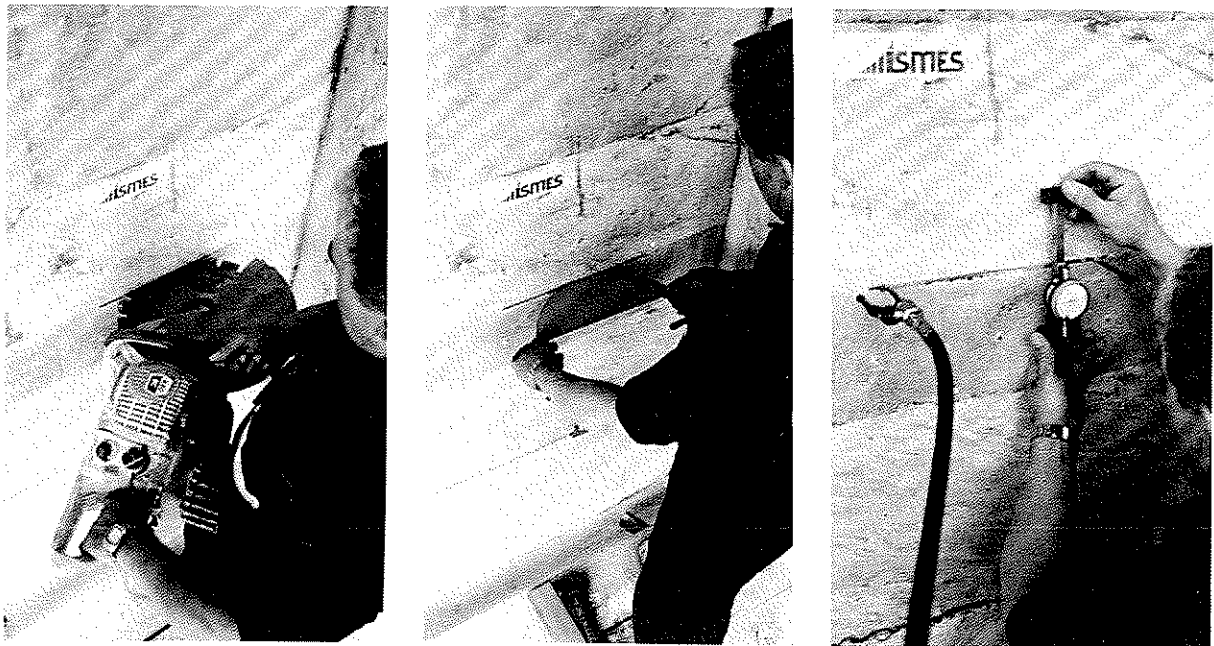
Fig 2 - Flat-jack testing phases on a stone masonry

A different cutting technique has recently been set up in the case of a stone masonry with very thin mortar layers. The cut is made by means of a steel plate with diamond tools and the jack has the same shape as the cutting (circular segment with length 32 cm, depth 12 cm and thickness 4 mm). The different phases of the testing technique applied to a stone masonry is shown in Fig 2. It must be pointed out that the very limited thickness of this kind of jack imposed very delicate problems in the design and construction of the flat-jacks.

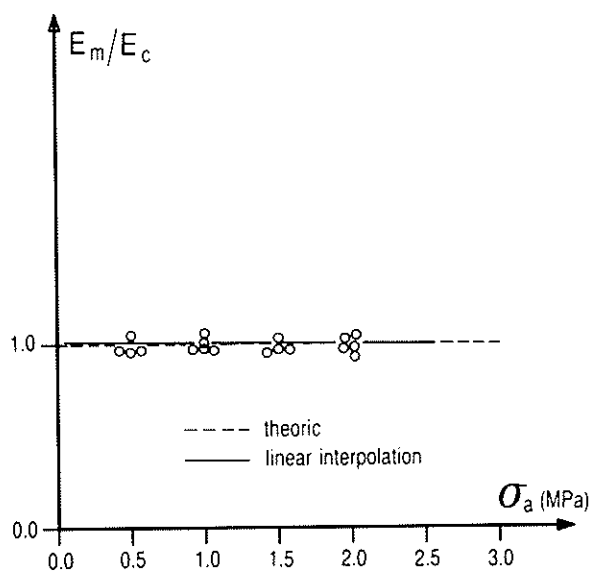
Comparison between the deformability moduli obtained by flat-jacks (E_m) and by conventional compression test (E_c)

In the diagram of Fig 13 the values of the ratio between the deformability modulus determined by the flat-jack test (E_m) and that determined by the conventional compression test (E_c) on specimens having the same size of the specimens included between the two jacks are reported. It can be observed that the values of the ratios E_m/E_c are close to unit and this means that the confining effect of the masonry on three sides of the specimen is negligible; therefore the flat-jack test can be considered as a conventional compression test. Some tests were also carried out using smaller jacks (24 x 12 cm). In this case, the values of the deformability modulus determined by the flat-jack test are much higher than those determined by conventional compression test. This is ascribed to the fact that the masonry sample interposed between the two small jacks has a few layers of mortar and, therefore, it is not representative of the overall behaviour of the masonry.

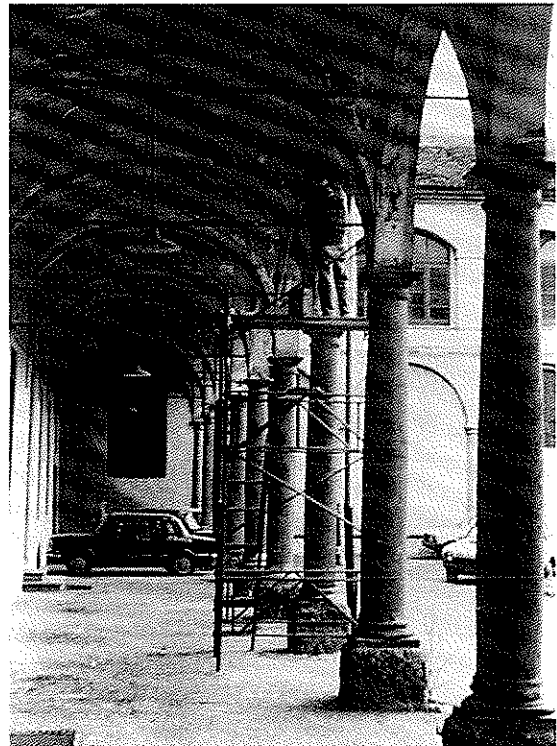
Fig 19

View of the first cloister of St. Eustorgio Church - Milan

The St. Eustorgio Cloisters are attached to the homonymous church. The construction of the first cloister (Fig 19) dates back to the first half of 13th century. The construction of the second one started in 1380. Both cloisters were repeatedly damaged and restored in the following centuries during Spanish and French occupation, and rebuilt in 1600.

After that time, they underwent further damages, the latest occurred during the Second World War when one side of the second cloister was destroyed. At present, the supporting structures of the cloisters are cracked at many points, and some of them show a marked non-verticality.

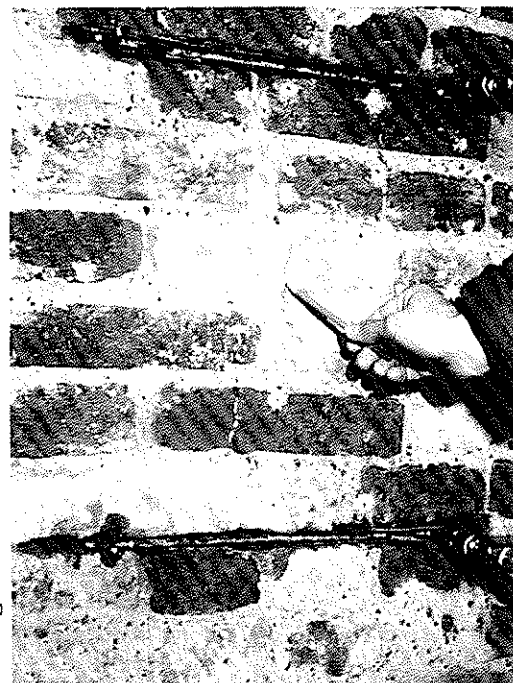
Fig 22 - Deformability test with two flat-jacks on a wall of St.Eustorgio cloisters. Stress-strain diagram up to failure and view of the masonry sample after the test

Using two flat-jacks at some points in the vertical walls, the deformability characteristics of the masonry have been determined. Then the load applied has been increased, until the appearance of the first cracks in the bricks in order to estimate the compressive strength of the masonry. Fig 22 shows the typical stress-strain curve obtained at a test point and the corresponding crack patterns. It can be observed that the damage undergone by the masonry is quite negligible.

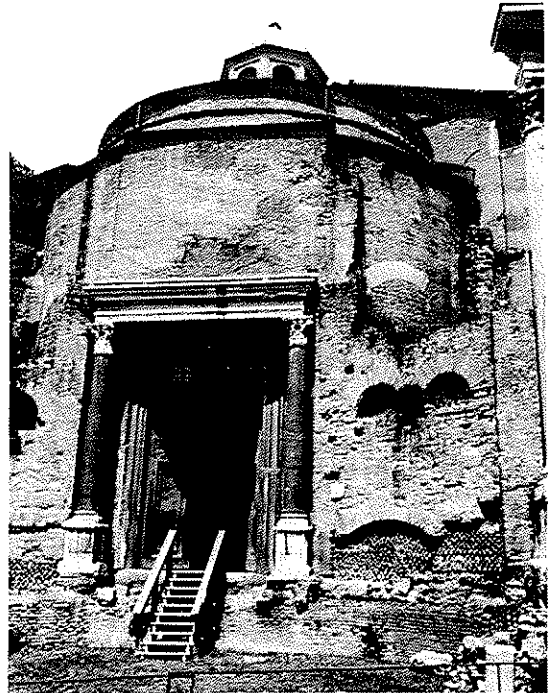
Fig 26

View of the Romolo's Temple -
Rome

The so called Romolo's Temple (Fig 26), the construction of which started in 309 a.c. during the age of the emperor Massenzio, presents a cylindrical structure (external diameter 14,70 m, height 9,10 m and wall thickness 1,22 m) surrounded by a hemispherical dome which is considered one of the largest brick masonry Roman domes in the world.

Today the Temple shows clear sings of static decay; long vertical cracks, from the ground up to the top of the dome, are present as well as a marked non-verticality in some parts of the perimetral wall.

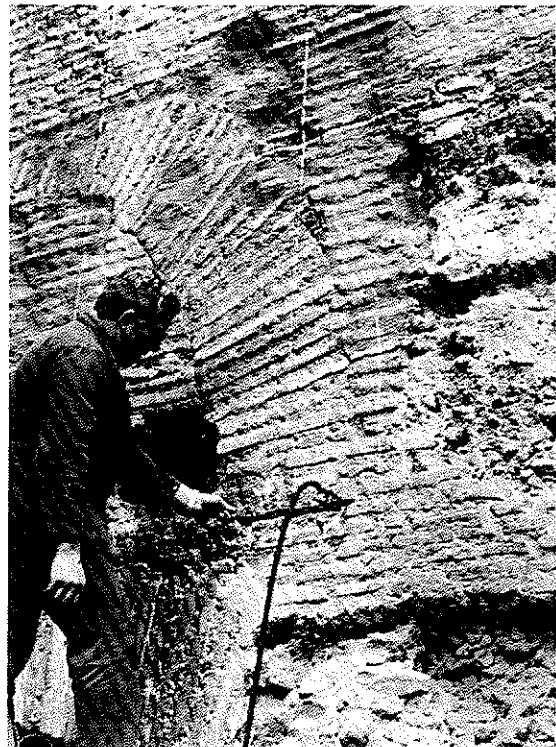
Fig 28

View of a flat-jack test on the external side of the perimetral wall

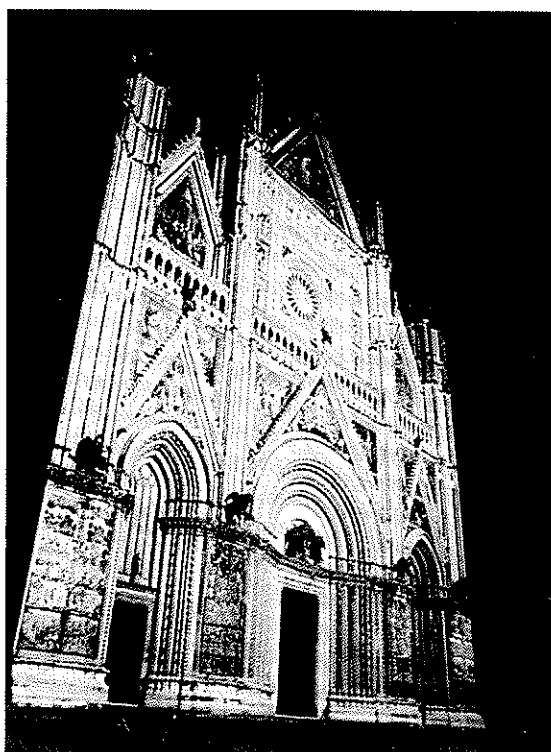
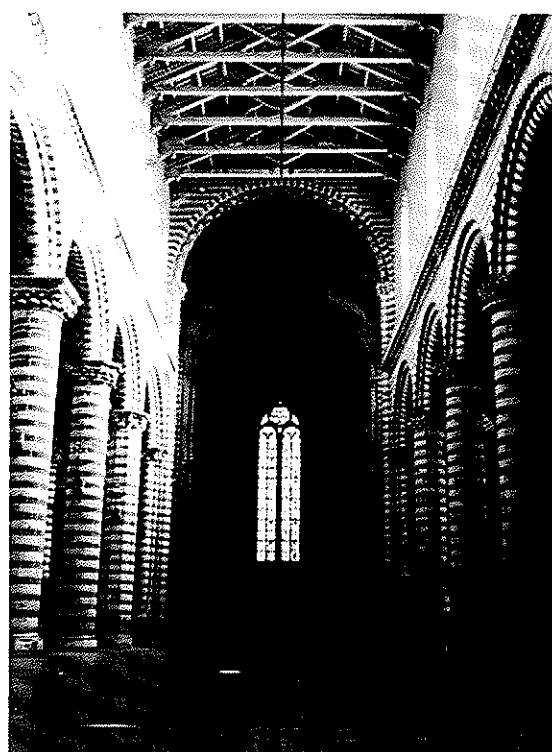
Fig 31 - Facade and internal view of the Cathedral of Orvieto

The construction of the Cathedral, a masterpiece of the Gothic architecture, started in 1290 (probably designed by Arnolfo di Cambio) and was completed by Lorenzo Maitani in 1330 (Fig 31).

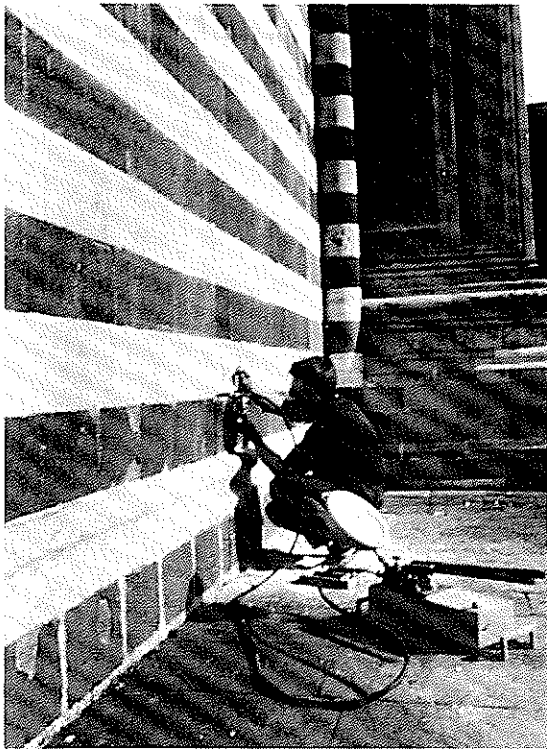
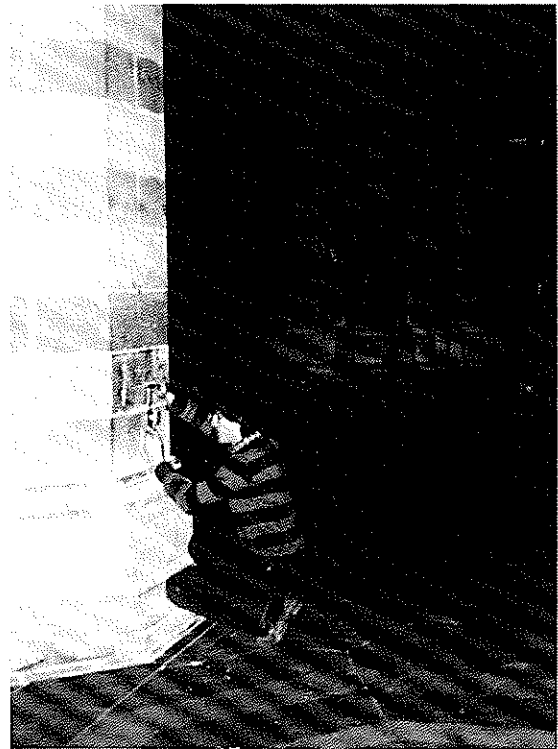
Fig 33 - View of flat-jack test on a lateral wall and on a column

Flat-jack tests were carried out at 17 points of the perimetral walls by using the circular shaped jacks and at 17 points of the columns by using smaller jacks (12 x 12 cm and 24 x 12 cm). The testing points on walls and pillars were chosen in order to check eventual load eccentricity. Fig 32 shows the plan of the Cathedral with the indication of the testing points and the stress values measured by the flat-jack tests. Fig 33 shows a view of flat-jack test on the external wall and on a column.
