**G.P. Giani (\*), O. Del Greco (\*),  
B.Astori (\*\*), P.P.Rossi (\*\*\*)**

***Analysis and control of the static behaviour  
of the Consolazione Church in Todi, Italy***

(reprinted from the Proceedings of the International Symposium *The Engineering Geology of Ancient Works, Monuments and Historical Sites*, Athens, 1988, september 19-23)

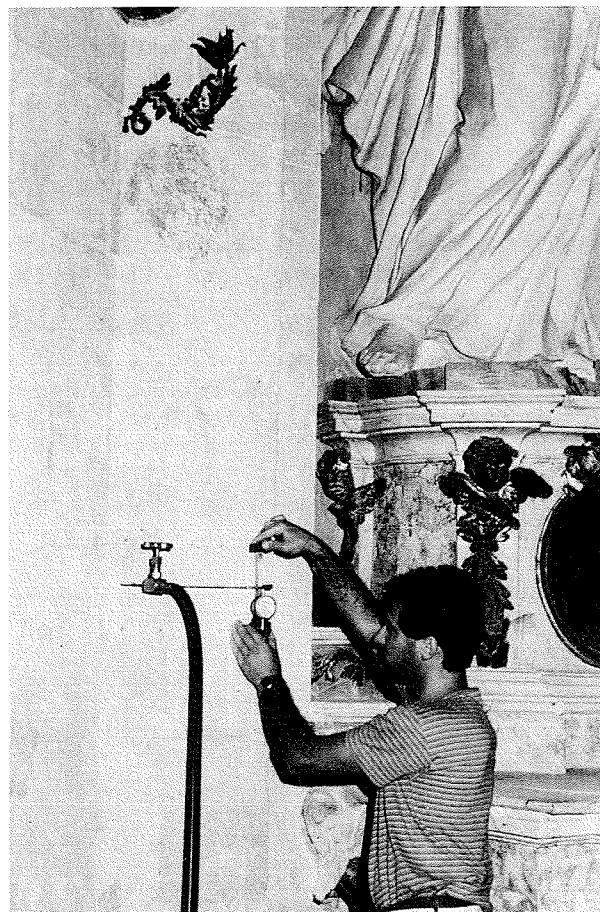
Fig.4 - Flat-jack test carried out on a pillar.

18 flat jack tests were carried out for the stress determination on the pillar and wall masonry at a height of about 1.5 m inside the church and at an elevation of about 2.0 m on the outside of the church (figure 4).

The flat jack technique has been employed in order to determine the state of stress in the pillars and in the wall apses of the church (Rossi P.P., 1982, 1985 - Binda et al., 1983). The deformability characteristics of the examined structural elements are also determined by interpreting the test for the state of stress. The testing technique has also been reported
