*Testing and monitoring  
for the restoration of the  
metropolitan Cathedral  
in Mexico City*

# TESTING AND MONITORING FOR THE RESTORATION OF THE METROPOLITAN CATHEDRAL IN MEXICO CITY

The Mexico City Metropolitan Cathedral is undergoing rehabilitation work based on the subexcavation technique in order to correct the significant differential settlements now reaching up to 2.4 m. During this work, the monitoring systems play a very important role. The paper illustrates the automatic monitoring systems installed by ISMES and ENEL to monitor in real time the movements of the supporting structure of the Basilica. The most interesting data recorded by the monitoring systems are presented, as well as the results of the flat-jack tests performed to measure the existing state of stress of the major supporting structures.

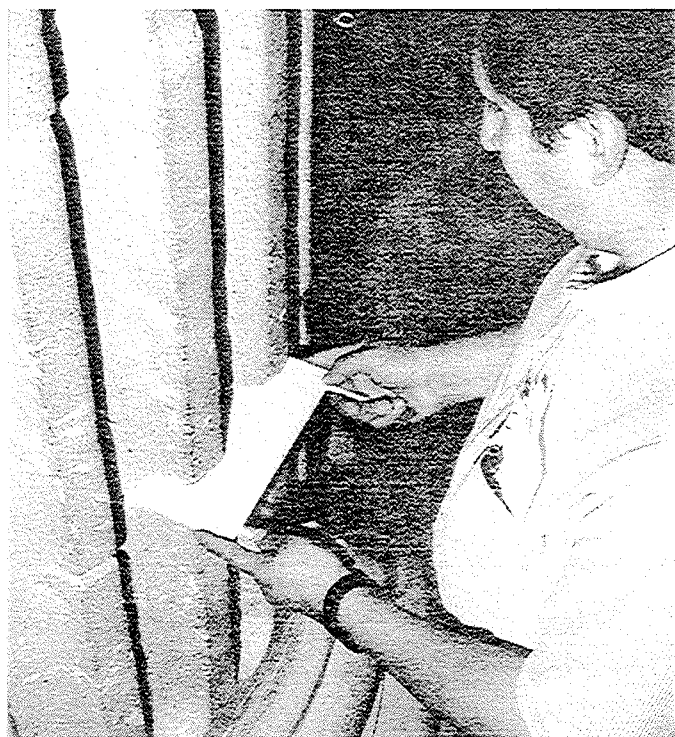
Fig. 4 - View of a flat-jack test for measuring the state of stress of a column.

A phase of a flat-jack test on a pillar is shown in Fig. 4. Owing to the special shape of the surface of the columns, the presence of the decorative vertical channelling has been neglected.

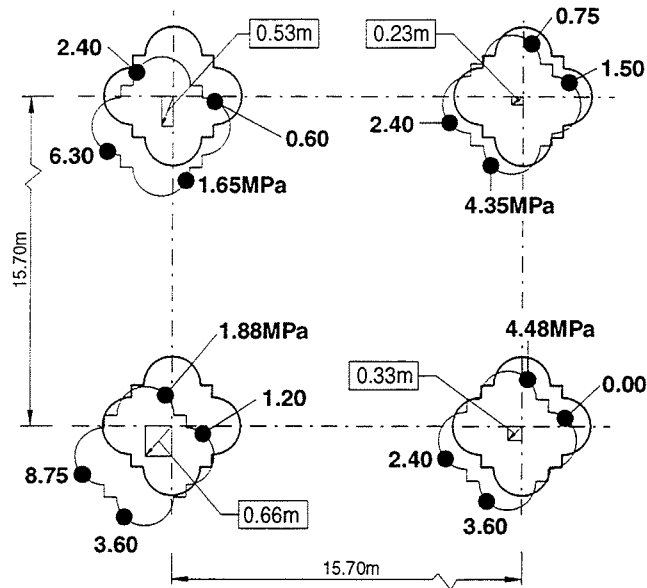
Fig. 5 - Stress state measured by flat-jack testing technique on the four columns supporting the central dome. The deviation from verticality of the columns is shown.

As an example, Fig. 5 shows the stress values measured on the main columns which are supporting the control dome. In the same figure, the deviation from verticality of the four columns is also indicated. It can be observed that the measured values of the states of stress are in good agreement with the deviation from verticality of the columns. The greatest value of the state of stress (8.75 MPa) has been measured on the columns which present the greatest value of deviation from verticality (0.66 m). In some points the measured values of the state of stress are very low, which means that some portions

of the supporting structures have been unloaded by the crack pattern.

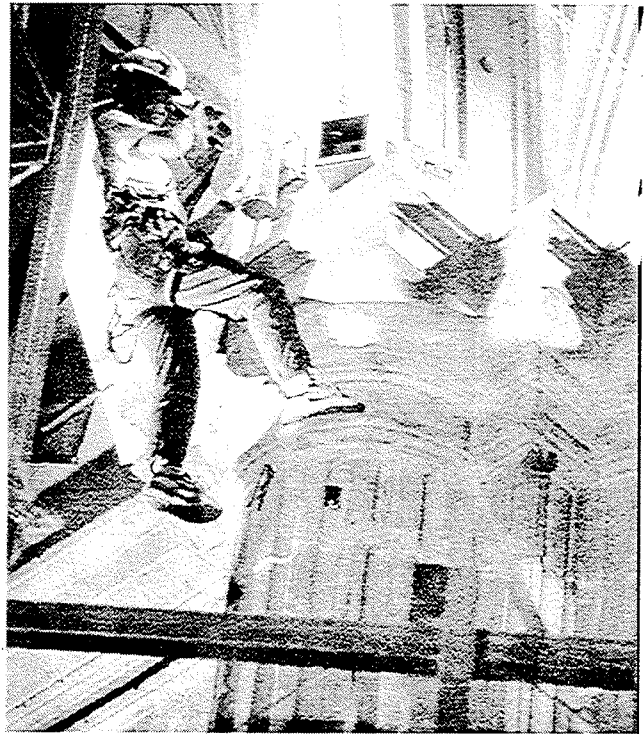
Fig. 8 - Installation of a long-base extensometer at the top of a column.

The general lay-out of the instruments is shown in Fig. 7 while in Fig. 8 the installation of a long-base extensometer at the top of a column, is shown.
