A LOW-COST PROCEDURE FOR QUICK MONITORING OF MONUMENTS AND BUILDINGS

Christian ROSSI, Pier Paolo ROSSI
R.teknos Srl Bergamo (Italy)

Abstract

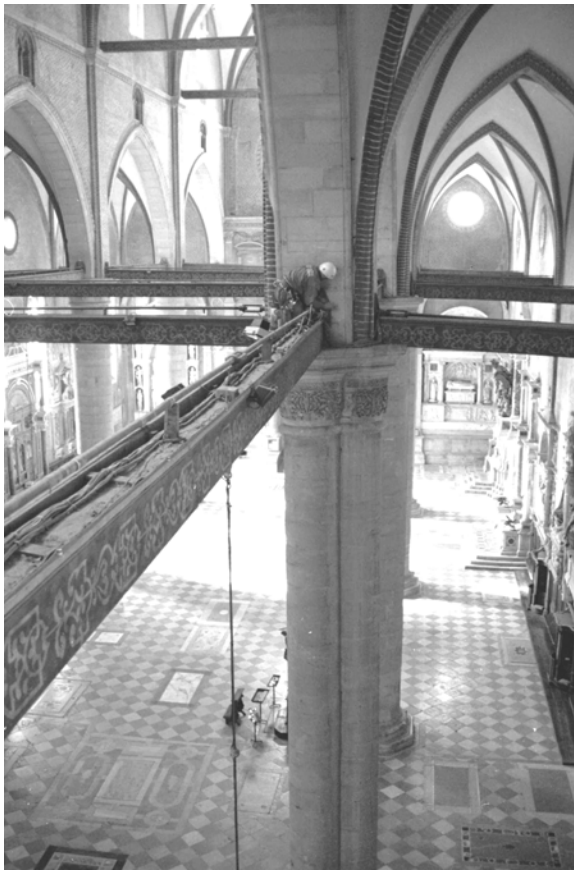
Fig. 2
Church of SS. Giovanni and Paolo in Venice
Installation of crack-gauges and long base
extensometers on the upper part of the columns
with the aid of climbers.

In May 2000, three direct pendulums, with laser measuring device, were installed in order to measure the absolute displacements of three columns with very high deviation from verticality. All the instruments were installed in a very short time (about 3 days) in the upper part of the masonry structures with the assistance of expert climbers, without any scaffolding (fig. 2).

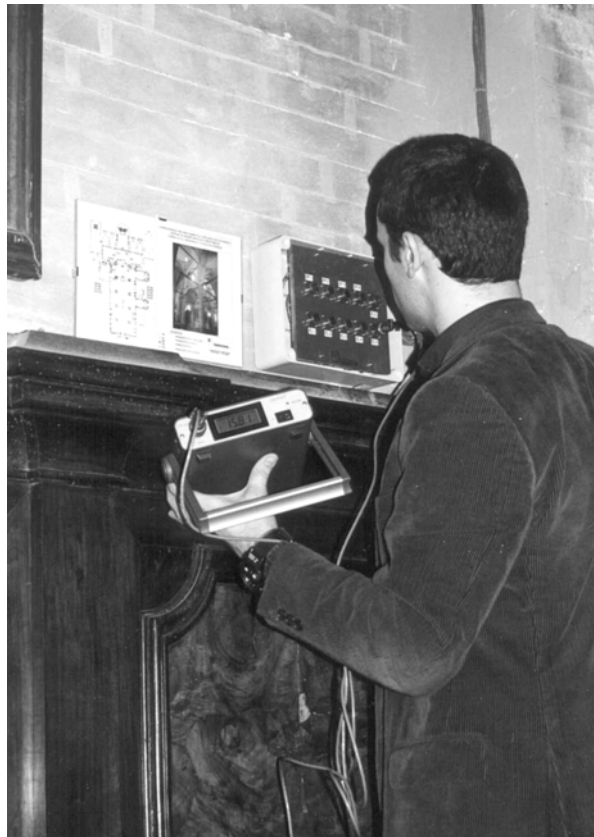
Fig. 3
Church of SS. Giovanni and Paolo in Venice
Removable electric unit for periodical acquisition of the data

The cables of the extensometers, of the crack-gauges and of the thermal-gauges were collected by two switching units where the removable electrical apparatus was connected for periodical readings (fig. 3).

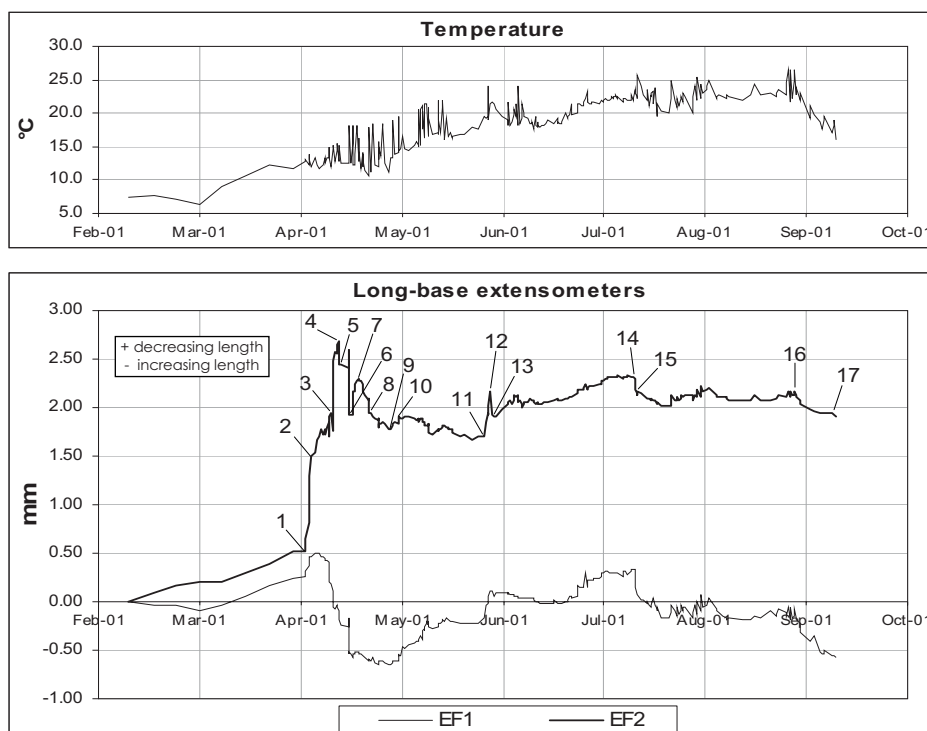
Church of Angone in the Camonica Valley

Diagrams of the relative movements of the lateral walls (extensometers EL1, EL2) during all the phases of the strengthening works.

1 start of borehole drilling for micropiles; **1-2** five boreholes were drilled close to the bell-tower without grouting the micropiles; **2-3** during this phase each micropile was grouted just after drilling; **3-4** the effect of five additional micropiles induced a further rotation of the bell-tower; a crack appeared between the bell-tower and the lateral wall which inverted its tilting (see extensometer EF1); **4-5** a provisional reinforcing steel chain was installed; **5-6** the tension of the chains was increased **6-7** a further rotation due to five new micropiles was observed; **7-8** two new provisional reinforcing steel chains were installed; **8-9** the tension of the new steel chains was gradually increased; **9-10** a residual movement induced by the last four micropiles was observed; **10** the reinforced concrete beam which connects the micropiles heads to the bell-tower and presbiterial walls, is completed; **10-11** the consolidation of the lateral wall of the church is completed; **11-12-13** unloading and reloading test to verify the effect of the steel chains tension; **13-14** only the temperature increasing is affecting the deformation behaviour; **14-15** final tensioning of the steel chains close to extensometers EL1 and EL2; **16-17** the effect of temperature decrease is clearly evidenced by the measurements of extensometers EL1 and EL2.

During the first period of observation, from Feb. to Apr. 01, a progressive movement of the bell tower was observed, which means that the settlement process of soil foundation was continuing (see diagram of extensometer EF2 in fig. 8).

movement (0.70 mm) occurred during the execution of other micropiles and a new crack appeared in the right wall between the anchoring points of the instruments EL1 and EL2. As a result of this crack it was observed that the part of the wall regarding EL1 was non collaborating any more with the remaining part of the wall and the bell tower. In fact the diagram of EL1 in fig. 8 shows an inversion of the movement while EL2 continues its movement in the same direction. After this crack occurred, provisional steel chains were installed and tensioned under the control of the monitoring system.

Fig. 8 describes in detail all the phases of the works and it can be observed how promptly the instruments are able to evidence the effect of all the operations on the deformation behaviour of the church.
