A quick and low-cost method for strengthening high buildings: the case of St. Stefano's bell-tower in Venice.

ABSTRACT: During the crack-pattern survey carried out on the walls of St. Stefano's bell-tower with the aid of climbers, it was observed that the old confining steel chains were seriously damaged. The loss of efficiency of these chains required the prompt installation of a provisional strengthening system based on the use of high resistance steel cables with steel plates at the corners. The paper illustrates the phases of installation of the corner plates and the cables (carried out by few climbers) emphasizing the rapidity of the work as well as the flexibility and reversibility characteristics of this method.

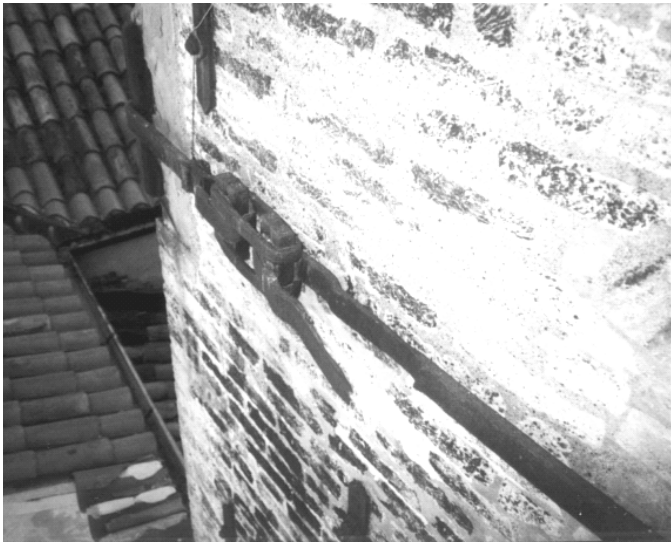
Figure 3. Deformations of the old chains installed in 1902 observed during the crack-pattern survey.

But the most serious problems are concerning the conditions of the junction points which connect the different parts of the chains. Almost all the junctions show high deformation processes due to a severe tensile state of stress exceeding the resistance capacity of the junction points.

The photographs taken during the survey of the external walls clearly show the marked tendency of

opening of several joints which connect the parts of the chains (figure 3,4).

The high state of stress which is responsible of the deformation of the joints, can be related both to the reduction of the section of the steel chains due to oxidation processes and to the increasing of the transversal deformation of the tower due to progressive opening of the vertical cracks.

It was decided to leave the old external chains in their actual conditions and to add, at each of the four levels, new external chains able to guarantee the same confining effect of the old ones in the hypothesis of their structural integrity.

The new confining system, on purpose designed to let an easy and rapid installation, is composed by steel plates anchored at the corners of the bell tower and high-resistance steel cables provided with mechanical tensioning devices to apply the desired confining effect.

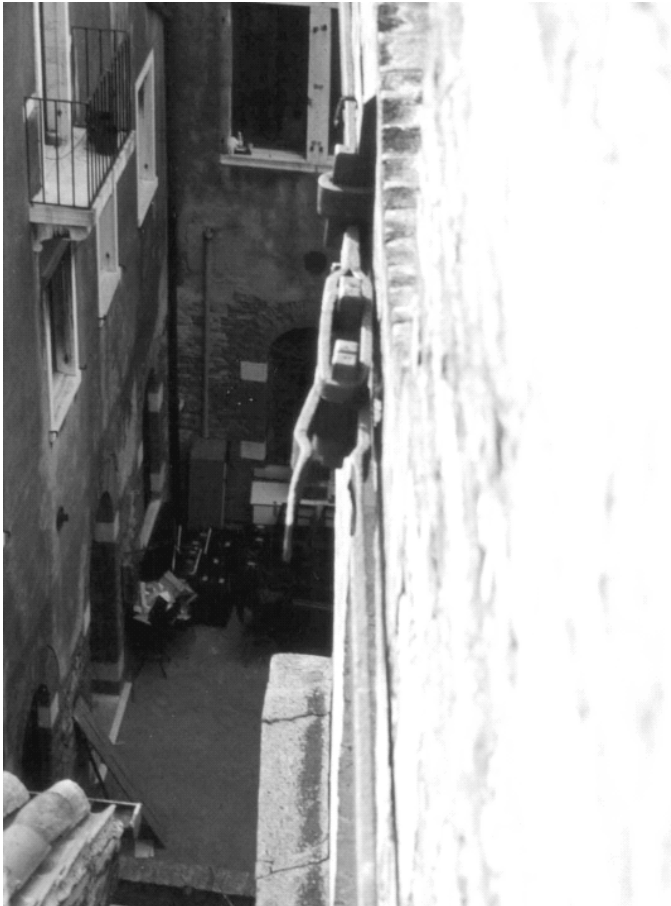
Figure 4. Deformations of the old chains installed in 1902, detail.

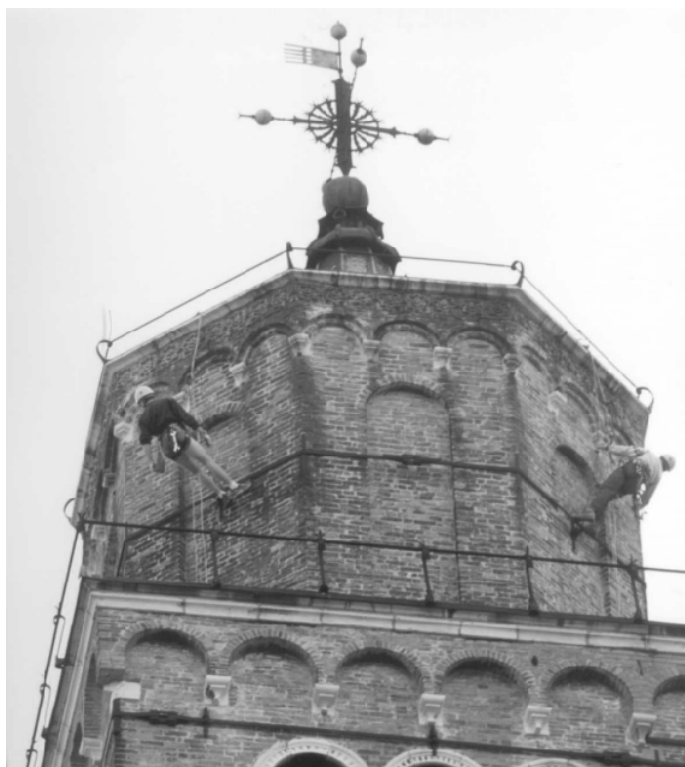
Figure 7. Phase of installation of the strengthening system

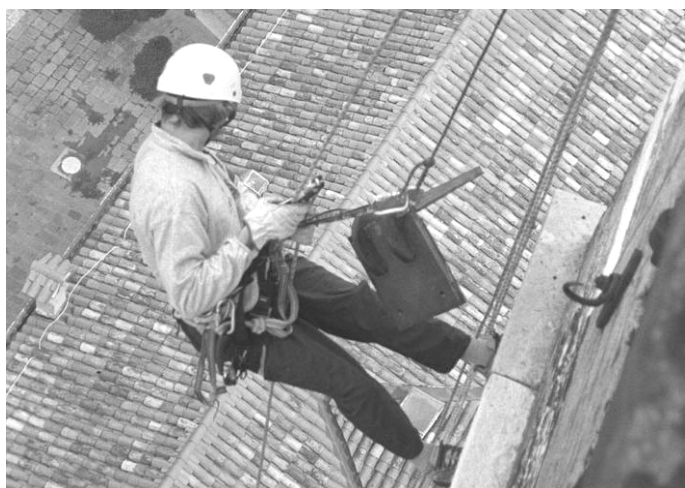
Figure 8. Installation phases of the steel plates

In each layer, the new confining apparatus is composed by steel corner plates (obtained by welding two plates $300 \times 300 \times 20$ mm) on which two high-resistance steel cables with a diameter of 10 mm are installed on circular shaped supports. In order to avoid any risk of damage of the masonry, the faces of the corner plates which are in contact with the masonry are covered by a layer of neoprene 10 mm thick.

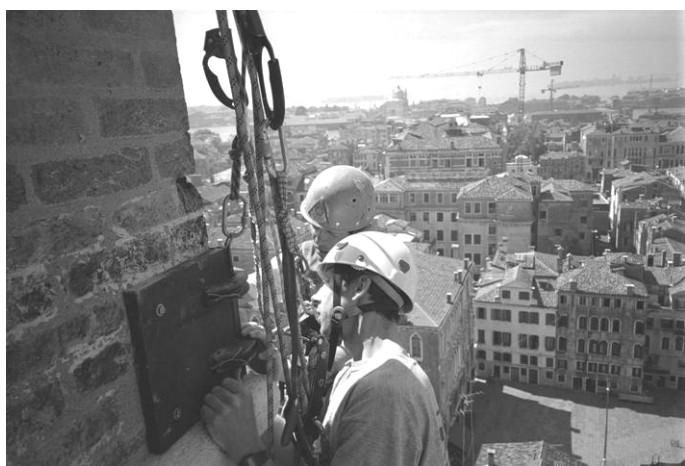
Figure 9. Positioning of the steel plates at the corners of the bell-tower

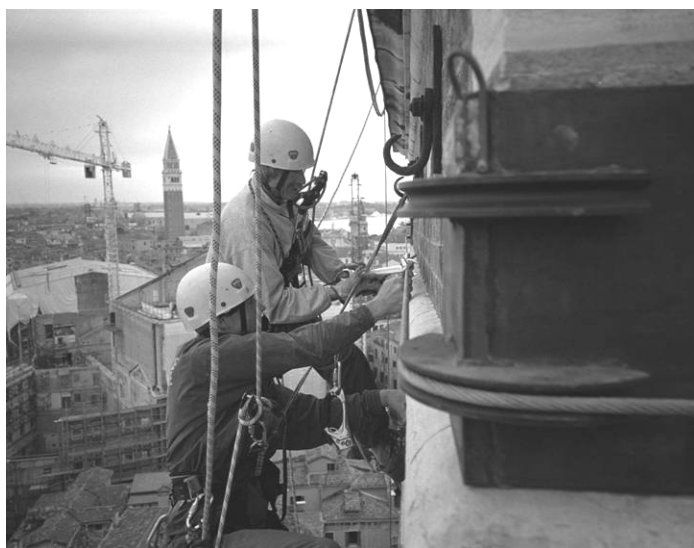
Figure 10. Installation and tensioning of the cables

On the opposite sides of each cable, tensioning devices are installed with a screw system in order to apply the tensile force required.

The ultimate tensile load which a couple of high-resistance steel cables can bear is 186.0 kN, which is a little higher than the estimate bearing capacity of the old chains (168.0 kN).

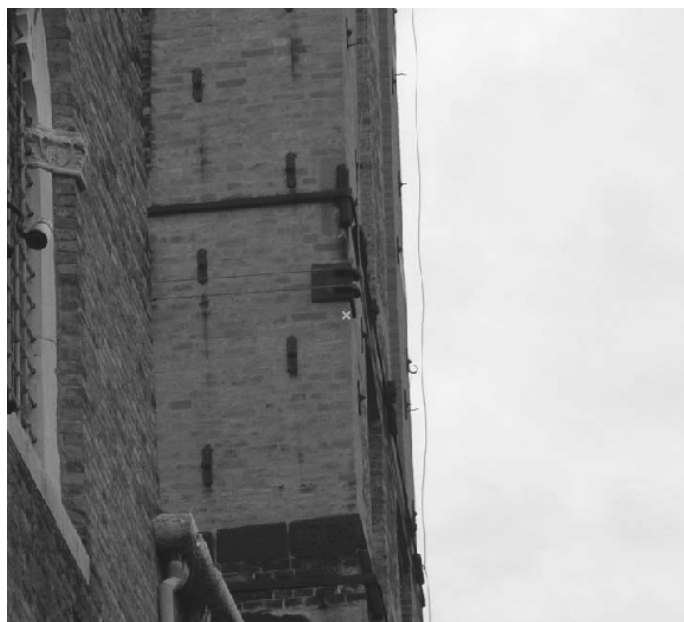
Figure 11. View of the new strengthening system

Finally it is also important to observe that the visual impact of the strengthening system installed on the St. Stefano's bell tower is completely negligible and from the ground is rather impossible to see the confining cables and the corner plates.
