## Summary

Following a restoration program commenced in the Seventies, the Church of S. Maria di Castello of Alessandria (Piedmont, Italy) is not plastered and its foundations are bare: this makes it possible to appreciate the severity of the damages to the building. This paper describes a non destructive testing campaign (core drilling and inspection to the brickwork, flat jack tests, monitoring system) which is currently underway.

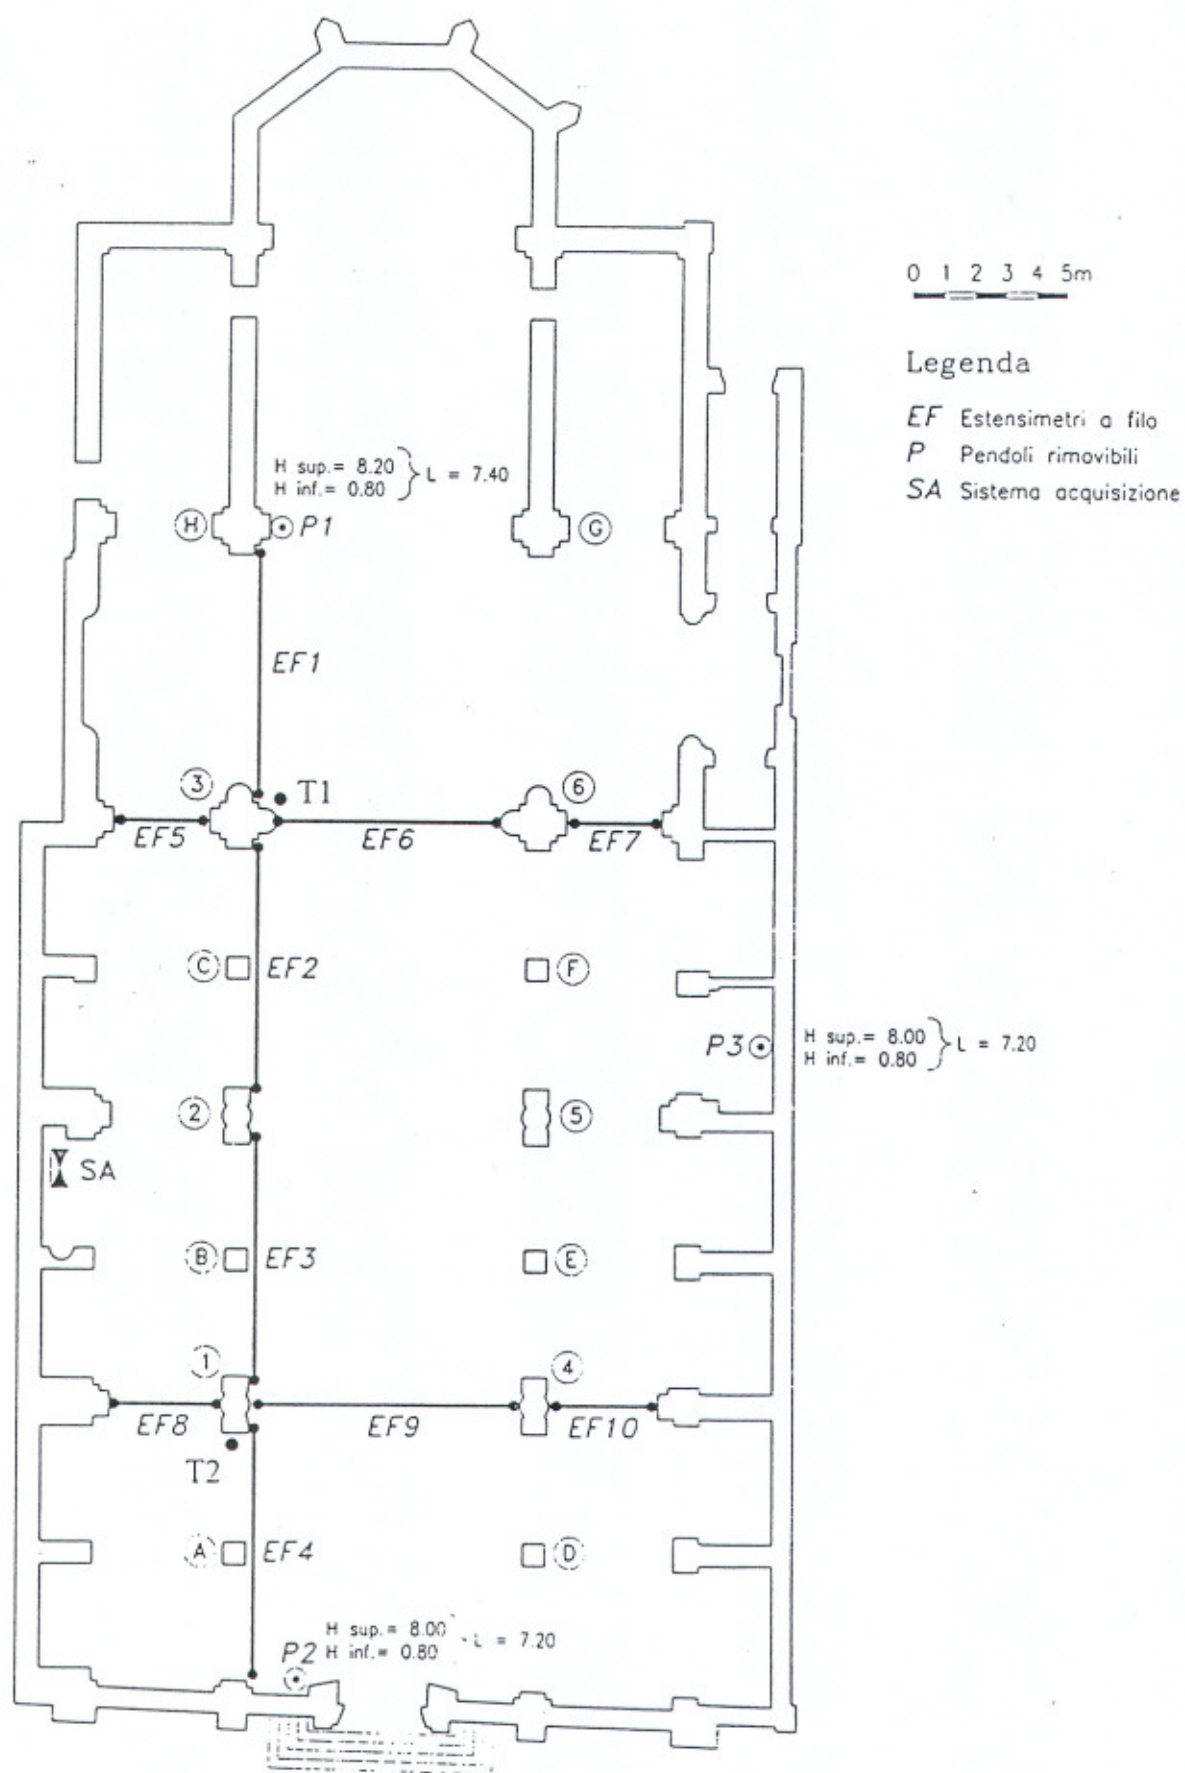
Fig.4 Plan view of the church showing the arrangement of the monitoring system

The monitoring system (fig. 4) installed was aimed at documenting the movements of the building in the transverse and longitudinal directions so as to be able to determine whether the lesions observed in these directions have evolved, or are likely to continue evolving over time even after the consolidation works already performed or about to be performed.

The results of the testing campaign turned out to be very significant, especially for the diagnostic part, and made it possible to clear up several aspects of the building's static conditions. As for the monitoring process, a longer time period will obviously be necessary to take full advantage of the observations made.
