Preliminary investigation and monitoring for the design of a strengthening intervention on the Frari basilica, Venice

ABSTRACT: The “latest” S. Maria Gloriosa dei Frari basilica was built in Venice between the first half of the XIV and the second half of XV century in gothic style. From the end of the construction the building suffered from structural deterioration mainly due to settlements affecting the bell-tower. At the end of the 19th and at the beginning of the 20th century the church underwent major repairs because of the increasing sinking and leaning of the bell-tower, causing worrying damages on the basilica adjacent structures. During the 20th century the bell-tower still suffered from differential settlements; the early 900’s foundation strengthening did not stop the tower to settle. This paper presents the main results of experimental and numerical investigation recently carried out in order to assess the present safety conditions of the structures and to feed the necessary strengthening intervention at the level of the bell-tower foundations.

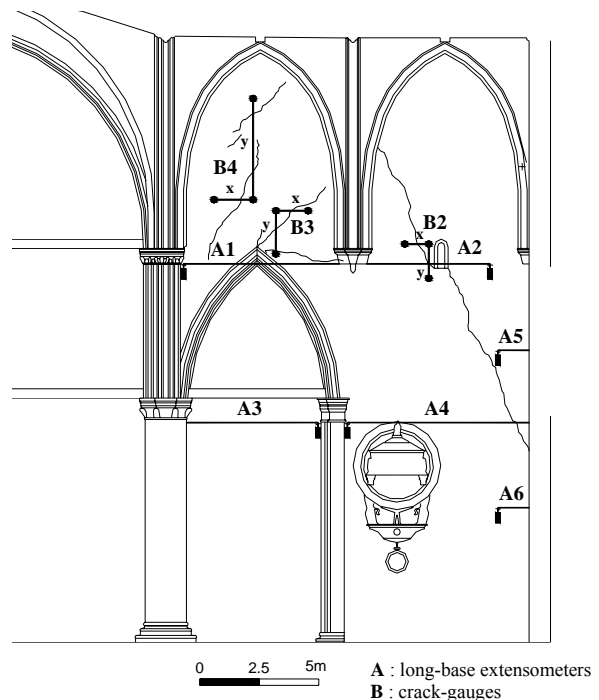
Figure 6: Structural monitoring system - scheme of instruments installation - 2001.

In 2001, in order to check the deformations of the bell-tower and of the adjacent structures of the basilica, an automatic monitoring system was installed, including the following instruments (Figure 6):

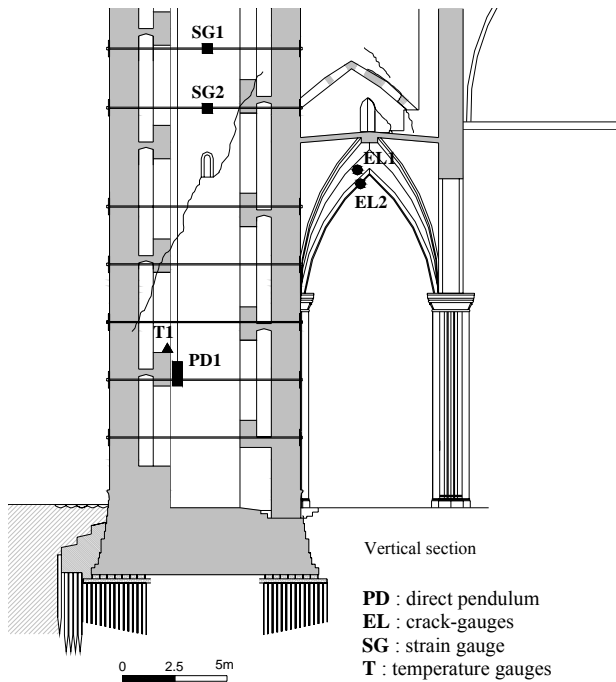
Figure 8: Scheme of installation of the instruments of the automatic monitoring system - 2003.

In 2003 the automatic monitoring system was also enlarged by the installation of the following instruments (Figure 8):

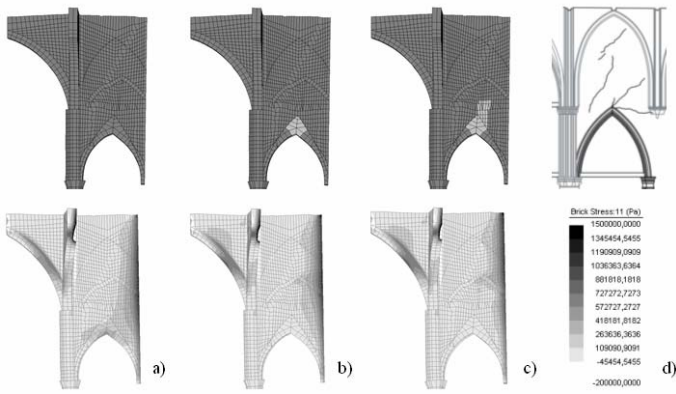
Figure 9. Successive weakening of the tensed elements; from (a), where all the material has the same properties through (b) and (c) it is possible to reach a final “acceptable” configuration. The tensile stress progressively decreases, and it is possible to notice some peaks (a) where a remarkable crack originates (d).

Weakening the elements subject to high tension, a smeared crack pattern was assumed, and the propagation of some principal cracks was followed by the subsequent iterative process (Figure 9), see Rots & Invernizzi (2001)..

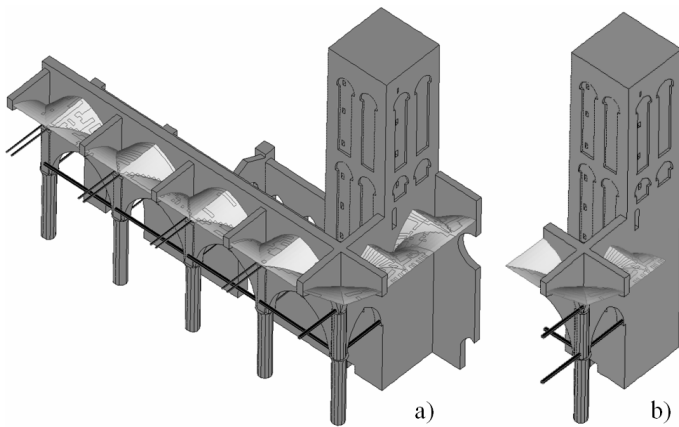
Figure 10. a) “Global” model including the bell-tower, the St Peter's chapel, the left aisle, half the main nave and half the transept with its façade; b) “simplified” model including the bell-tower, the first transversal arch with its supporting column and the four quarter-vaults above this last.

A FE model, considering a wide portion of church, the bell-tower and the St. Peter's chapel was first implemented (Figure 10a). The “simplified” model, used for the calculations, includes 32,760 brick, 1400 shell plate and 360 beam elements (Figure 10b).

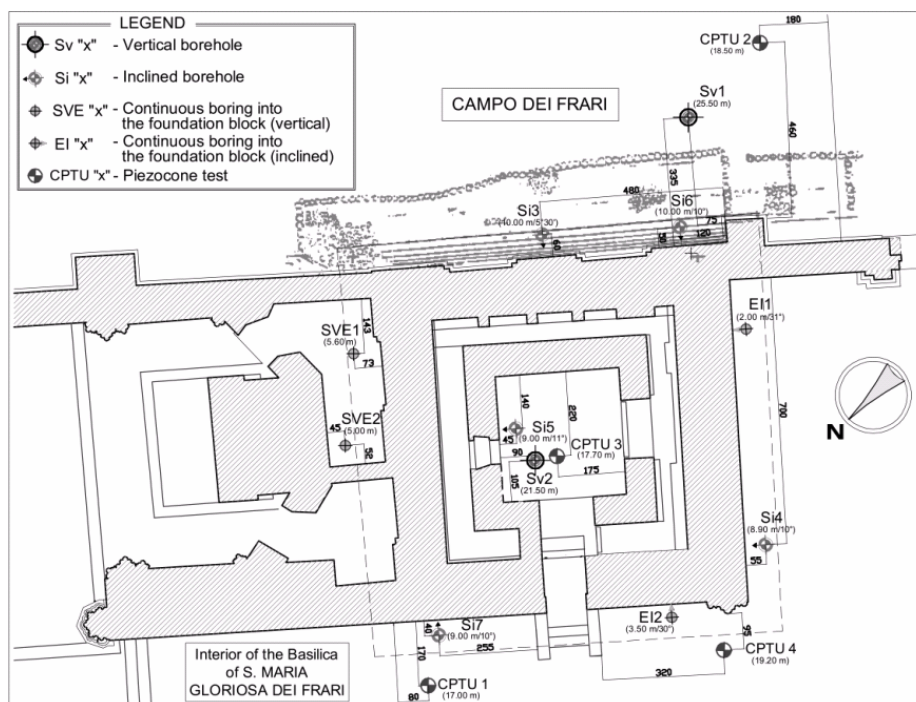
Figure 13. Geotechnical investigation programme

A new extensive geotechnical investigation campaign was carried out in May 2003, including (Figure 13):

- 5 inclined boreholes, labelled from Si3 to Si7 in Figure 13, where the drilling depth and inclination are respectively reported in brackets;

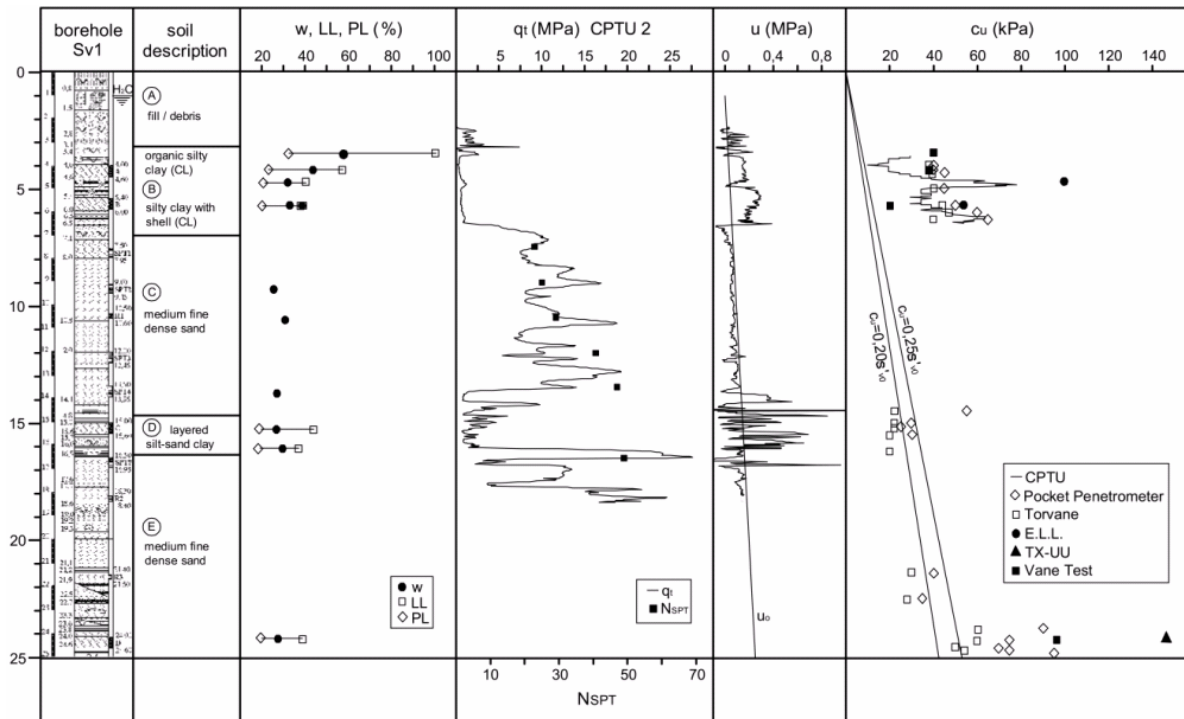
Figure 14. Soil profile

Figure 14 summarizes the main geotechnical properties of each stratigraphic unit, as deduced from laboratory and in situ tests. In particular, the following elastic and shear strength parameters in drained conditions were eventually assumed – for units B and C - in settlement and stability calculations: for Unit B: $E' = 3500-5000$ kPa, $c' \approx 0$ kPa, $\phi' = 28^\circ$; for Unit C: $E' = 35,000-40,000$ kPa, $c' = 0$ kPa, $\phi' = 35^\circ$.

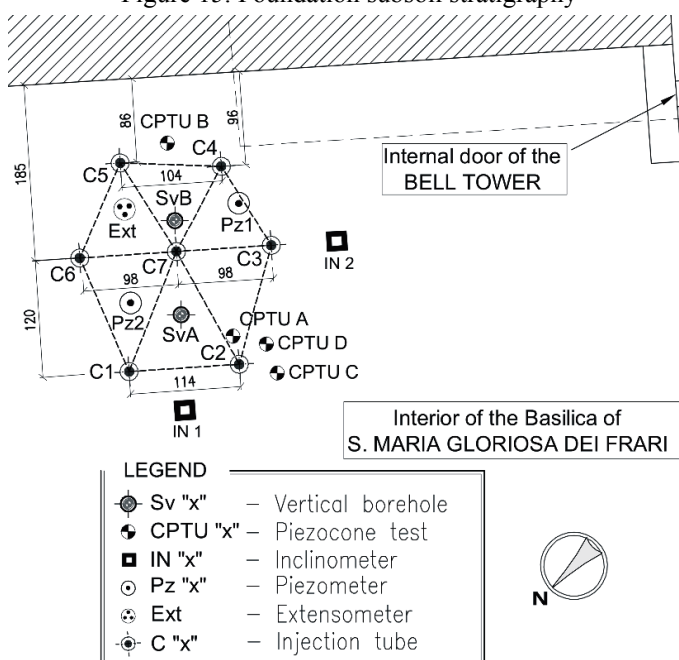
Figure 16. Soil fracturing full-scale test site

Figure 16 shows the relevant lay-out, placed according to an irregular triangular mesh for local obstacles. A total of seven injection tubes, 12.00 m

The importance of the drilling technique was especially pointed out, in order to prevent any consequence of local stress release, as well as the need of injecting rather elevated grout volumes in the cohesive soft soil, in order to achieve significant results.
