STRENGTHENING INTERVENTIONS OF THE ROMANESQUE TEMPLE OF SAN TOME' IN BERGAMO

Pier Paolo Rossi
R.Teknos s.r.l.
Via San Giovanni 14
24121 Bergamo
Italy
pierpaolorossi@rteknos.it

Christian Rossi
R.Teknos s.r.l.
Via San Giovanni 14
24121 Bergamo
Italy
christianrossi@rteknos.it

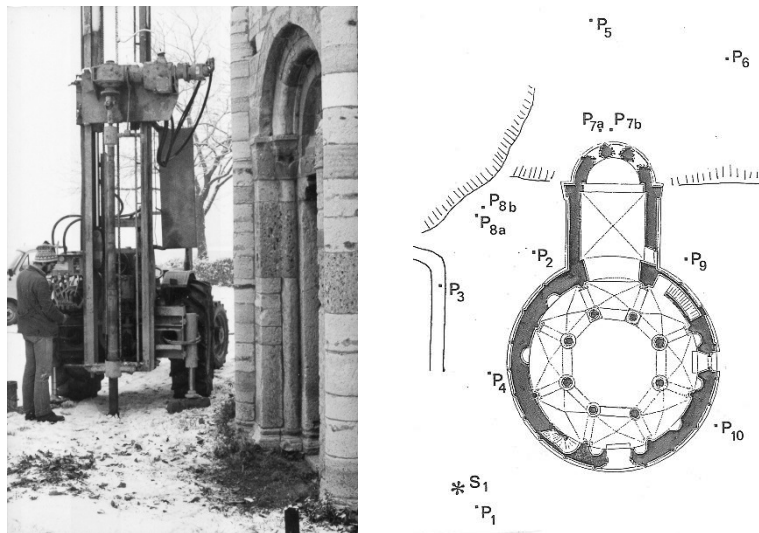
Figure 2. Geotechnical investigation and lay-out of the testing points.

At first, a geotechnical investigation was carried to define the stratigraphy and the mechanical characteristics of the different layers of the soil foundation. By using a continuous borehole 15 m deep and several static penetrometric tests, it was found, under the foundations of the temple, a formation of glacial and fluvial origin, which is resting on a layer of conglomerate (“ceppo”). The scheme of the testing points is shown in Figure 2. The mechanical characteristics of the soil foundations are satisfactory excluding a small portion near the head of the slope where a softer soil was found up to a depth of about 3 m.
