Monitoring-driven design of a multiphase intervention for the preservation of the Frari bell Tower in Venice

Summary

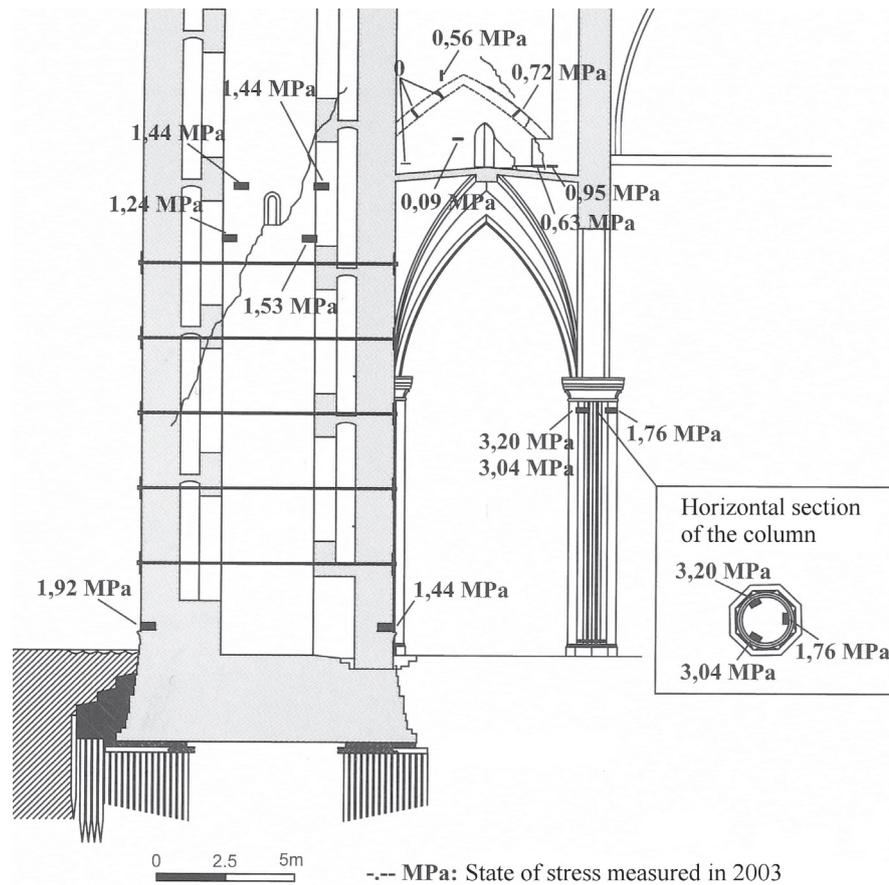
A rather detailed geotechnical investigation was carried out in May 2003 (tests “x”/A in Fig. 6) and, on that basis, the subsequent ground improvement intervention by soil fracturing was planned. The investigations of such A-phase consisted of: 4 piezocene tests, 2 vertical and 5 inclined continuous coring boreholes, 4 continuous borings into the foundation block, together with the extraction of several undisturbed soil and foundation block samples for the subsequent execution of the laboratory tests, which enabled the stratigraphy, the subsoil properties and the geometry of the foundation block to be defined with some detail (GOTTARDI *et al.*, 2009). A section of the thus reconstructed peculiar bell tower foundation along the SE-NW direction is provided in figures 3 and 7. As usual in Venice (MARCHI *et al.*, 2006), the Frari bell tower foundation is made up of Istrian limestone squared blocks and short timber compaction piles (1.702.20 m long), with an interposed 0.40-0.50 m thick larch boarding.

Fig. 6 – Plan of the Frari bell tower with the location of the geotechnical in-situ investigations at various stages of the intervention (Gottardi *et al.*, 2013).

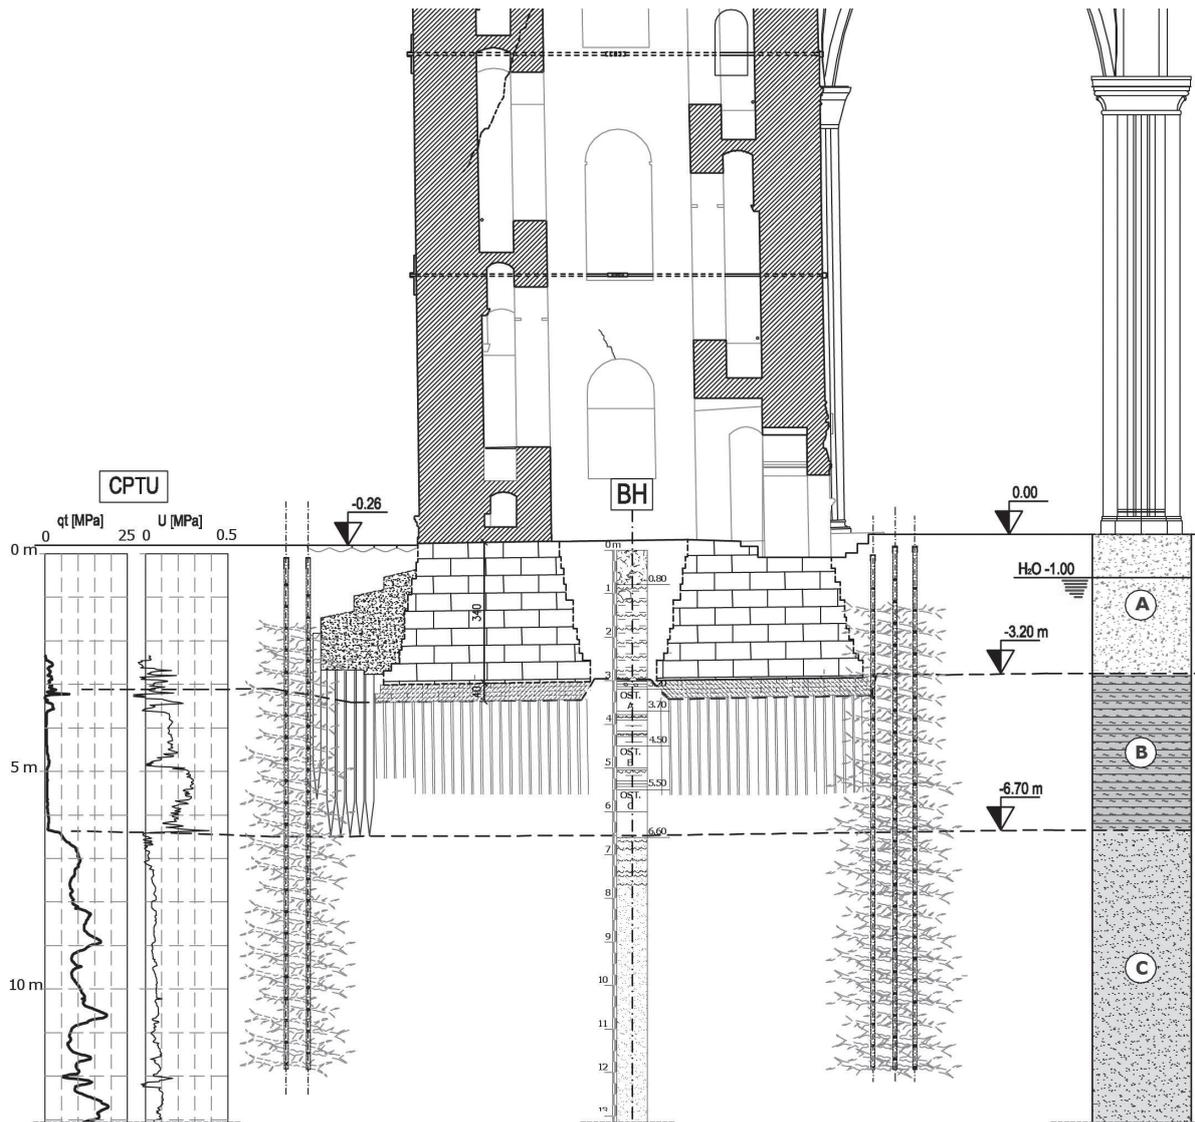
The soil profile under the tower, shown in figure 7, consists of:

Fig. 7 – Schematic section of the tower foundation and of the relevant subsoil (SE-NW direction in Fig. 6), with the in-situ test logs, the strengthening intervention of 1904 (left) and the TAMs of the new fracture grouting intervention (Marchi *et al.*, 2014).
 Fig. 7 – Sezione schematica della fondazione della torre e del terreno di fondazione (direzione SE-NW in Fig. 6). In evidenza i risultati di alcune significative prove in-situ, l'intervento di consolidamento del 1904 (a sinistra) e le canne valvolate (TAMs) per l'iniezione della malta cementizia.

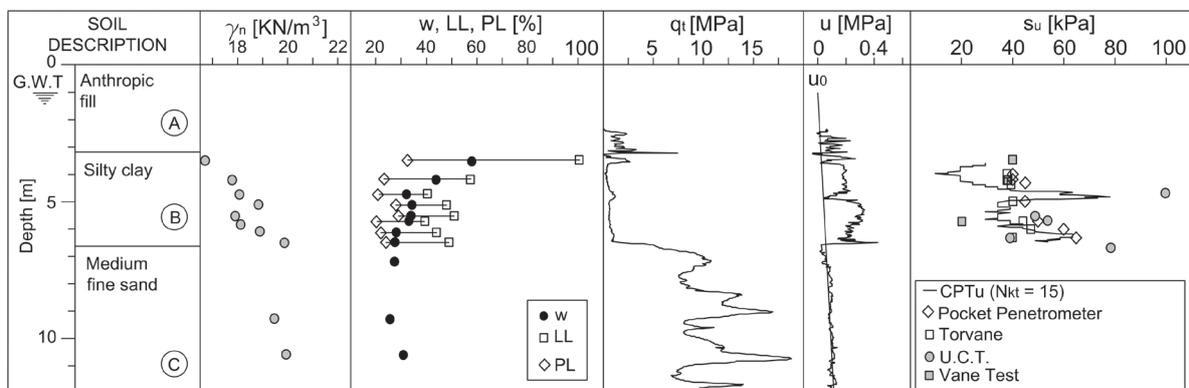
In figure 8 the relevant main geotechnical characteristics, as deduced from laboratory and in situ tests, are reported;

Fig. 8 – Upper soil profile with the relevant main geotechnical characteristics, as deduced from laboratory and in situ tests.
 Fig. 8 – Principali caratteristiche geotecniche del terreno di fondazione, da prove in sito e di laboratorio.

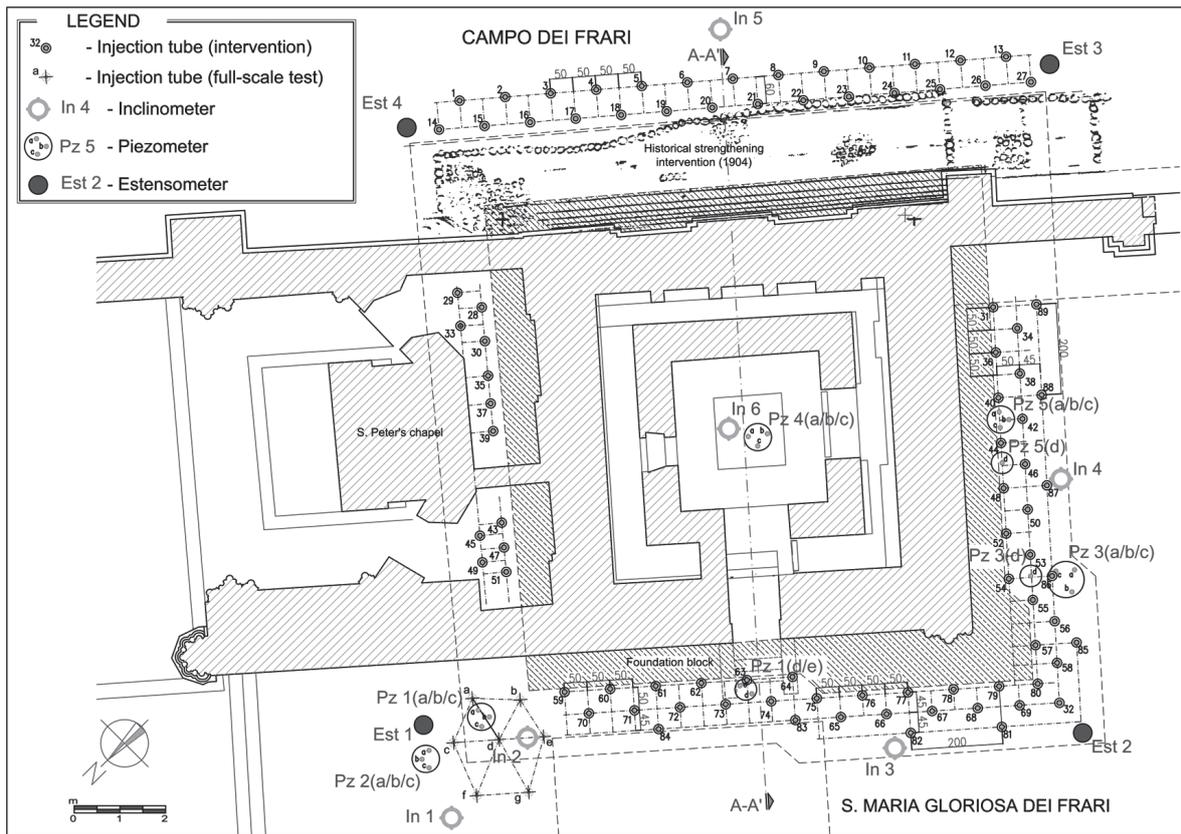
Fig. 10 – Plan of the Frari bell tower with TAMs lay-out and location of geotechnical monitoring devices (Lionello, 2008).

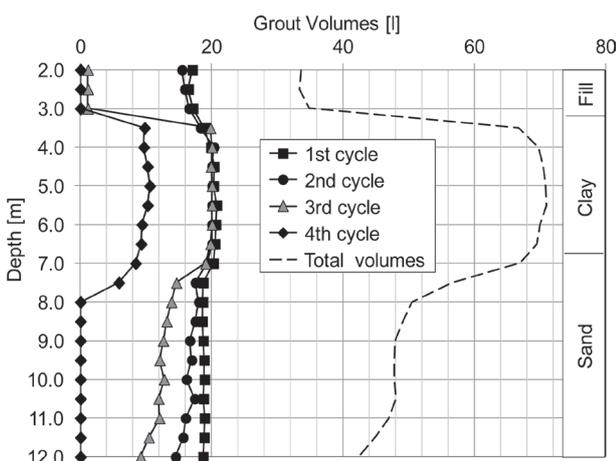
Fig. 11 – Average (for the overall 88 pipes) volumes injected from each valve, at selected depths, for the 1st, 2nd, 3rd and 4th cycle (Marchi et al., 2014)

During the intervention the flow rate was kept low and fixed at about 6 l/min. The resulting valve opening pressure and the following steady-state injection pressure were always recorded. In the final cycle, a flow rate of about half than the previous cycles was used. Relevant injected volumes are shown in figure 11. Constant grout volumes of 20 l/valve were injected each cycle in clay, whereas variable volumes between 14 and 20 l/valve in sand. In the 1st cycle all valves could be opened. In the 2nd cycle a few valves could not be opened in sand. In the 3rd and 4th cycles more restrictive criteria were adopted: a pre-fixed limit to the opening pressure of 500 kPa in clay and of 2500 kPa in sand, where therefore many more valves could not be opened. Figure 11 shows the total volumes injected in each cycle from each valve depth, divided by the total number of existing pipes (*i.e.* 88). Notice that the total amount of

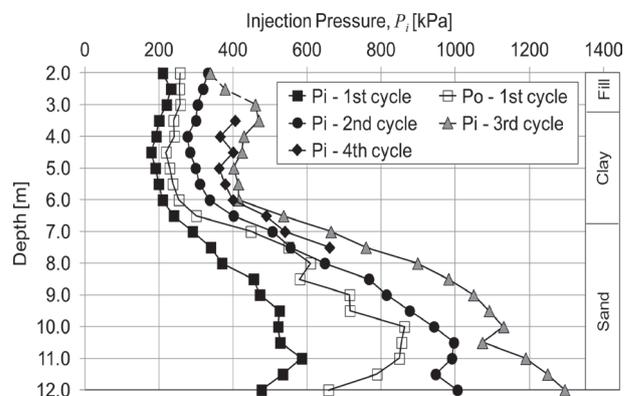
Fig. 12 – Average injection pressures vs. depth, for each cycle, as measured at the manometer (Marchi et al., 2014)

Figure 12 reports the average steady-state injection pressures (P_i) vs. depth for each cycle, as measured at the manometer. P_i is clearly greater in sand and tends to increase almost linearly with depth. Injection pressures vary between about 200–500 kPa in the first cycle to about 400–1200 kPa and more in the final cycle. In particular, the low injection pressures (P_i) recorded in the third cycle between 2.00 and 3.00 m depth are not significant since they result from only 5 pipes. In addition, P_i recorded in the fourth cycle, resulting from a reduced and selected number of pipes (55), turned out to be lower than that in the third cycle; this could be also due to the lower injection flow rate used in the final cycle, as already noticed in previous experiments. However, the clearly noticeable general increase of pressures with injection cycles reflects a corresponding increase of the soil minor principal stress during the intervention, as intended (MARCHI *et al.*, 2014).

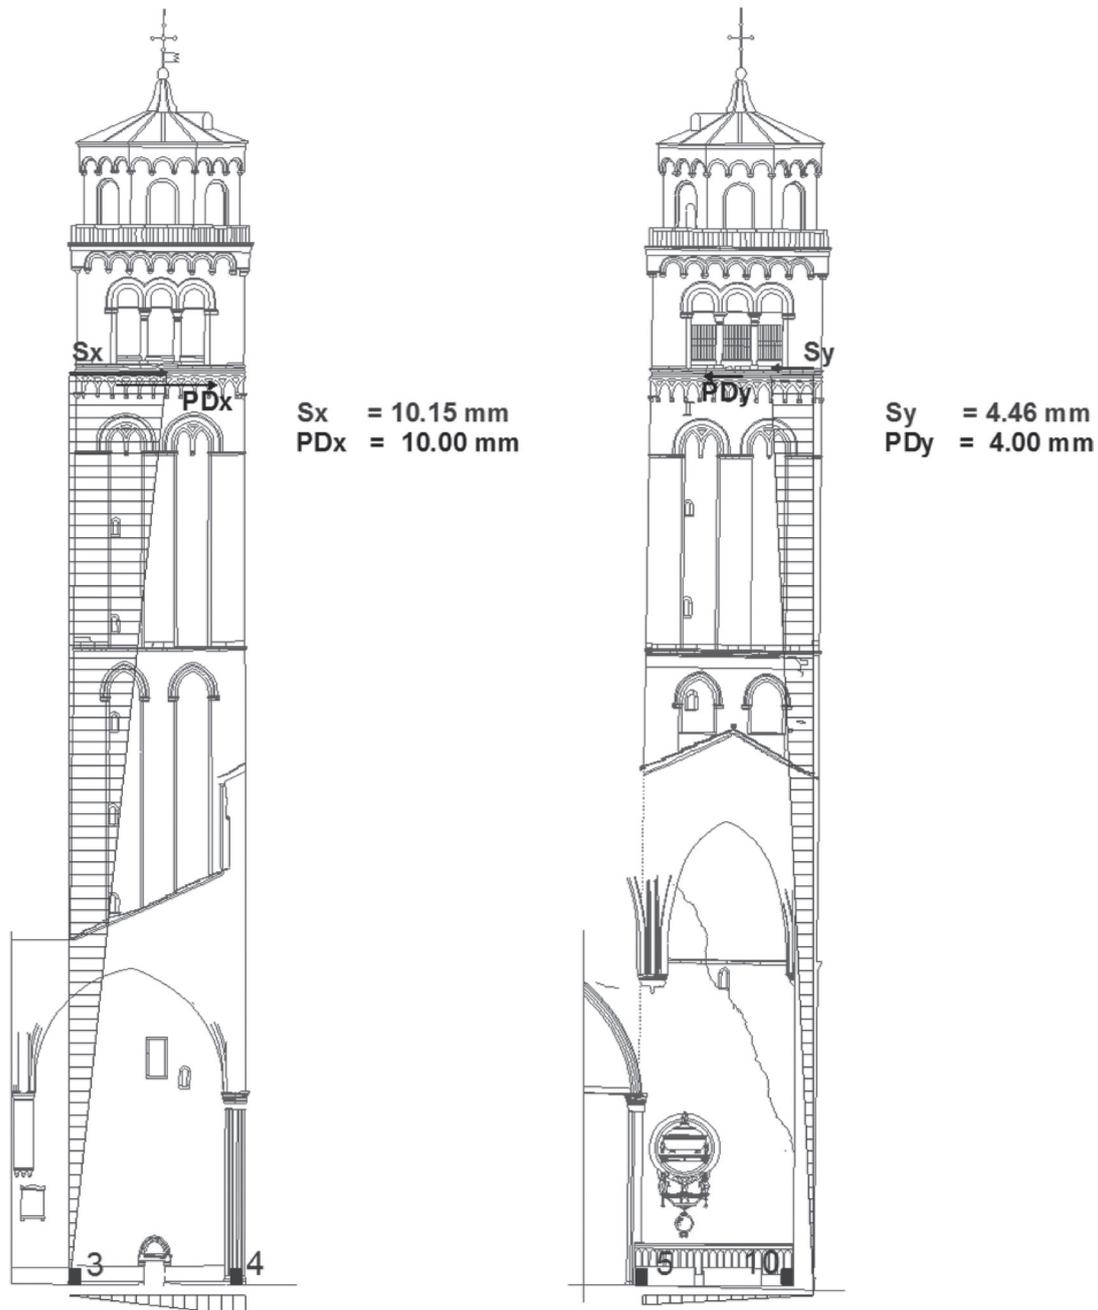
The settlement values are also in very good agreement with the measures obtained by the direct pendulum in the period from December 2003 to March 2007 (Fig. 18). Along the alignment of points 3 and 4, the differential settlements at the base of the bell tower (2.16 mm) multiplied for the ratio between the height and the base of the tower (4.70) turns out to be 10.15 mm, very close to the x component measured by the direct pendulum (10.00 mm). Along the alignment of points 5 and 10, the differential settlements at the base of the bell-tower (0.95 mm),

Fig. 18 – Comparison between the movements at the top of the Frari bell tower induced by the differential settlements of the foundations and those measured by the direct pendulum, in the period from December 2003 to March 2007 (Rossi & Rossi, 2012).
