Experimental and numerical analysis of the structural behaviour of St Stefano's bell-tower in Venice

A. Lionello, I. Cavaggioni

C. Modena, F. Casarin

ABSTRACT: The paper illustrates the results of two series of in situ tests for the analysis of the mechanical behaviour of the masonry structures: flat-jack tests, coring and video camera survey as well as a detailed crack-pattern survey. All the tests were carried out with the aid of climbers, without any kind of scaffolding. An automatic monitoring system was installed, including direct pendulum, crack-gauges, long-base extensometers, clinometers and thermal gauges for measuring air and masonry temperature. The diagrams of the measures recorded during a period of about two years are presented. A FE model was implemented in order to better interpret the results of both the experimental investigations and the monitoring.

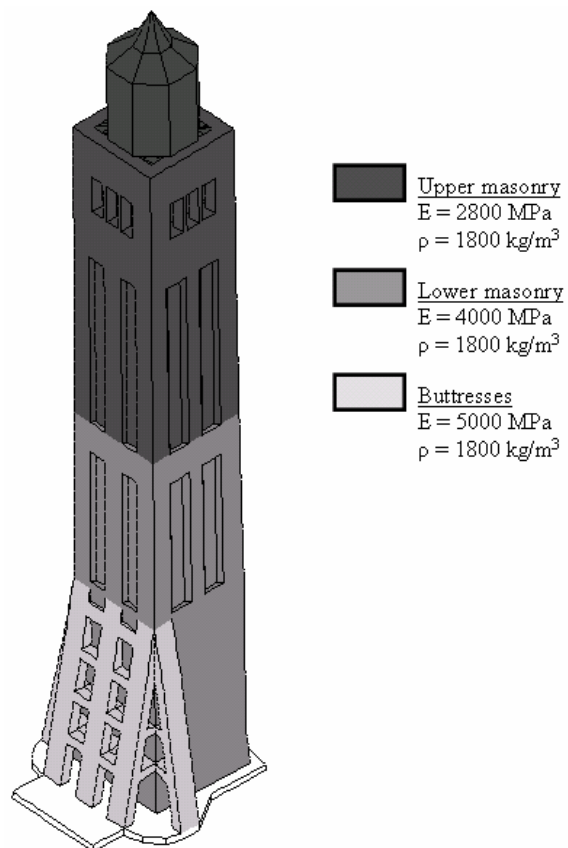
Figure 4. The 3-D model, materials and parameters

The model includes 17,650 brick and 540 shell plate elements, these last used for the belfry. The average dimension of the solid elements is 0.4 m in the buttresses, 0.5 m in the lower masonry walls of the tower, 1.0 m in the central/upper part (Fig. 4).

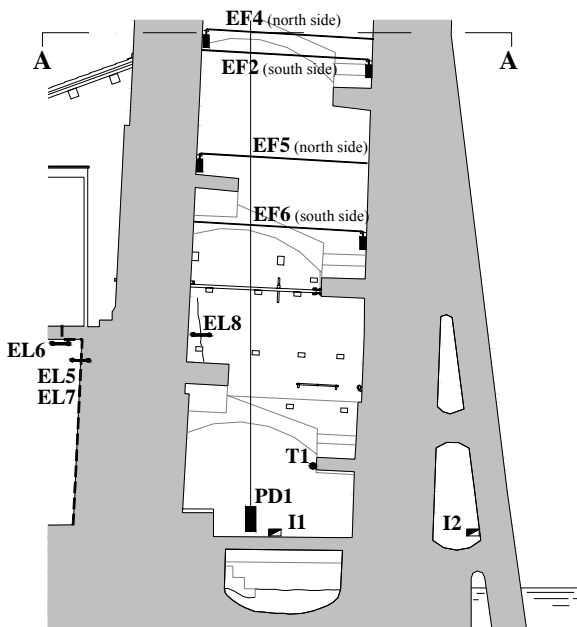
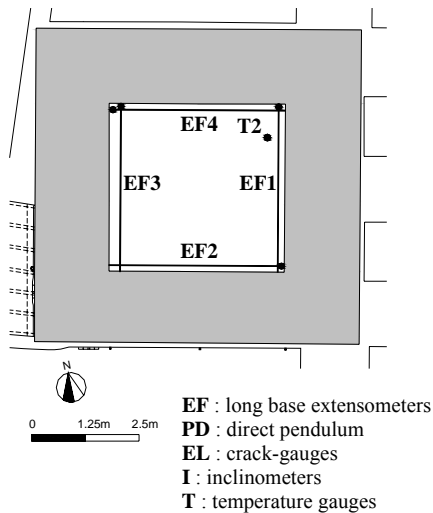
Figure 7. Scheme of installation of the instruments of the structural monitoring system

- direct pendulum equipped with automatic teleco-ordinometer, for the measure of the absolute horizontal movements of the top of the tower at the level of the bell's cell (44 m);
- 6 long base extensometers which invar wire kept in tension by a weight, installed in two horizontal sections of the tower in order to measure the relative displacements between the opposite walls;
- 8 crack-gauges installed on the main vertical cracks of the tower and on the joint between the tower and the adjoining buildings on west side;
- 2 inclinometers for the measure of tilting at the base of the tower and at the base of the concrete plate which supports the buttresses;
- several thermal-gauges to measure the temperature of the air (internal and external) and inside the masonry at different depths from the outer wall.

The scheme of installation of the main instruments is shown in Figure 7.

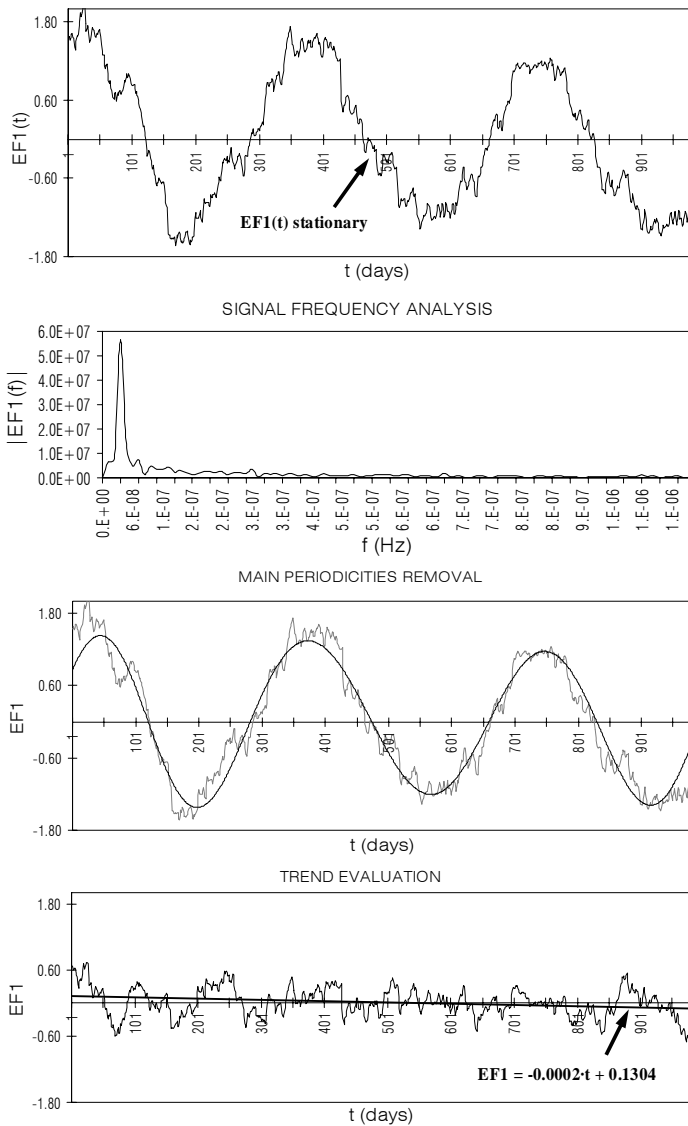
Figure 9. Methodological approach for signal analysis described for the data coming from the long base extensometer EF1. The analysis is implemented by the following steps: elimination of irregularities and non stationarity of the signal; signal frequency analysis; main periodicity removal by filtering the signal (in this case the main periodicity is about 341 days corresponding to a frequency of $3.39E-8$ Hz); trend evaluation by “least squares” linear regression. This trend obtained is pertinent to the stationary process: the real trend can be obtained by considering the method used to render signal stationary.

The methodological approach proposed for signal analysis of the static monitoring system data, illustrated in Figure 9, includes signal analysis, evaluation of signal’s harmonic component and evaluation of the signal trend.
