EASY AND RELIABLE REMOVABLE EQUIPMENT FOR IN-SITU COMPRESSION AND SHEAR TESTS ON LARGE MASONRY SAMPLES

ABSTRACT:

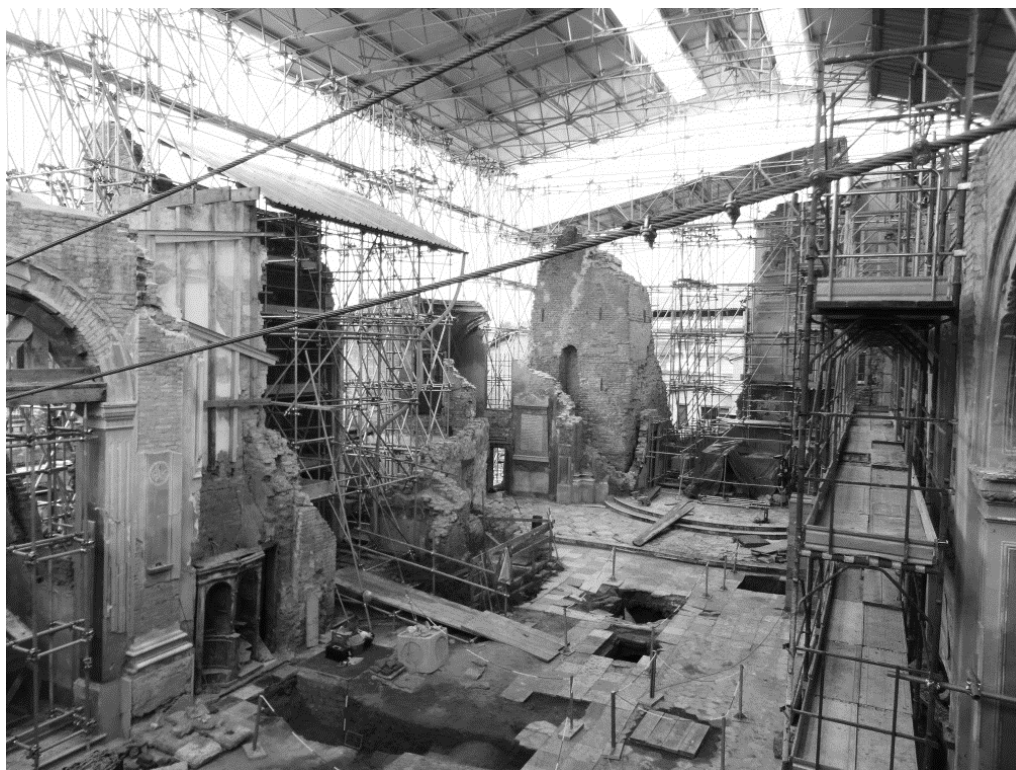
Figure 2. View of the provisional covering structure.

A steel reticular structure was chosen, for its structural flexibility, to sustain the covering structure of the church and to support in the meantime the lateral walls of the church.

The characteristics of the intervention and the material used, clearly indicate that the intervention is provisional and needs periodical survey. Within a period of about 10 years, a definitive design solution must be found for the reconstruction of the church. In Figure 2, a view of the provisional covering structure, is shown.

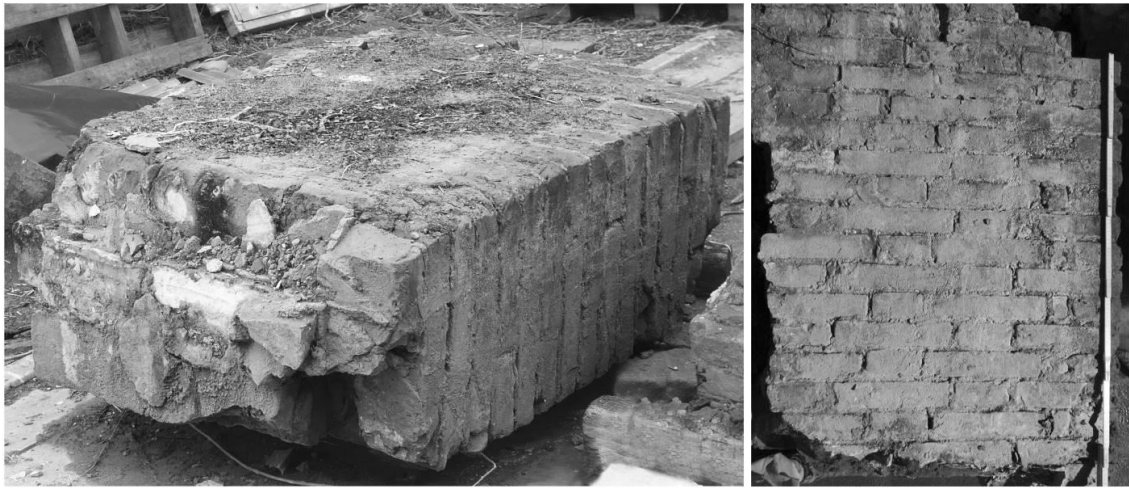
Figure 3. View of the masonry block collapsed during the earthquake and used for the compression and shear tests.

A large masonry block, which fell down during the earthquake from a lateral wall of the church, was chosen for the preparation of the specimens. The masonry block, with a thickness of about 50 cm, is shown in Figure 3.

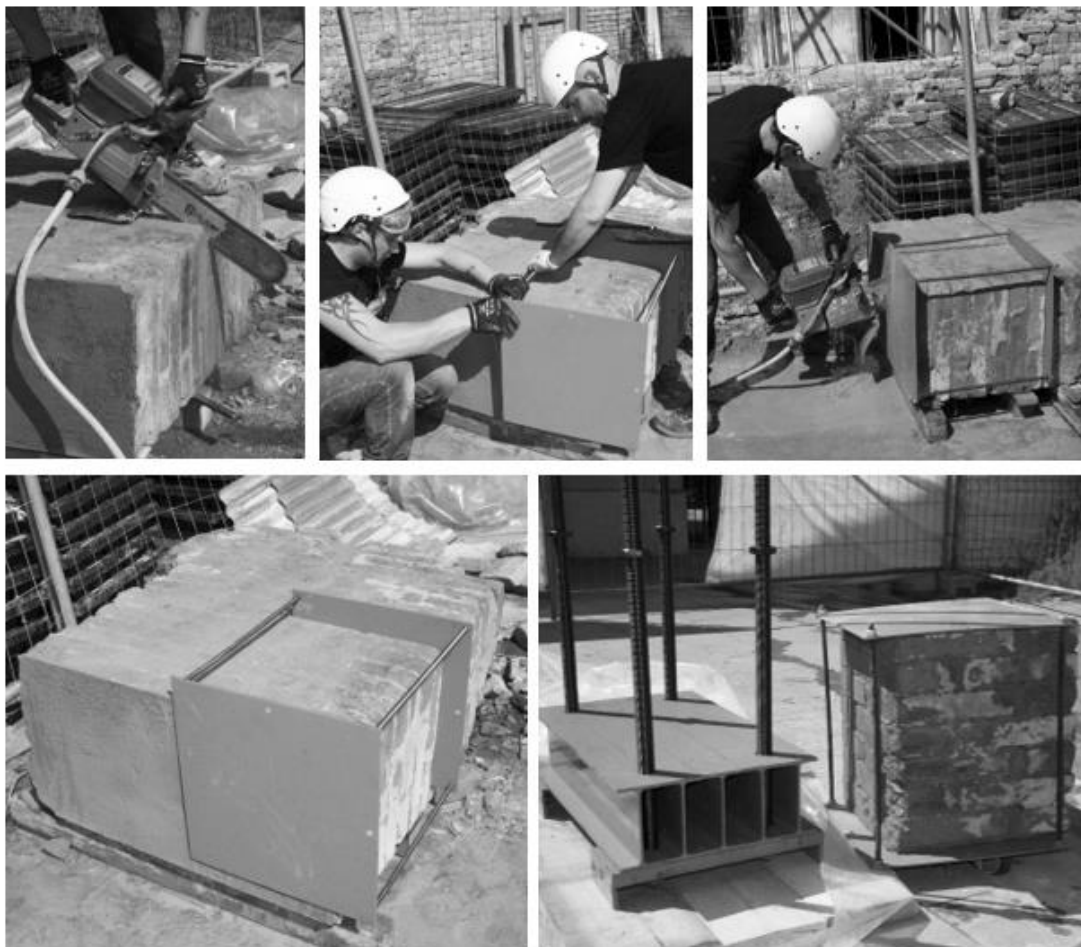
Figure 4. Cutting of the large size masonry specimens for the compression and shear tests. The steel frame used in the cutting phase is shown.

By using a cutting chain provided with diamond tools, large size specimens (50 x 50 x 50 cm) were obtained. In order to avoid damages and release of the masonry, (5 mm thick) steel plates were installed on the opposite faces of each specimen and connected each other by means of steel tendons. Only after the connection of the two plates with the tendons, the specimen was completely isolated from the masonry block by cutting the last face with the diamond chain. The cutting and preparation phases of the specimens for the compression test are shown in Figure 4.

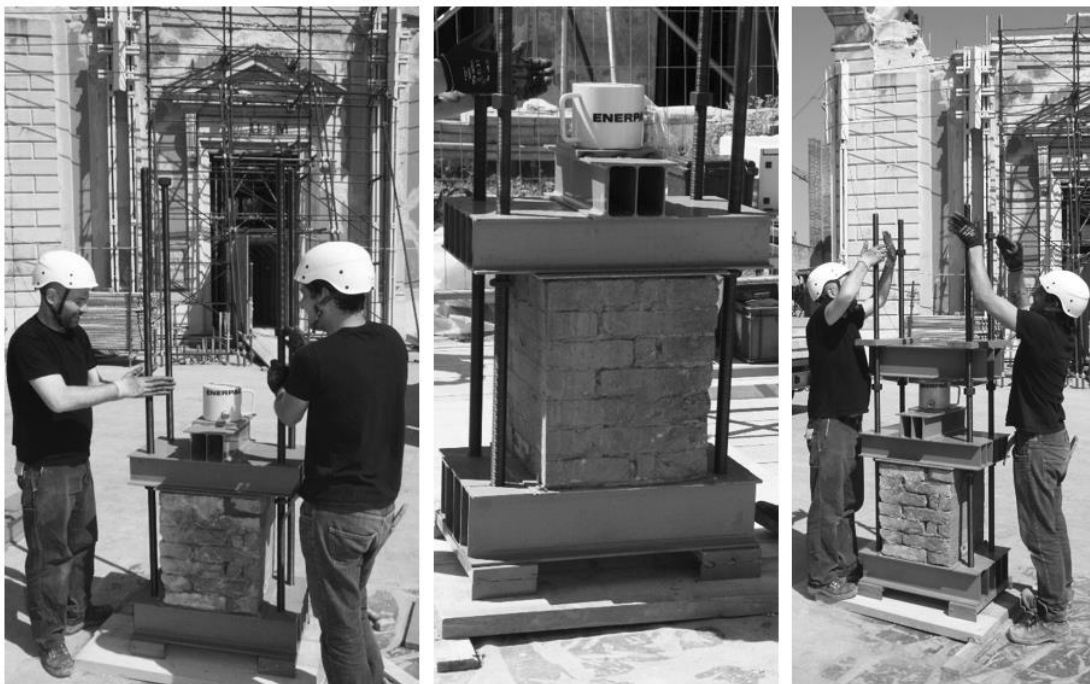
Figure 6. Phases of installation of the loading machine for compression test.

A simple and removable steel frame was set up. In order to reduce the weight of the equipment as much as possible, the lower and upper loading plates were made with some IPE profiles welded each other. Four steel columns at the corners support the compression load applied by the double-effect hydraulic jack. After the installation of the masonry specimen on the basement steel plate, the assembling of the loading machine was completed, as shown in Figure 6.

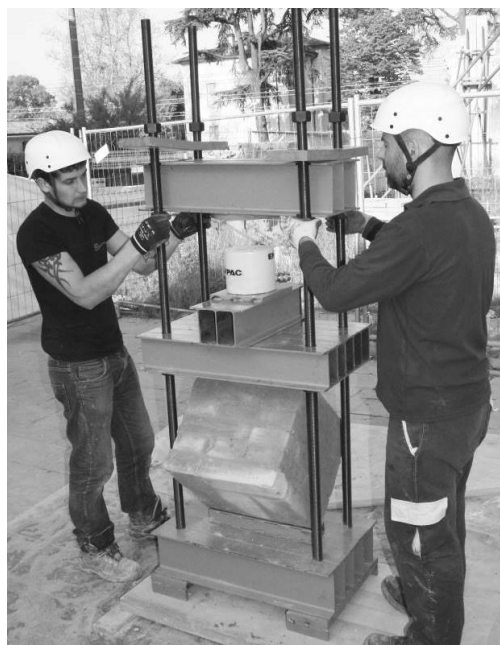
Figure 7. Setting of the loading machine for shear test through diagonal compression.

The same equipment used for the determination of the compression strength was used also for the determination of shear strength, by using a diagonal compression test. In figure 7, the setting of the equipment for the diagonal compression test, is shown. The detail of figure 8 shows the two steel devices which apply the diagonal load to the opposite edges of the specimen.

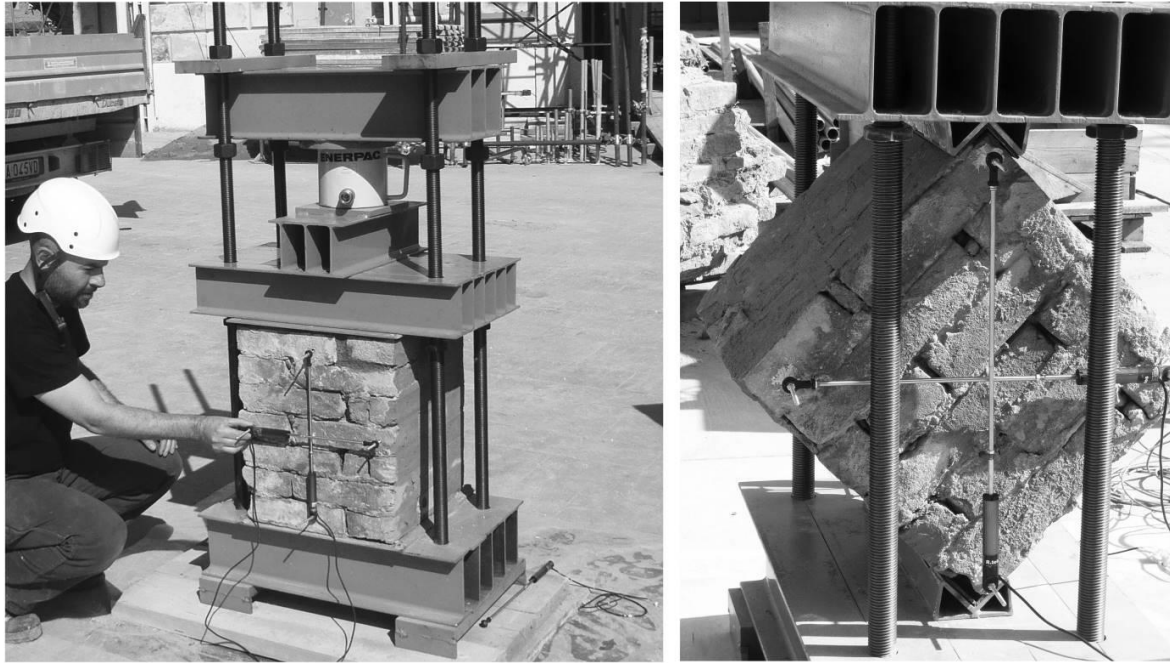
Figure 9. The deformations of the masonry specimens during compression and shear tests are measured by electrical transducers connected to an automatic acquisition system.

The deformations of the specimen during compression and shear test were measured by means of displacement transducers, connected to an automatic data acquisition system. The instruments installed on both faces of the specimens during compression and shear tests, are shown in figure 9.

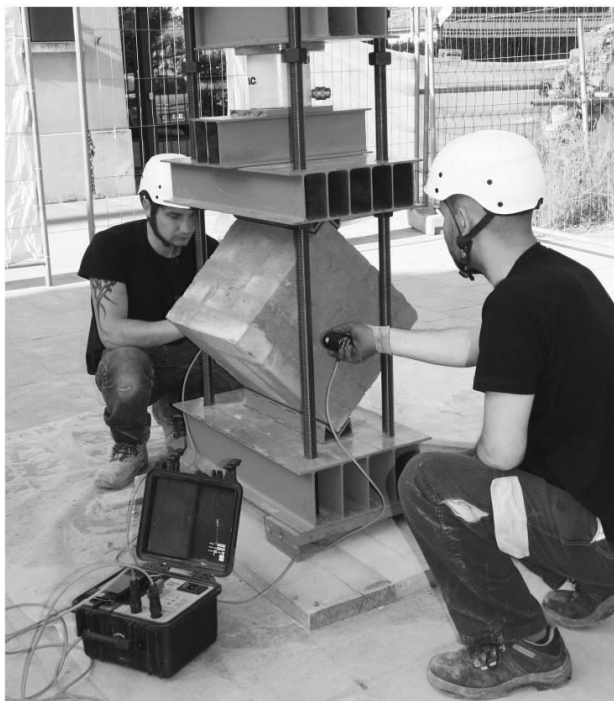
Figure 10. Measure of the sonic velocity in several points of the masonry sample.

Before the installation of the instruments, sonic velocity tests were carried out on the masonry specimens, as shown in figure 10. In the same figure, the values of sonic velocity measured in several points of the specimen, are shown. A good homogeneity of the results, with high values of sonic velocity, can be observed. These values were compared with the sonic velocity values measured in several points of the perimetral walls of the church.

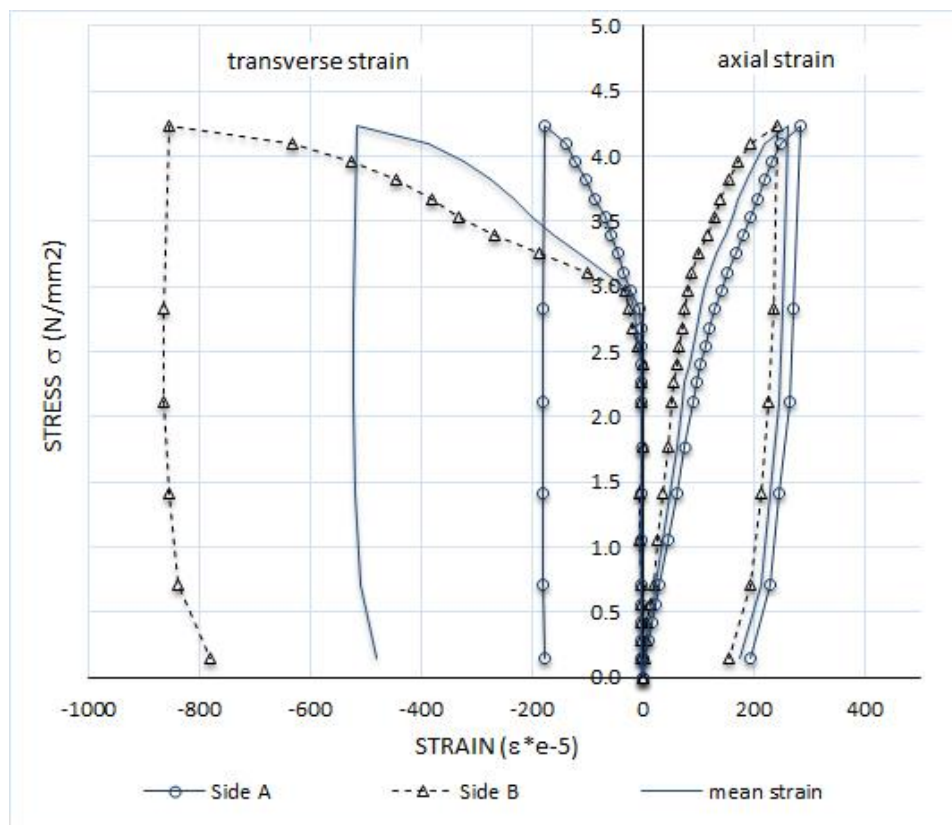
Figure 11. Axial and trasverse deformation of the specimen during compression test.

The compression test for the determination of the deformability modulus (E) and the compression strength (f_m) was carried out by increasing load levels up to the failure of the specimen. Figure 11 shows the behaviour of axial and transversal deformations of both faces of the specimen, as well as the average curves. It can be observed that the axial deformations of the two faces are very close to each other also after the limit of elastic behaviour. As regards the transversal deformations, it can be observed that the behaviour of the two faces is quite the same up to the limit of the elastic behaviour of the masonry. Over

this limit, a sudden diversion of the two curves is observed, with face B showing a much higher transverse deformation than face A.

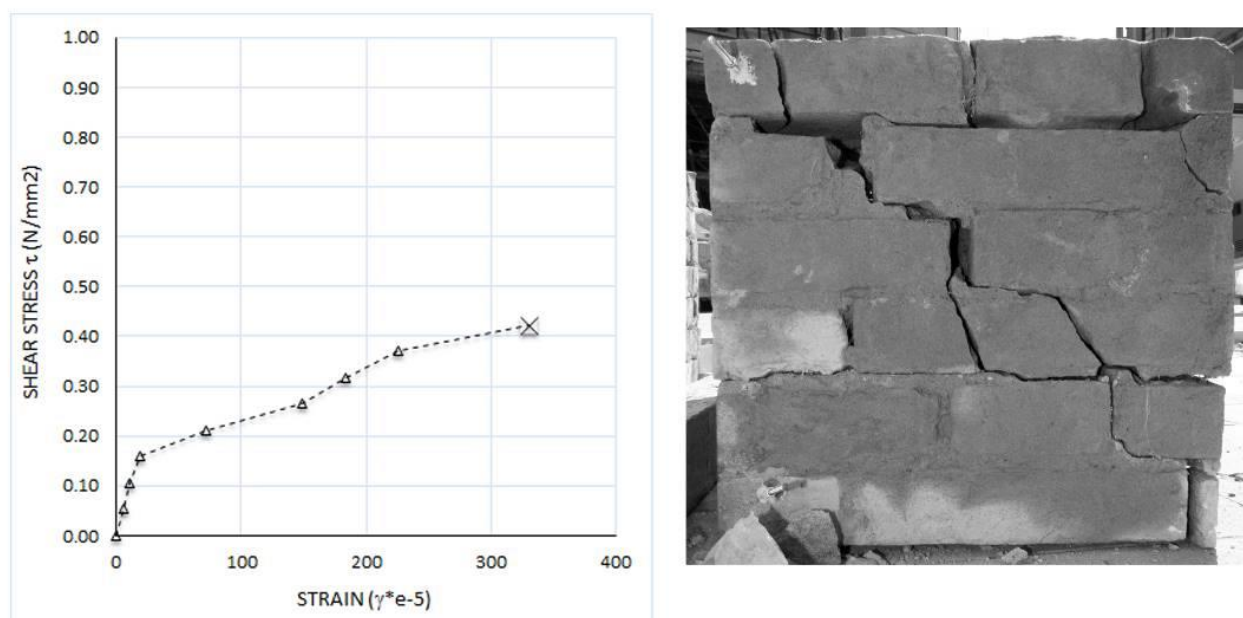
Figure 12. Shear stress-strain diagrams and detail of the masonry after the shear failure.

The diagonal compression test for the determination of the shear strength of the masonry specimen was carried out with increasing load levels up to failure. The shear moduli values are shown in Table 2

The shear strength obtained is $f_t = 0.16$ MPa.

A detail of the sample after the shear failure is shown in figure 12.
